RISING DAMP EVALUATION AND TREATMENT A QUASI-EXPERIMENTAL CASE STUDY

Submitted in Partial Fulfilment of the Requirements of
the Degree of Doctor of the Built Environment, May 2017

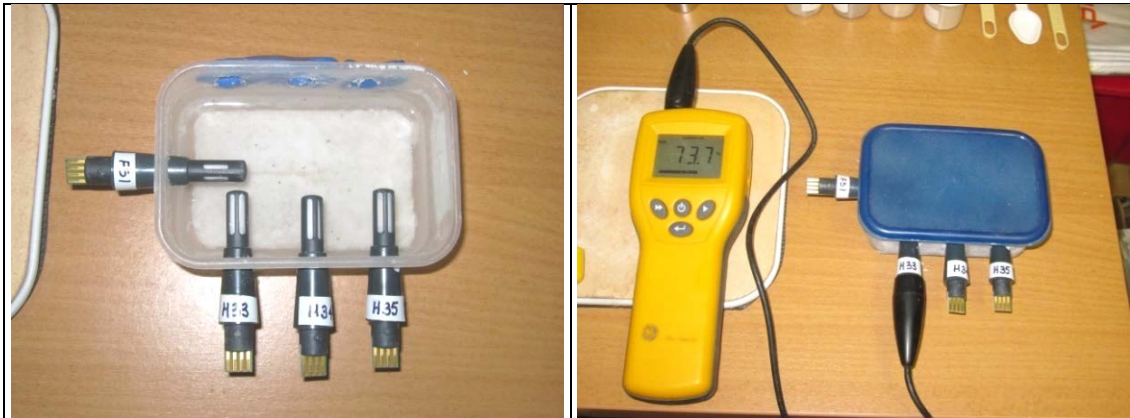
Figure 54: Hygrostick batch testing apparatus shown without lid.

This small plastic container was used for batch testing the Hygrosticks. In its base is a saturated solution of sodium chloride which provides the required 75.0% relative humidity environment when the container is sealed.

The Hygrosticks are pushed through 12 mm diameter holes drilled into the container's sides; the probe's tapered shape and rubberised surface provides an airtight seal.

The container accommodates eight Hygrosticks. In this example, only four are undergoing test. The unused holes on the rear and right-hand sides of the container are temporarily sealed with butyl tape.

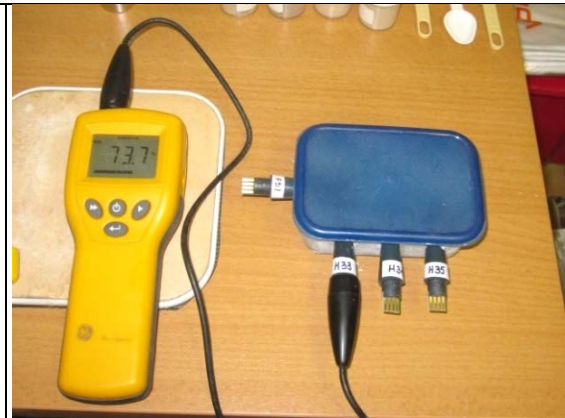
Figure 55: Hygrostick batch testing apparatus with Protimeter MMS meter attached.

The Hygrosticks are left in place for a few hours, typically overnight, and their relative humidity and temperature values subsequently read with a Protimeter MMS meter that is attached to each probe in turn using the proprietary extension lead as shown.

Hygrostick reference H33 is currently being read: its relative humidity, shown on the meter's display, is 73.7% which falls within the allowable tolerance of 75.0% \pm 2.0% for these sensors (GE Sensing, 2005, p. 17).

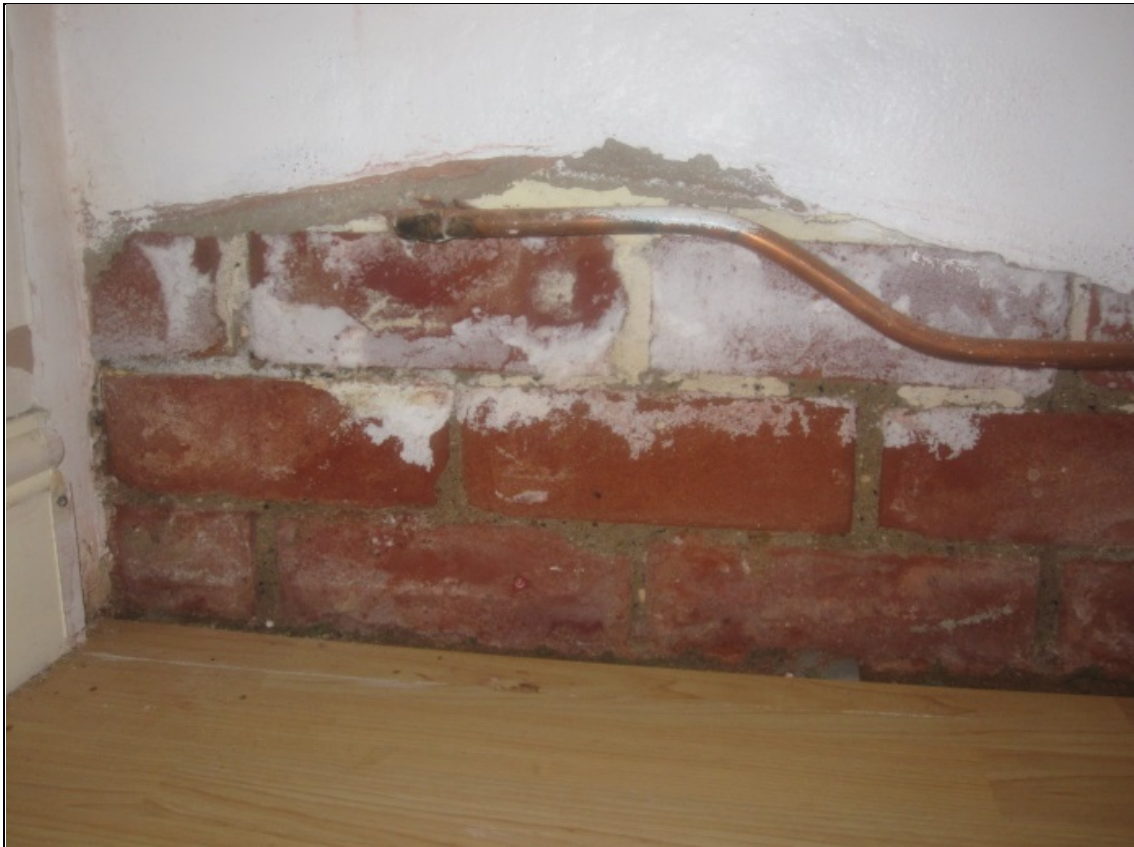
Figure 57: Understairs cupboard right-hand side wall (location of Panel A) illustrating the construction found behind the dry lining.

With the dry lining removed, the bottom three courses of brickwork were found to be without a plaster finish. Efflorescent salts had formed on the third brick course, suggesting evaporation of moisture and thus that this region of the wall was damp affected.

There were no such sampling issues with respect to the base of the understairs cupboard right-hand side wall because the plasterwork, which had previously been hidden by plasterboard dry lining, was discovered to have fallen away, thus exposing the bottom three courses of bricks. Thick deposits of efflorescent salts had accumulated on the face of the third course of these bricks, as shown on Figure 57 below. These efflorescent salts, which are not hygroscopic, essentially confirmed the wall to be damp affected: the salts crystallising on the surface from solution during the evaporation process (Property Care Association, 2007, p. 1).

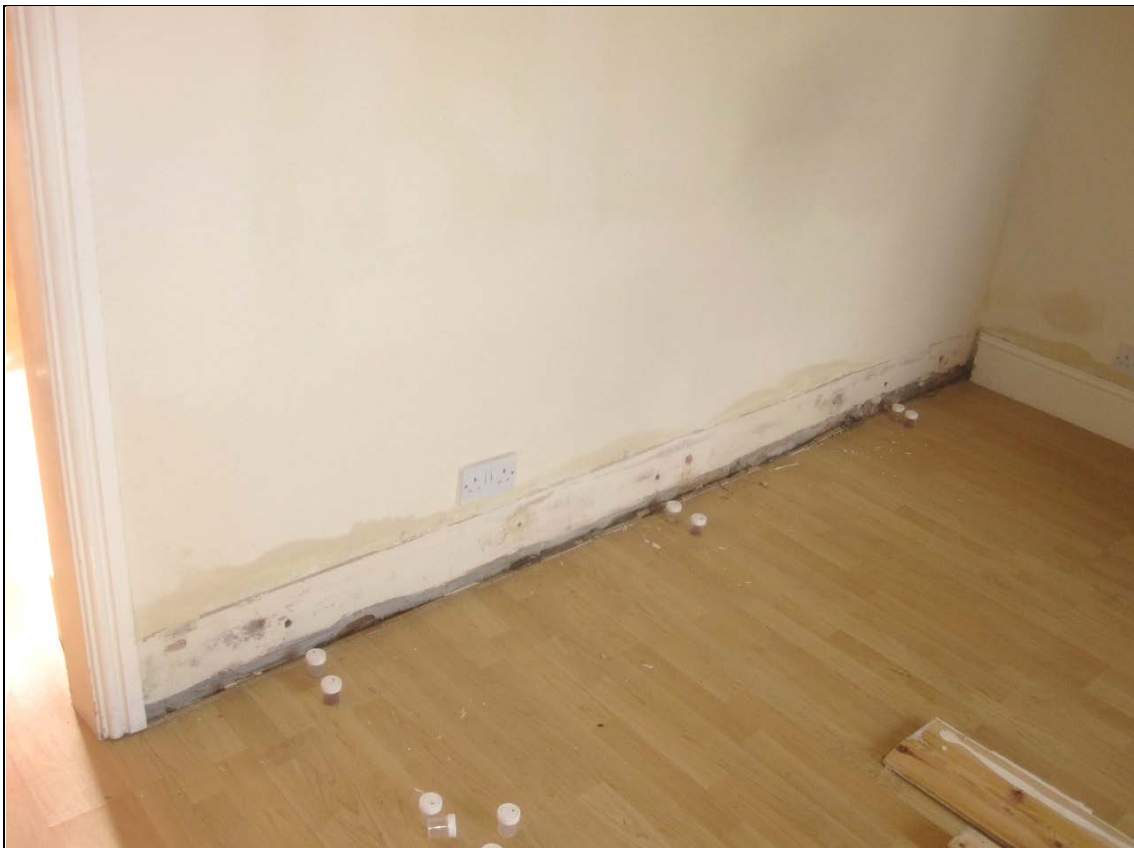
Figure 58: Living room rear wall removal of samples from panel positions C, D, and E for Stage 1 moisture analysis.

Of the samples removed from the base of Panels C, D, and E, the plasterwork portion was separated from the underlying brick portion and each placed into individual, screw topped, airtight containers to be taken off-site for processing.

Figure 58 and Figure 59 below illustrate the location of samples removed from Panels C, D, and E and Panels A and B, respectively. All drilled samples were placed in individual, screw topped, air tight containers, labelled, and taken off-site for processing.

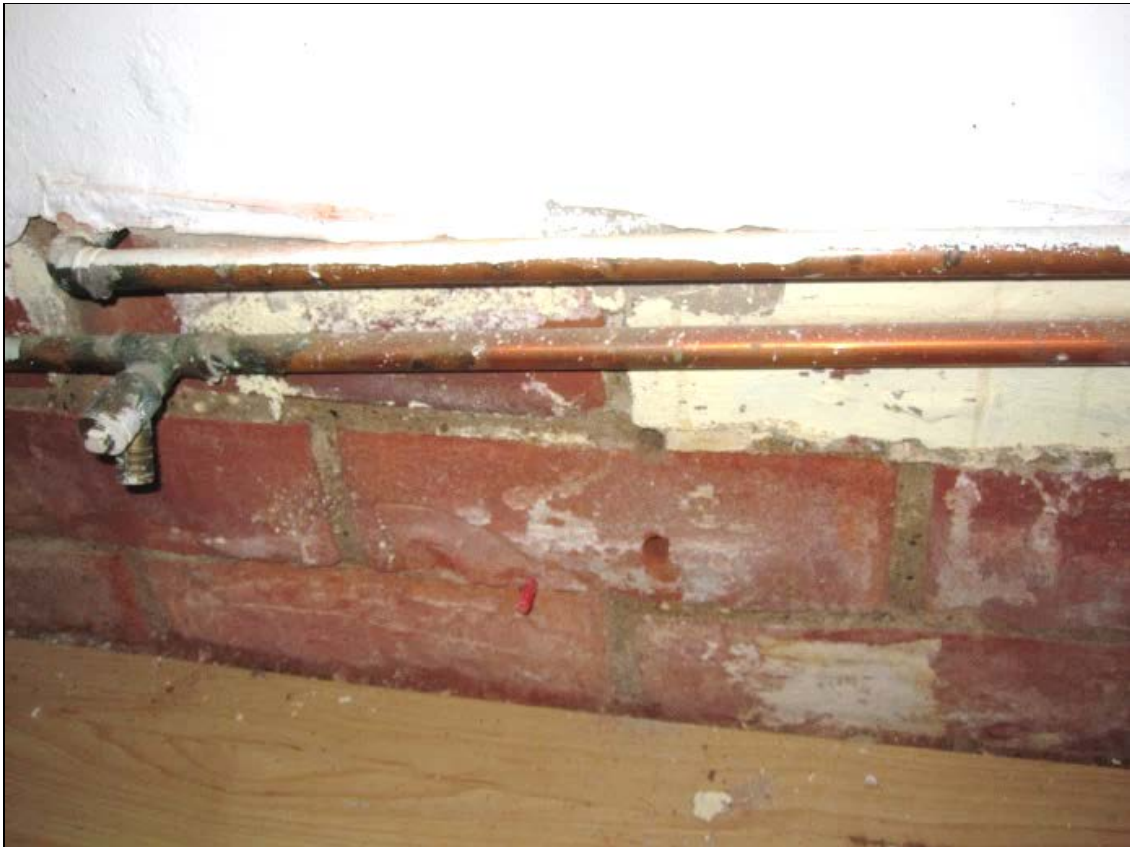
Figure 59: Understairs cupboard removal of samples from Panel A for Stage 1 moisture analysis.

For Panel A and the adjacent Panel B, samples were removed from the second brick course, 120 mm above floor level, and from the mortar joint between the second and third brick courses, 170 mm above the floor.

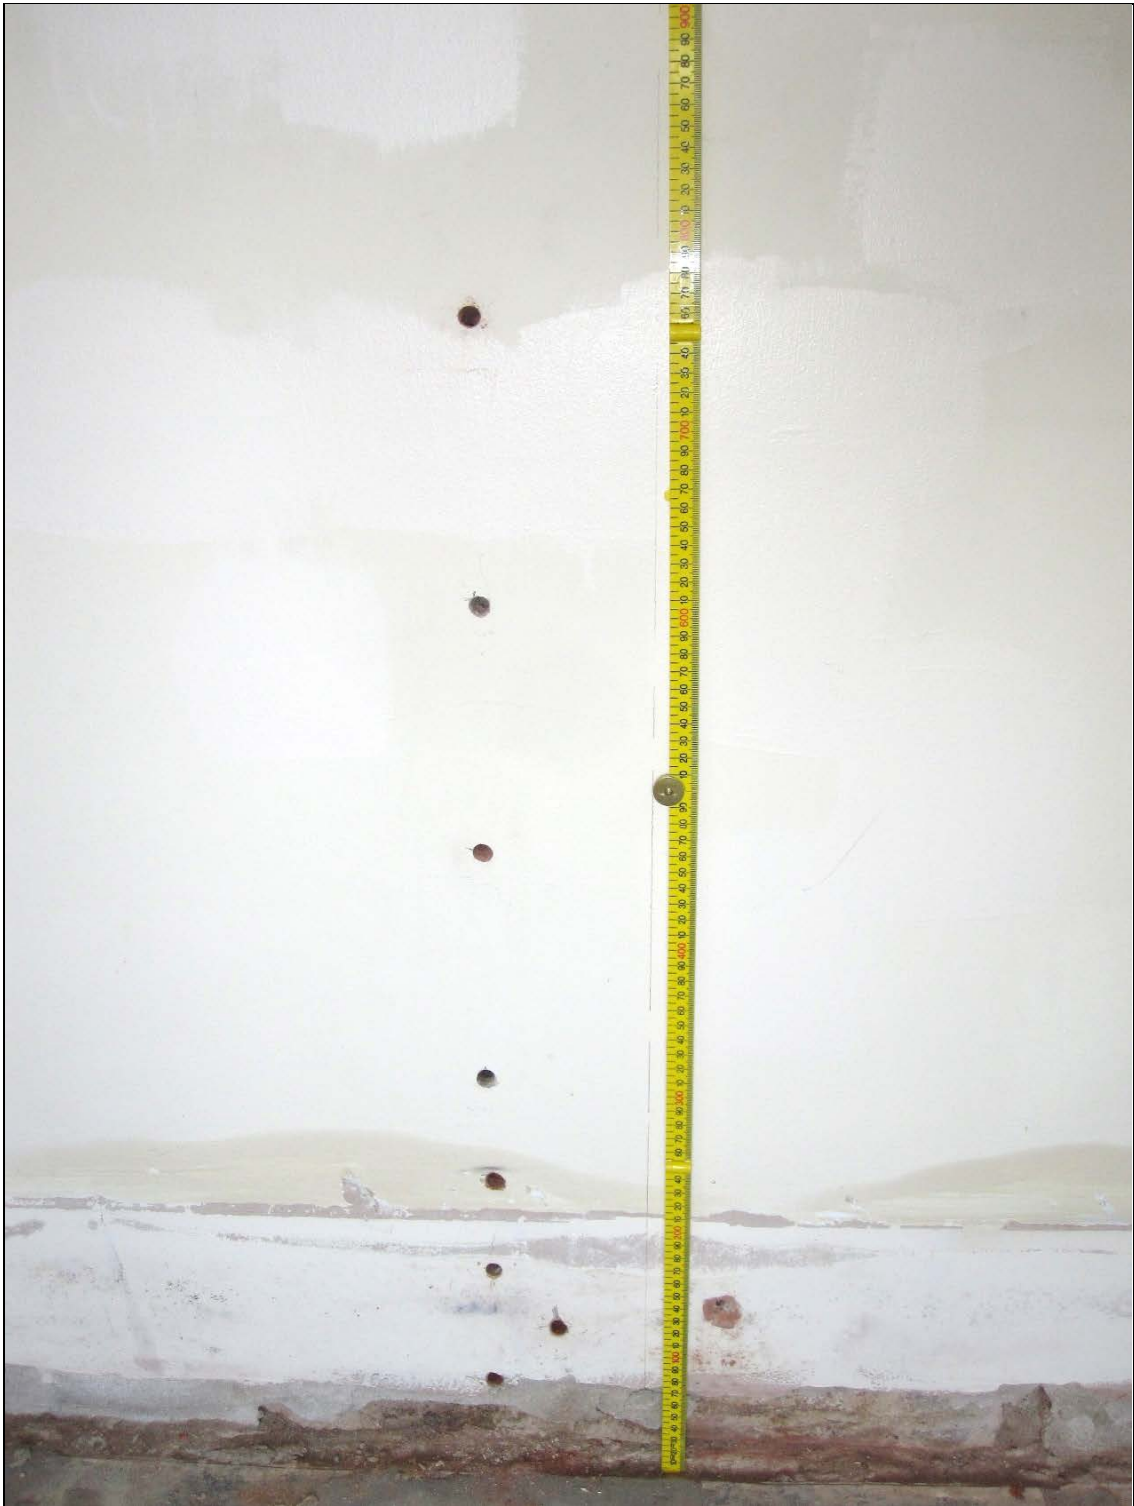
Figure 60: Panel D illustrating typical drilling pattern for Stage 2 moisture analyses.

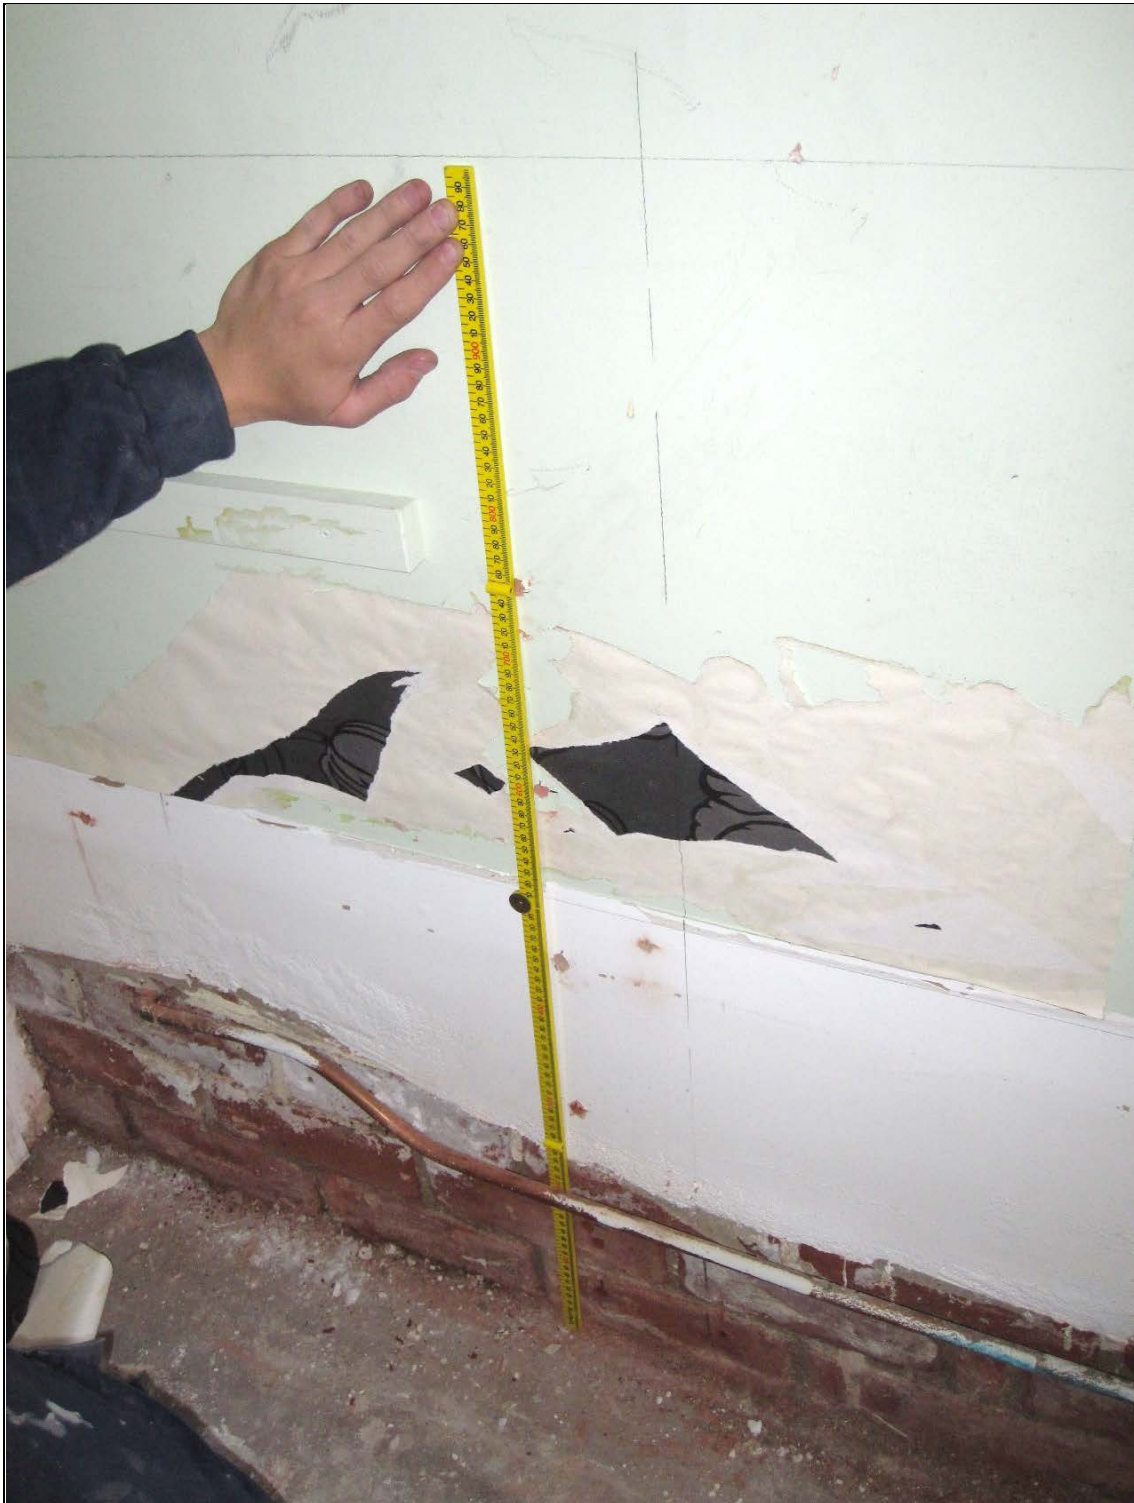
Figure 61: Panel A illustrating drilling pattern for samples required for Stage 2 moisture analysis.

The seven sampling points drilled in Panels A and B in the understairs cupboard were in essentially the same vertical positions as those drilled in Panels C, D, and E located in the living room. However, because of the absence of plaster at the wall base, the bottom three positions comprised a single sample of brick.

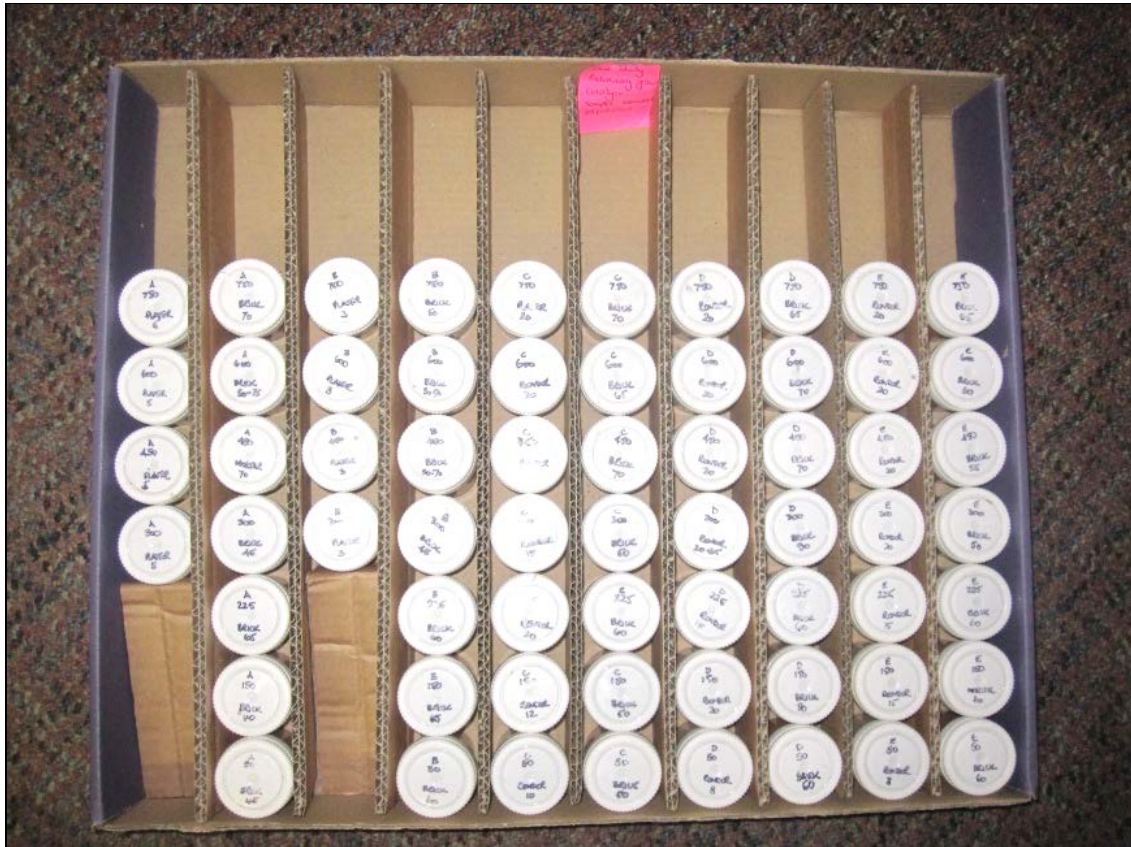
Figure 63: Samples obtained for the Stage 2 moisture analysis placed in individual air tight containers ready for processing.

For each of the seven sampling points of the individual test panels, the plaster portion, where available, was kept separate from the underlying masonry portion. Each of the samples was placed in individual, screw topped, air tight, containers, labelled, and taken off site to undergo gravimetric moisture analysis. In this photograph, the samples have been arranged in their respective positions: the first two columns representing Panel A, the second two columns Panel B, and so forth. For each pair of containers, the plaster portion is on the left and the masonry (predominantly brick) portion on the right. The bottom three containers of the left-hand columns of Panels A and B are missing because there was no plaster in these locations from which to obtain samples.

Each Stage 2 sample was placed in an individual, screw topped, air tight container, labelled, inserted into a container configured to represent its respective panel position, as shown in Figure 63 below, and taken off-site for processing.

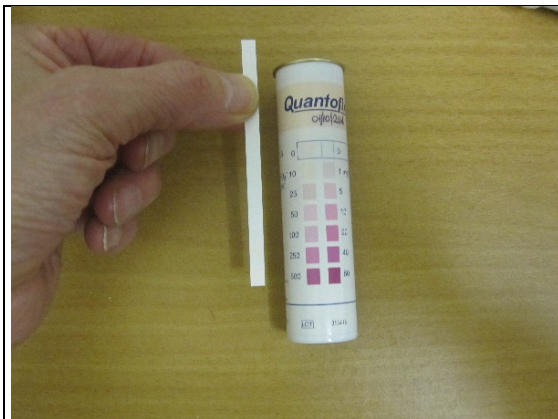
Figure 74: Quantofix nitrate test strip: unexposed strip.

This Quantofix test strip can be used to detect both nitrates and nitrites. The strip, which in this photograph has not yet been used, has two white tabs at its tip: the end tab is used for nitrate identification purposes. In use, the strip is dipped into water and the end tab changes colour in the presence of nitrates. By comparing the tab to a coloured scale printed on the side of the container, the nitrate concentration can be determined.

An unused nitrate test strip has an end tab that is white, as shown in Figure 74 below. In the presence of nitrates, this end tab becomes pink, as shown in Figure 75 below; the deeper this pink coloration, the more concentrated the nitrates. When used for testing, the strip is dipped into water for one second, removed, and after one minute compared to a seven-part, coloured scale provided on the test strip's container that is shown in Figure 74 and Figure 75. This scale provides the concentration of nitrates in values of 0, 10, 25, 50, 100, 250, and 500 milligrams per litre of water.

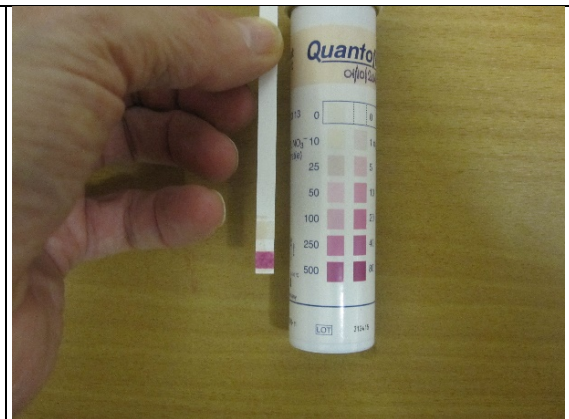
Figure 75: Quantofix nitrate test strip: positive result.

This Quantofix test strip has been dipped into a solution made up from 500 mg of sample mixed with distilled water. This particular strip was used to test the brick sample obtained from Panel B, position 4 at 300 mm above the floor. For nitrate detection, the end tab of the strip is compared to the colour of the scale printed on the left-hand side of the container. In this photograph, the test is strongly positive for nitrates with a match to the colour provided for a concentration of 500 mg/l.

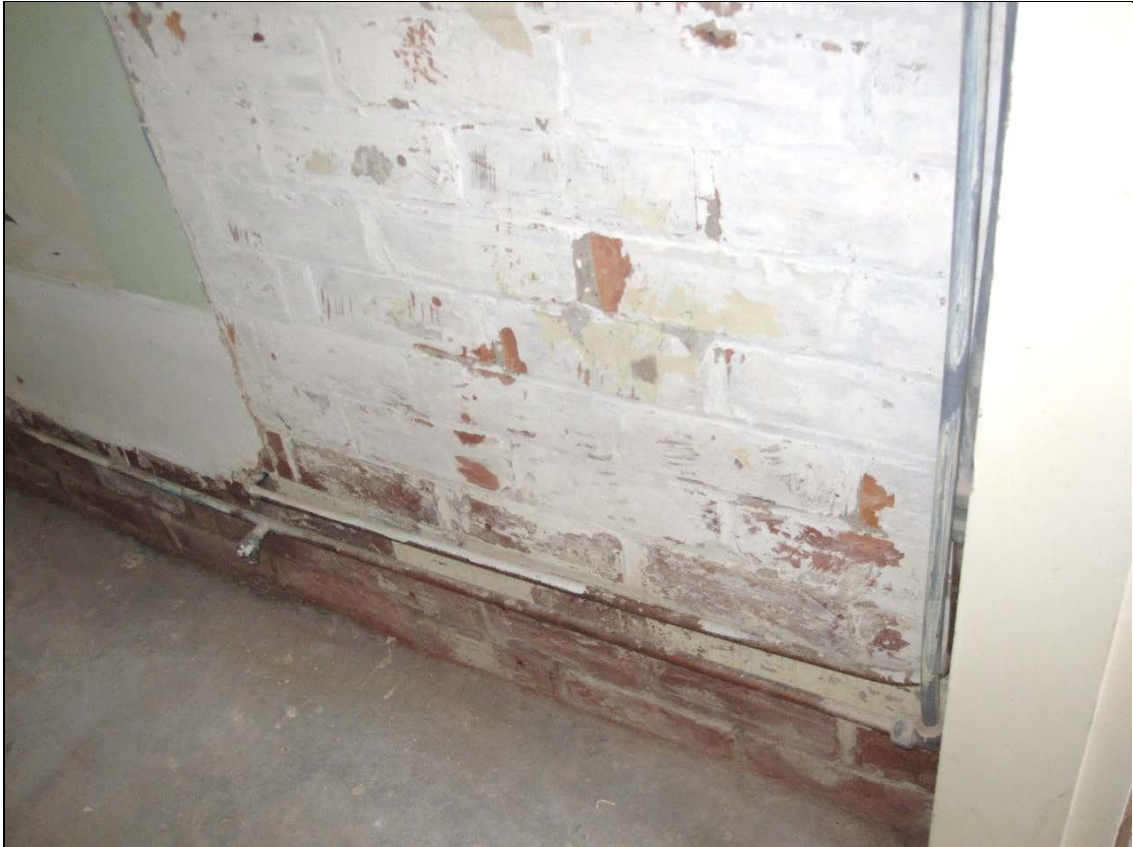
Figure 76: Panel B with existing plaster stripped.

Removal of the existing plaster from Panel B revealed it to be a slender coating just 3-5 mm thick. The underlying masonry wall was painted with white emulsion, which had deteriorated in the damp region at the base of the wall base, exposing the underlying brickwork.

The existing plaster on the face of Panel B was relatively thin, being just 3-5 mm thick, and varied from 8-20 mm on the face of Panel C and on the reverse side of both panels, as shown in Figure 76 and Figure 77 below.

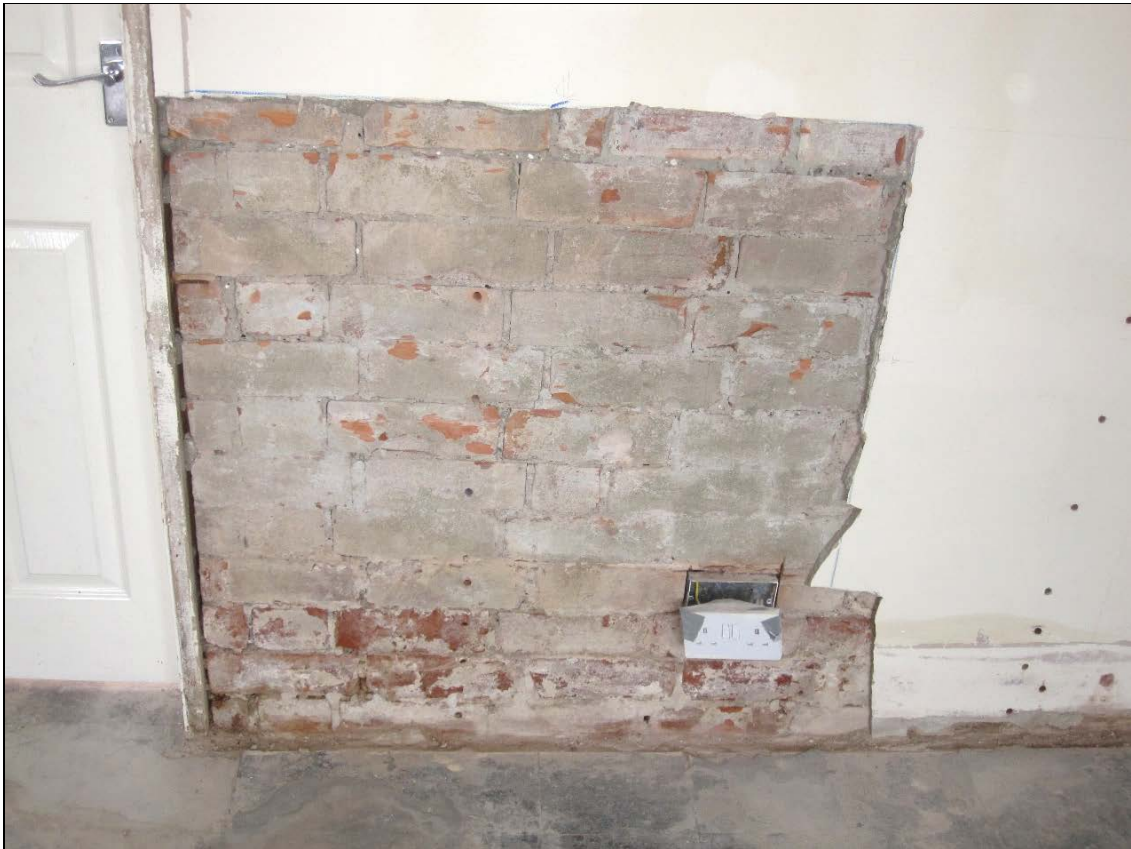
Figure 77: Panel C with existing plaster stripped.

Removal of the existing plaster from Panel C revealed it to vary in thickness from 8-20 mm. The existing plaster on the reverse sides of both Panel C and Panel B was of similar thickness.

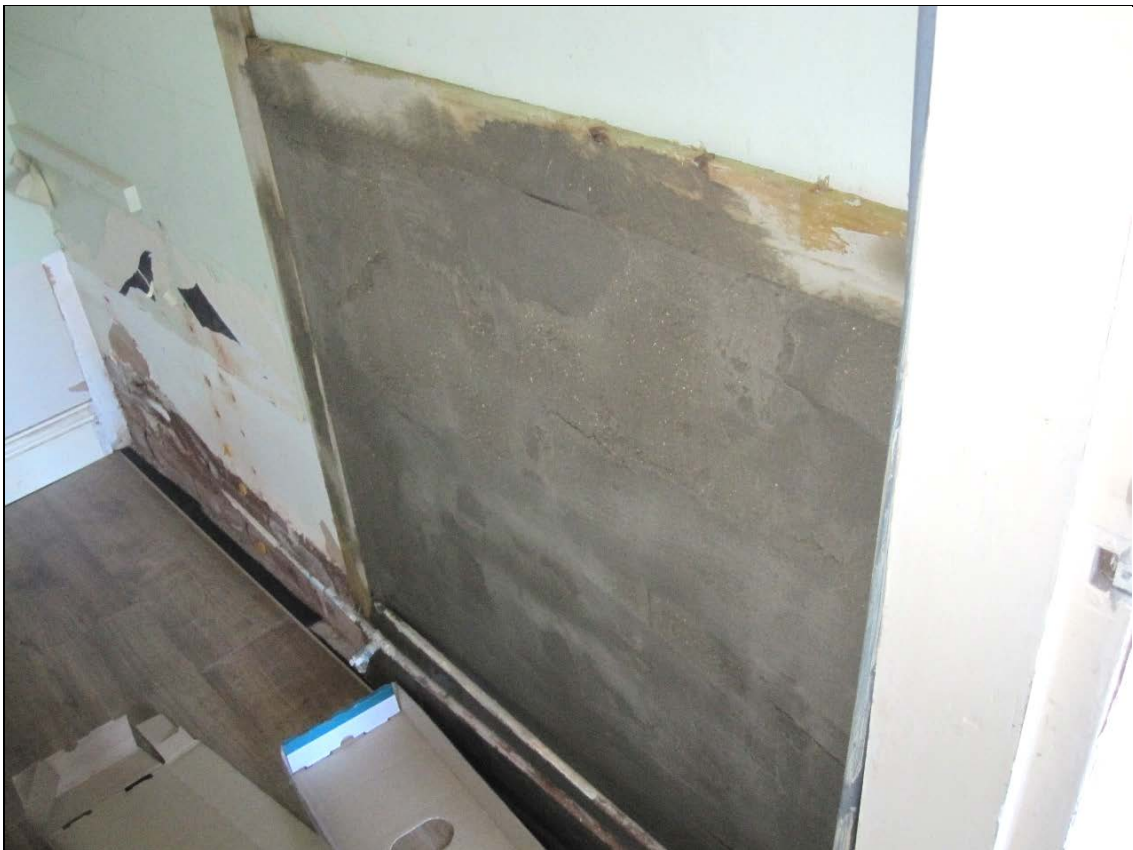
Figure 78: Panel B: low-permeability cement render applied.

20 mm thick battens were temporarily fitted at the top and side edges of Panel B to serve as guides and enable two accurately controlled 10 mm thick coats of cement render to be applied.

render was intended to evaluate the effect of restricting evaporation from the panel's surface and thus to determine how this may influence capillary moisture within the depth of the wall. Therefore, rather than attempt reinstatement within the available 3-5 mm thickness, 20 mm deep timber battens were fixed to the side and top edges of Panel B, as shown in Figure 78 below, to serve as guides and enable the manufacturer's specified thickness of render to be applied.

Mixing and application of the low-permeability cement render was undertaken in accordance with Safeguard Europe's specification for such work and their Renderguard

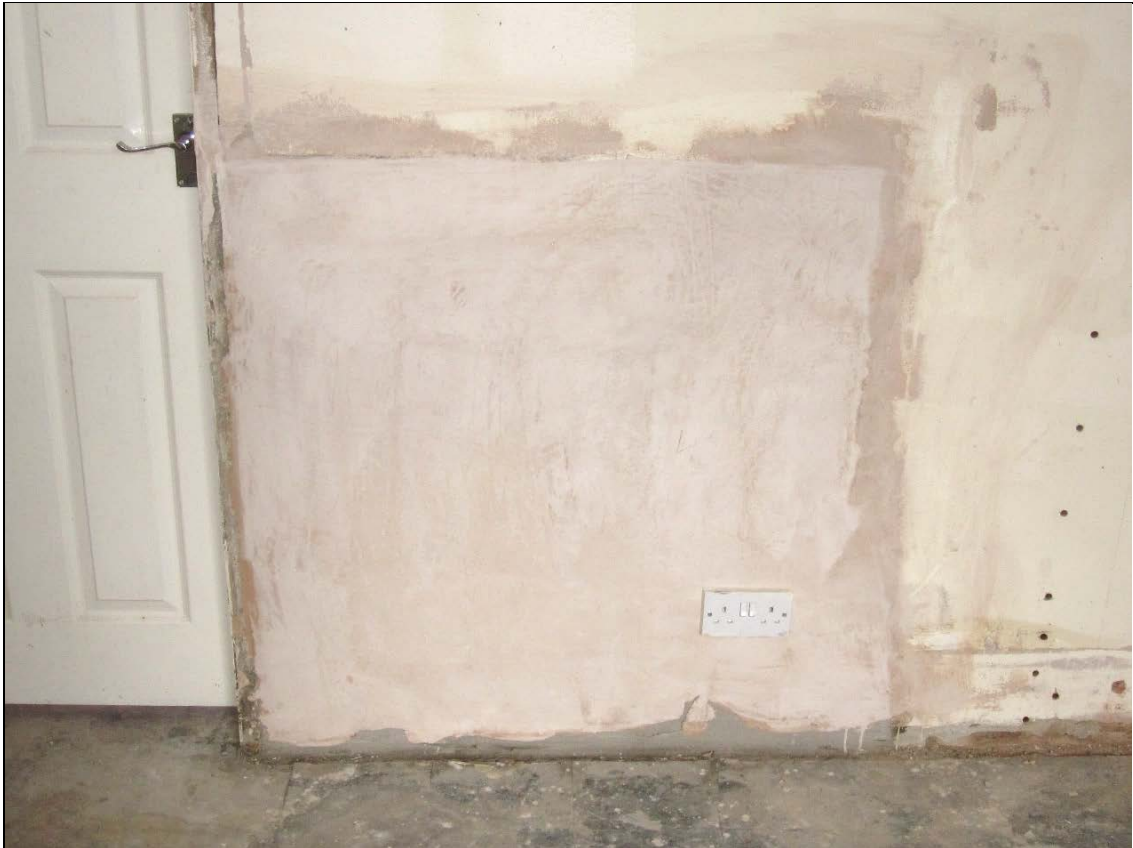
Figure 79: Panel C on completion of plasterwork reinstatement.

Panel C four days after the plaster finish coat had been applied to the low-permeability cement render backing coat.

Gold additive was used in the batching water (Safeguard Europe Ltd., 2005).³¹ Although not essential for the purposes of the study, a finish coat of Thistle Board Finish plaster was applied to the render. The completed plasterwork of Panel C's front face is shown in Figure 79 below with the reverse side of this panel and of Panel B shown in Figure 80 overleaf.

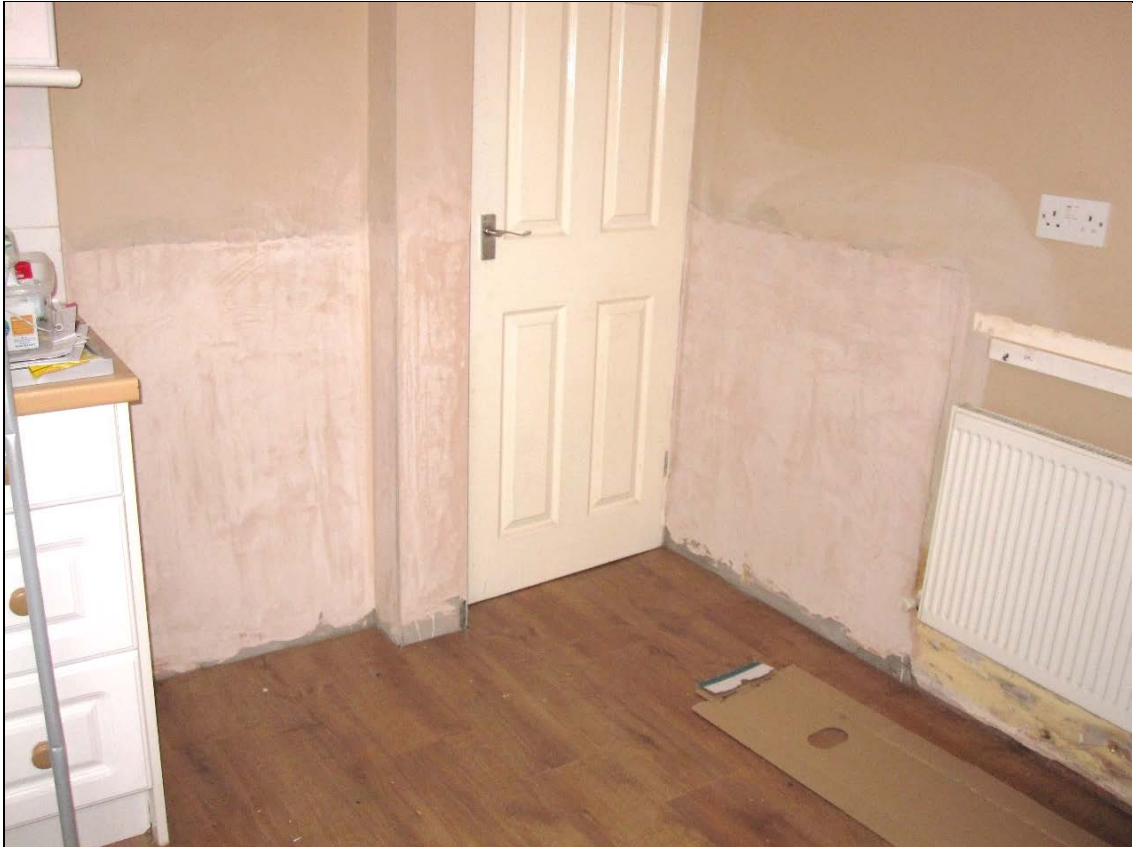
Figure 80: Panels B and C reverse side on completion of plasterwork reinstatement. Reverse side of Panel B (right side of door opening) and Panel C (left side of door opening) after the plaster finish coat had been applied to the low-permeability cement render backing coat.

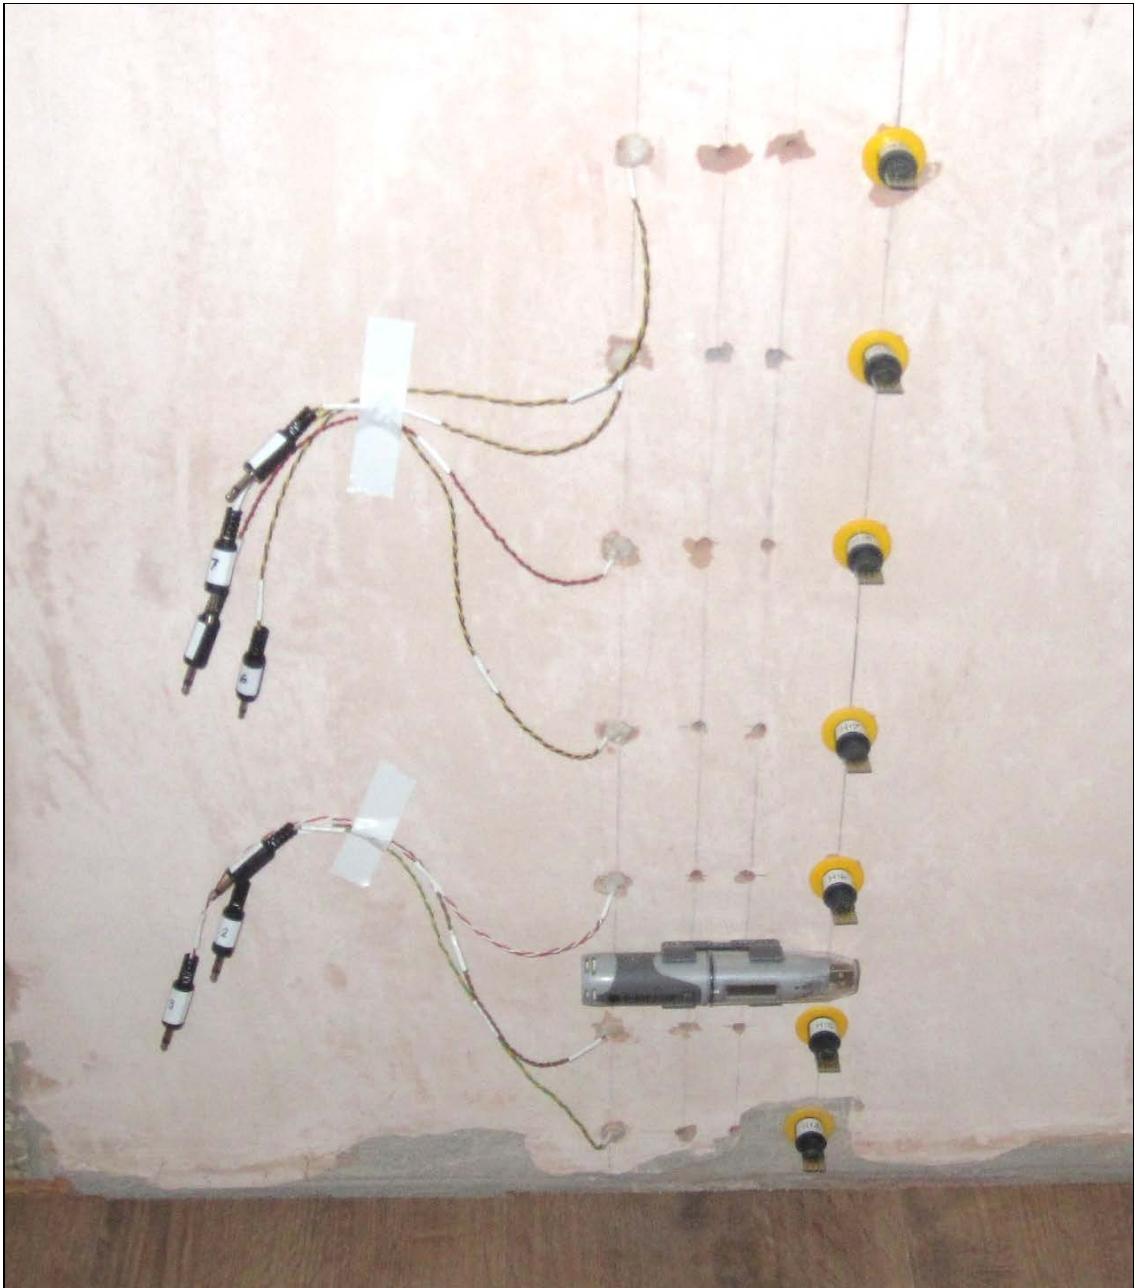
Figure 83: Panel C typical moisture measuring apparatus configuration with Hygrosticks in place.

Typical configuration of test panels following installation of the Hygrosticks into the Humidity Sleeves.

Figure 83 below shows the same panel with Hygrosticks inserted into each of the Humidity Sleeves.

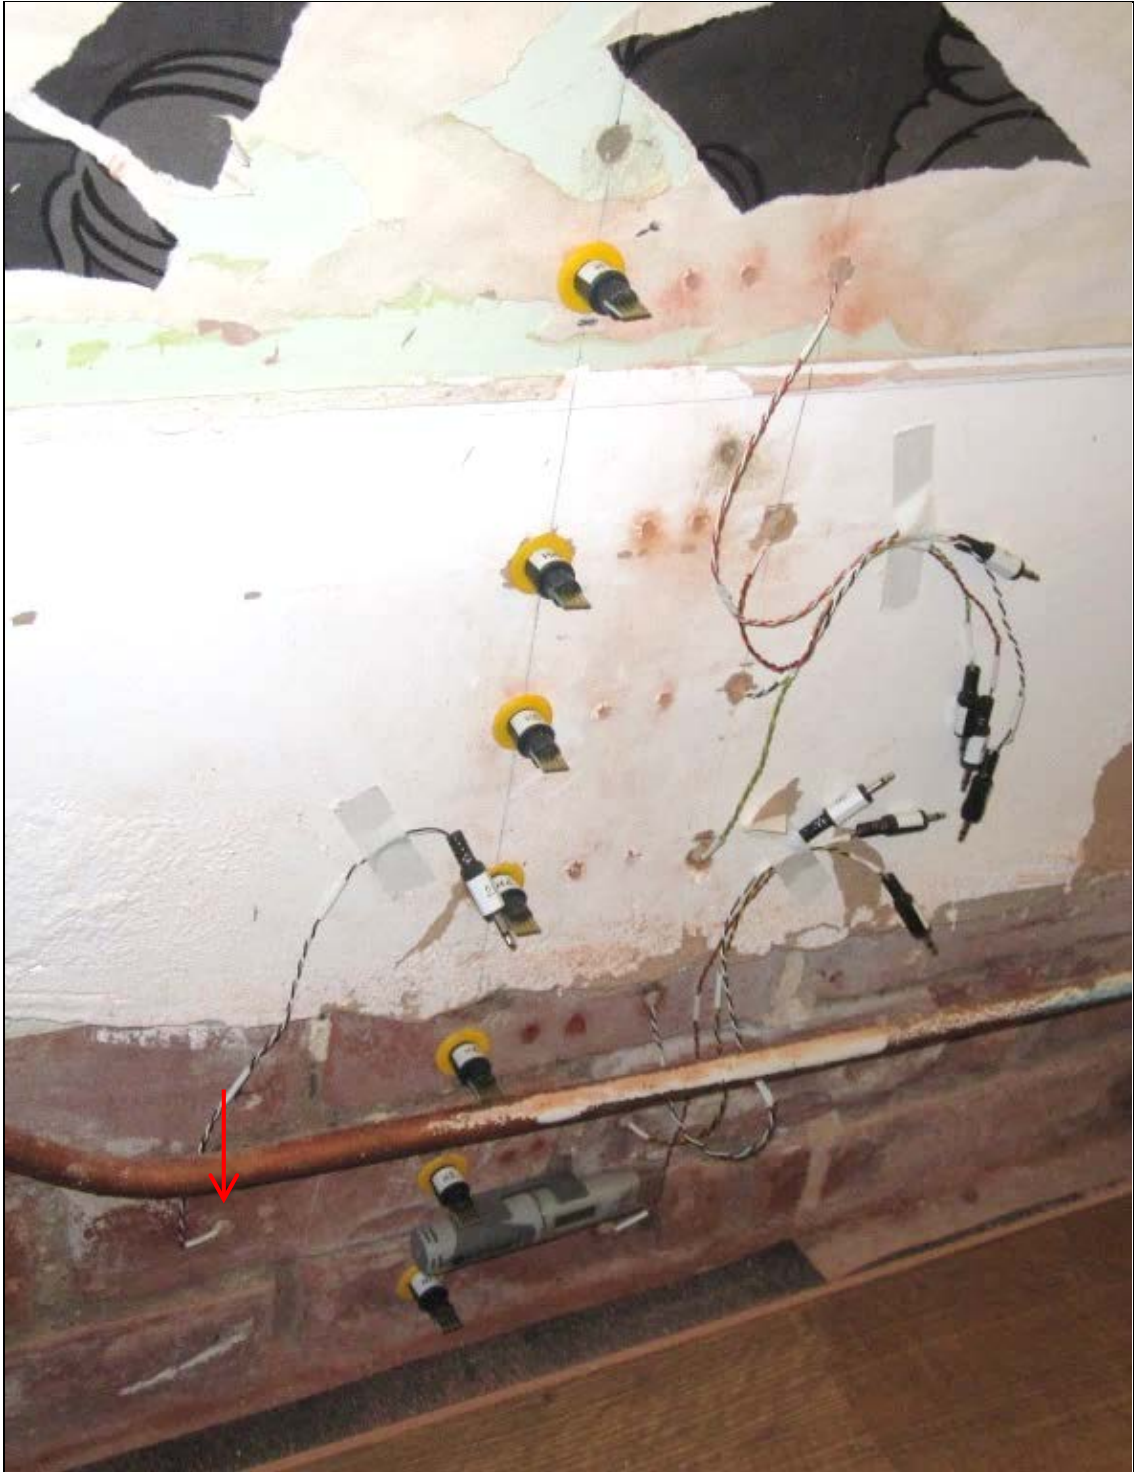
Figure 84: Panel A with additional Timber Probe Type 1 installed in row 2.

Panel A with moisture monitoring equipment in place. The additional Timber Probe Type 1 was installed in row 2 (arrowed) 100 mm to the left of the column of Humidity Sleeves.

The necessity to take two additional masonry samples from A2 and B3 for Stage 3 moisture analyses had required the drilling of two further holes. Into these two extra holes were placed, respectively, an additional Timber Probe Type 1 and a Humidity Sleeve, as shown in Figure 84 and Figure 85 below, to complete the basic apparatus configuration of these two panels.

on Panels C, D, and E, a far more significant rise affected Panels A and B: 20.3-28.7°C for Hygrosticks A1-A7 and 20.7-24.5°C for B1-B7. These anomalous values were attributed to heat from a radiator that was mounted on the kitchen side of Panel A and, as pictured in Figure 84 and Figure 85 above, from uninsulated central heating pipes that extended across the bases of Panels A and B.

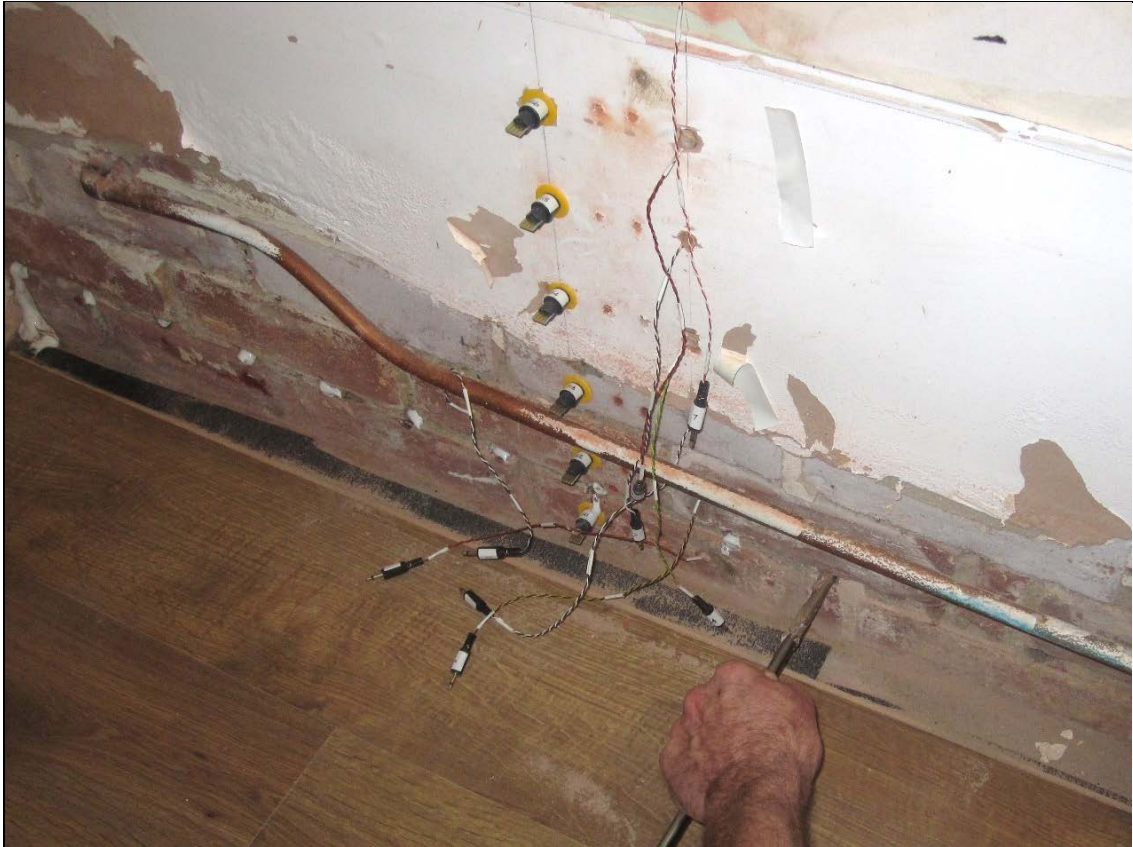
Figure 87: Panel A inserting damp proofing cream into pre-drilled holes.

Inserting the damp proofing cream into the pre-drilled 12 mm diameter holes of Panel A using the proprietary applicator.

Panel A was to receive the damp proofing cream but its plaster was not to be replaced. This damp proofing cream was installed in the lowest horizontal mortar bed joint using the procedure described earlier in this chapter and illustrated in Figure 86 and Figure 87 below.

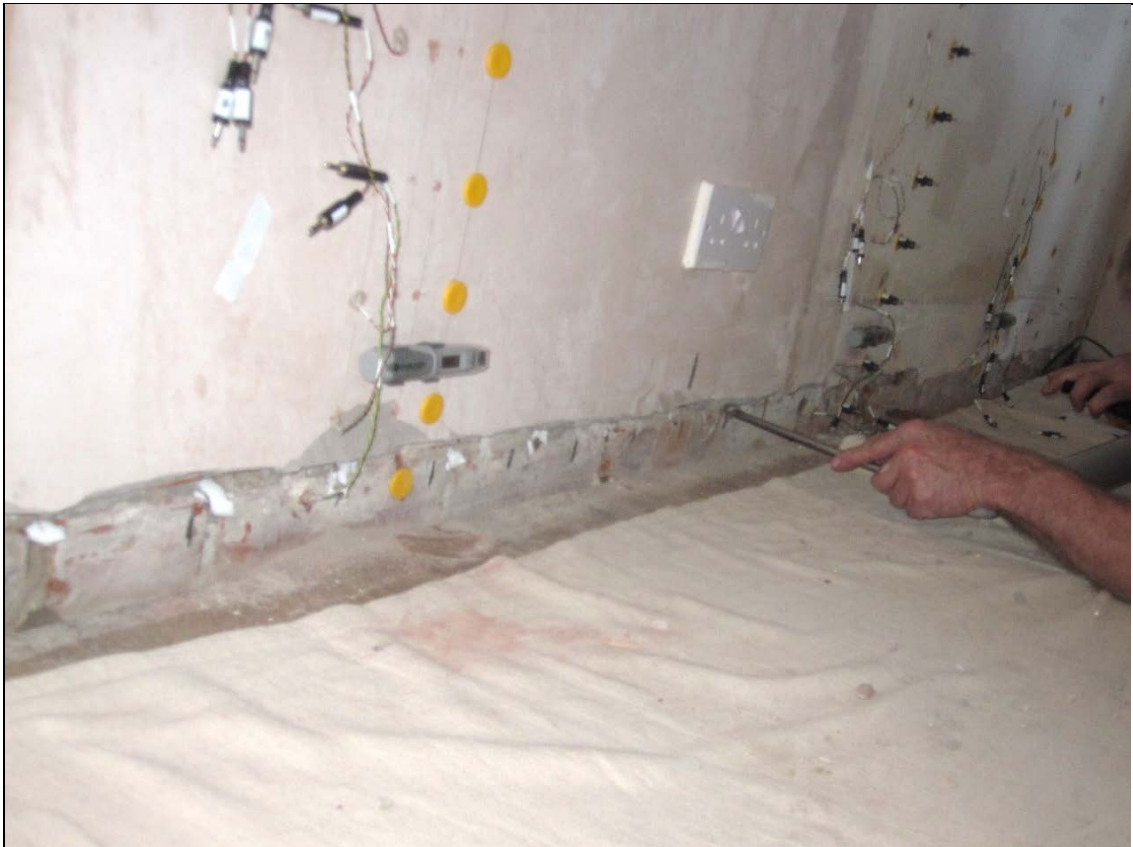
Figure 88: Panel C inserting damp proofing cream into pre-drilled holes.

Inserting the damp proofing cream into the pre-drilled 12 mm diameter holes of Panel C using the proprietary applicator. To accommodate this treatment, the bottom edge of the render has been trimmed to expose the horizontal mortar bed joint.

For Panel C, low-permeability cement render had been applied at Stage 3 Step 1. To facilitate installation of the damp proofing cream the bottom edge of this render was trimmed to expose the lowest horizontal mortar bed joint; in all other respects, the method of installation was identical to that used on Panel A, as shown in Figure 88 below.

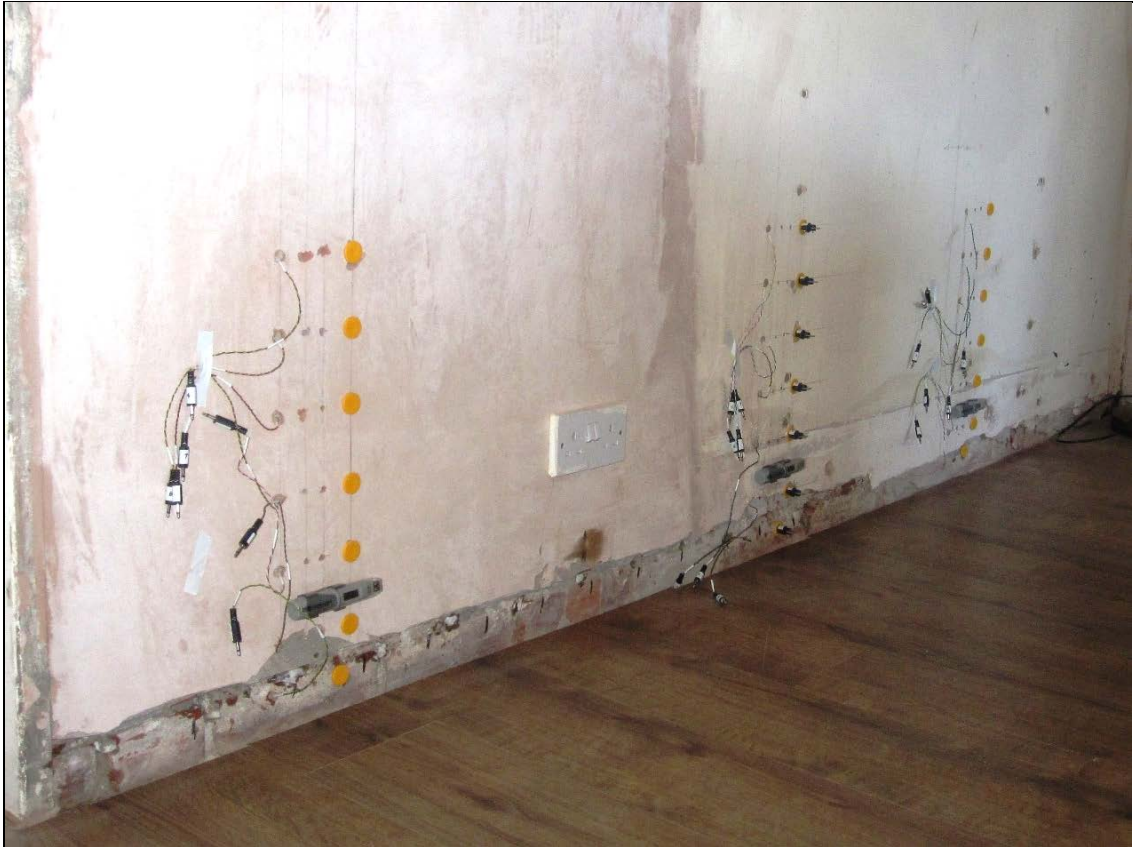
Figure 89: Panels C, D, and E: initial test panel set-up complete.

Panels C, D, and E with initial set up complete:

- Moisture measuring apparatus installed;
- Panel C's low-permeability render applied;
- Bottom edge of plasterwork trimmed above the lowest horizontal mortar bed joint;
- Holes drilled in the lowest mortar bed joint of Panels C and D to accommodate the damp proofing cream;
- Damp proofing cream inserted into the pre-drilled holes of Panel C.

Finally, for consistency the bottom edge of the plasterwork of Panel E (the control) was trimmed above the lowest horizontal mortar bed joint. The arrangement of the three panels, C, D, and E, is shown in Figure 89 below.
