RISING DAMP EVALUATION AND TREATMENT A QUASI-EXPERIMENTAL CASE STUDY

Submitted in Partial Fulfilment of the Requirements of
the Degree of Doctor of the Built Environment, May 2017

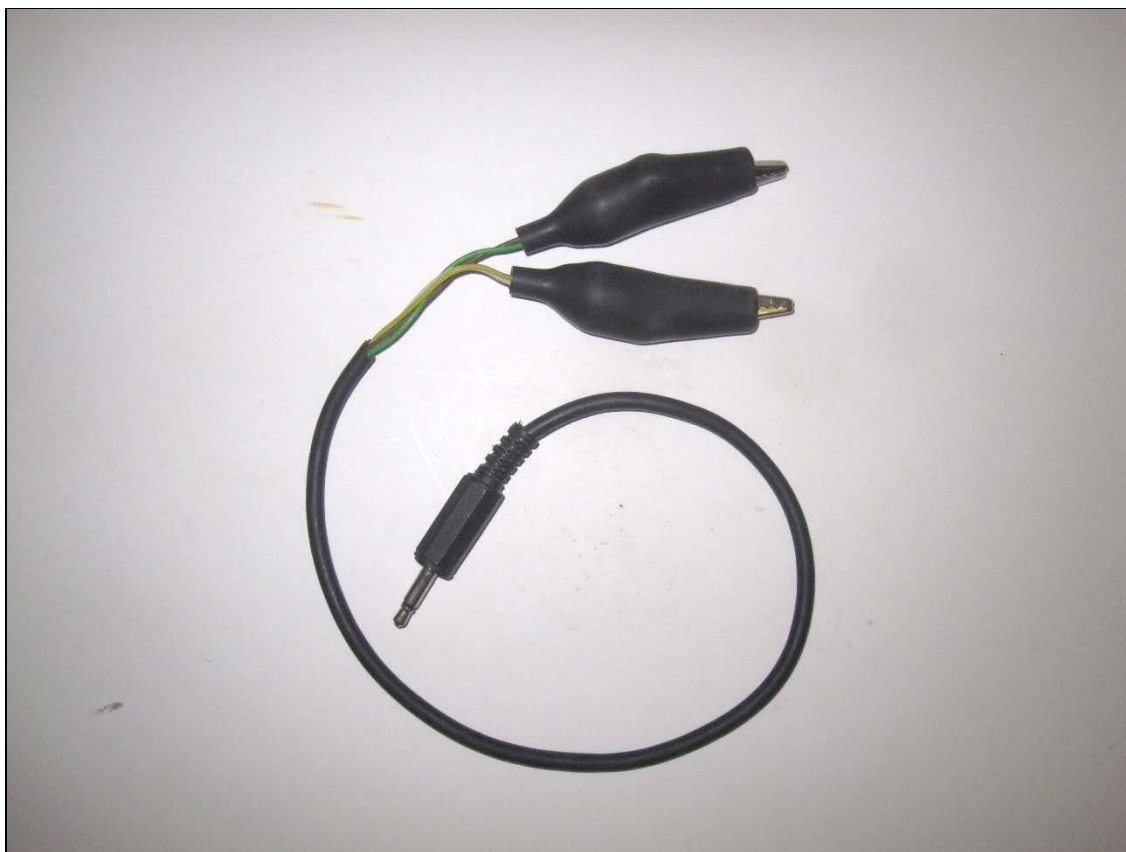
Figure 95: Timber Probe Type 1 test lead.

The test lead comprised a standard, 2-pole, 3.5 mm jack plug with each of its attached wires terminated with an insulated crocodile clip. Following removal of their original jack plugs, this test lead enabled the remaining parts of the Timber Probe Type 1 undergoing test to be connected to the Protimeter.

The Type 1 probes had been installed in tight-fitting holes to ensure maximum contact with the surrounding masonry. Contact with moisture caused their dowel bodies to expand and this meant they could not easily be removed from their accommodating holes. Despite this difficulty, it was possible to test the continuity of the external wiring and the 3.5 mm jack plugs that connected the probes to the Protimeter. These tests were carried out using a multi-meter and a test lead, shown in Figure 95 below, that had been constructed for this purpose.

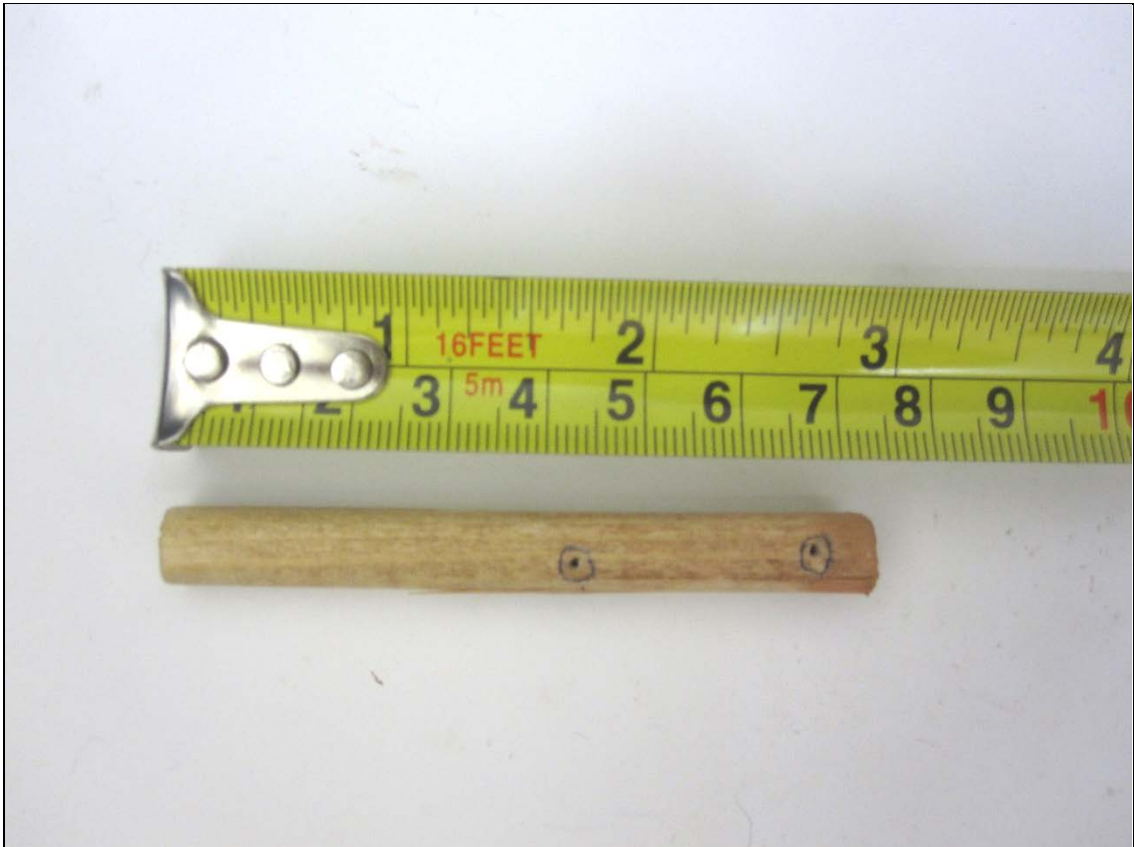
Figure 96: 9 mm diameter plain softwood dowel.

The plain softwood dowels were made from 75 mm lengths of the same 9 mm dia. timber used for the bodies of the Timber Probes Type 1. The holes where the needles of the Protimeter Heavy Duty Probe are inserted are circled.

To insert these dowels, one of the pair of 5 mm diameter holes that had been drilled to accommodate the Deep Wall Probes was enlarged to 9 mm. This size hole enabled the plain dowels to make good contact with the masonry while allowing sufficient width for expansion of the timber and, importantly, easy removal. Before insertion, the pins of the Protimeter Heavy Duty Probe were pushed into the dowels' surface to create two small holes that marked where future measure-mode values would be taken, as shown in Figure 96 and Figure 97 below.

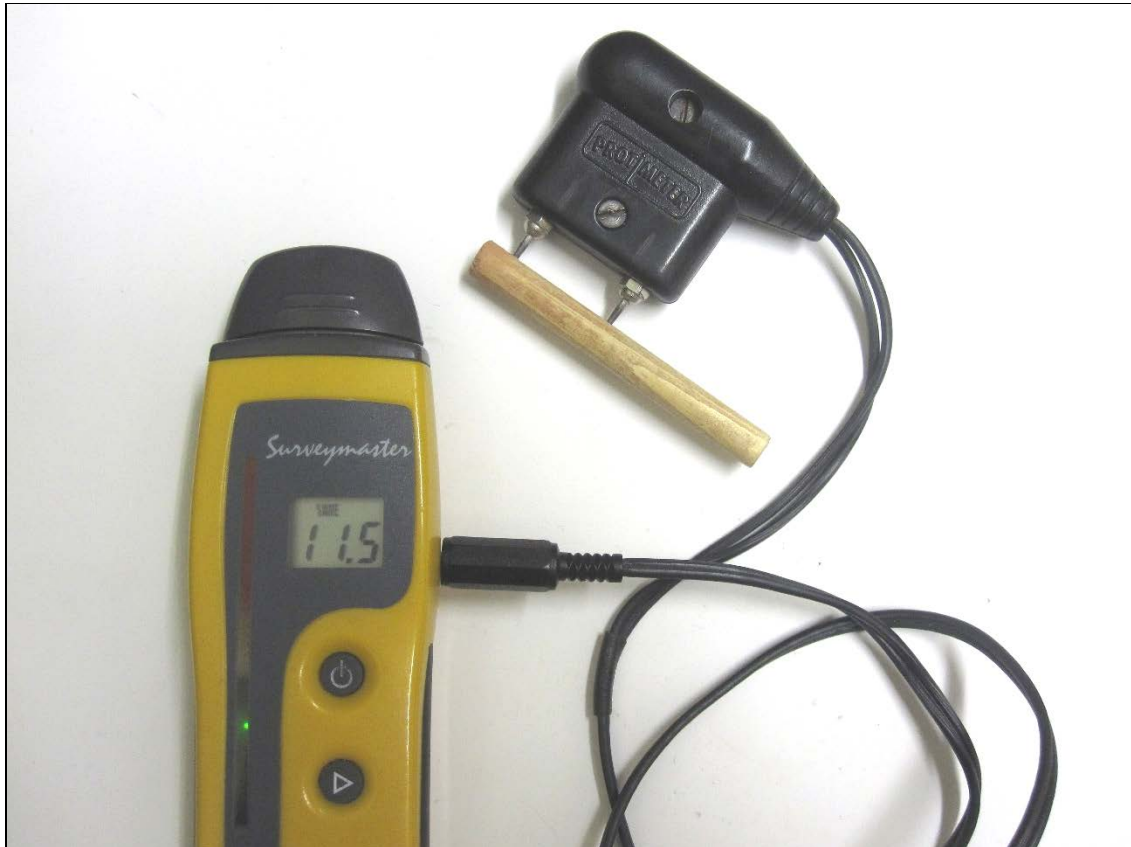
Figure 97: 9 mm diameter plain softwood dowel undergoing reading using the Protimeter measure-mode function.

Protimeter measure-mode values are obtained from the 9 mm dia. plain softwood dowels by removing them from their accommodating hole and pushing the needles of the Heavy Duty Probe directly into the timber surface. In this photograph, the Protimeter display shows 11.5%.

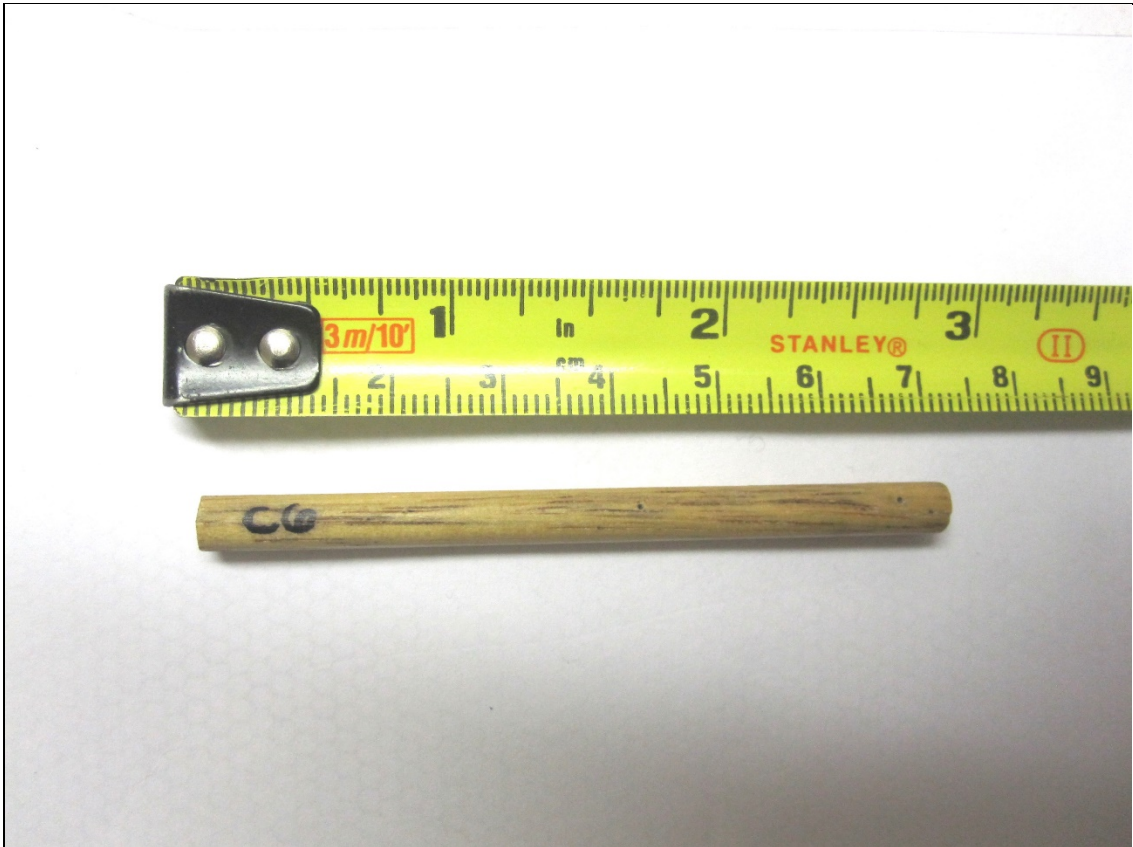
Figure 98: 5 mm diameter plain hardwood dowel.

5 mm dia. hardwood dowel was cut into 75 mm lengths and inserted into the test panels following enlargement to 6 mm of one of the pair of 5 mm dia. holes previously drilled to accommodate the Deep Wall Probes of the Protimeter.

Secondly, given the positive outcome of the 9 mm plain softwood dowels, this method would be extended across all five panels and used as an additional method of monitoring moisture change. To avoid unnecessary disturbance of the test panels, 5 mm hardwood dowel was sourced from a local timber merchant, cut into 75 mm lengths, as illustrated in Figure 98, and installed by enlarging one of the pair of existing 5 mm diameter holes in each of the seven rows of the five panels to 6 mm.

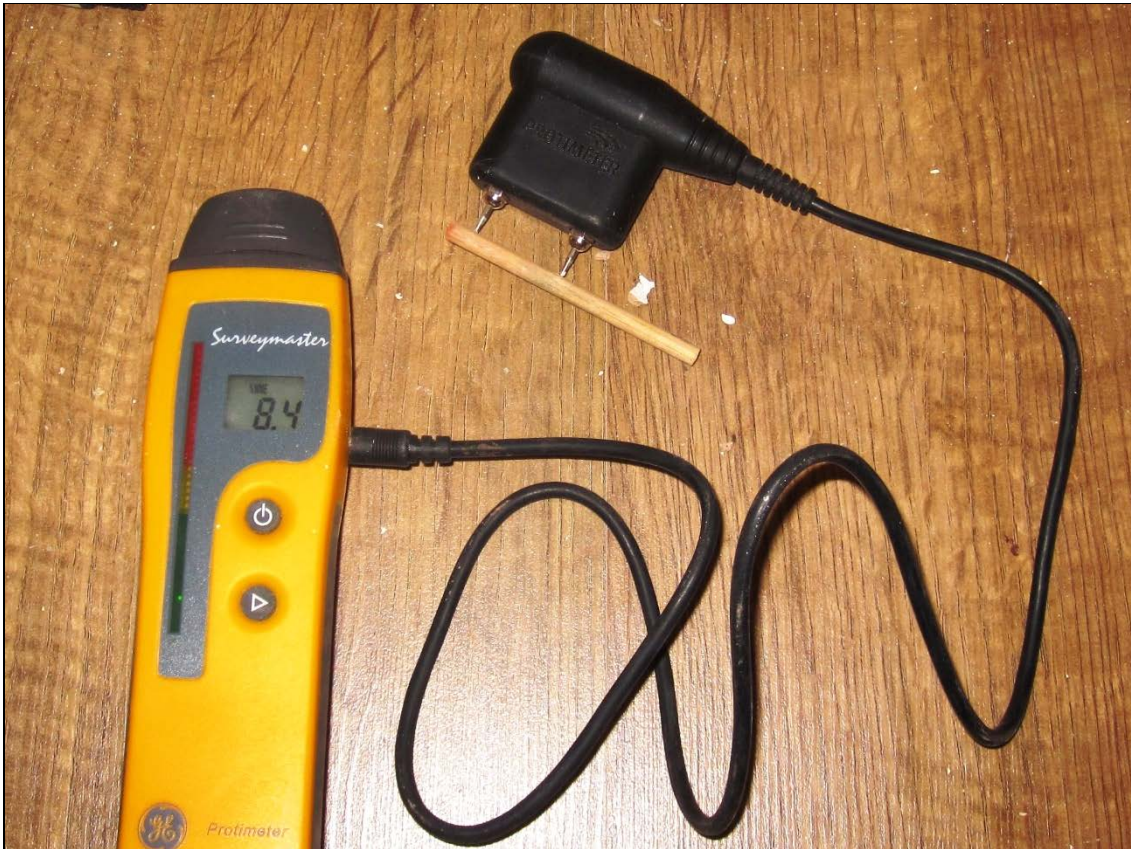
Figure 99: 5 mm diameter plain hardwood dowel undergoing reading using the Protimeter measure-mode function.

Protimeter measure-mode values are obtained from the 5 mm plain hardwood dowels by removing them from their accommodating hole and pushing the needles of the Heavy Duty Probe directly into the timber surface. In this photograph, the Protimeter display shows 8.4%.

The method used to obtain Protimeter measure-mode values from these 5 mm plain hardwood dowels was, as shown Figure 99 below, precisely the same as that described previously for the 9 mm plain softwood dowels.

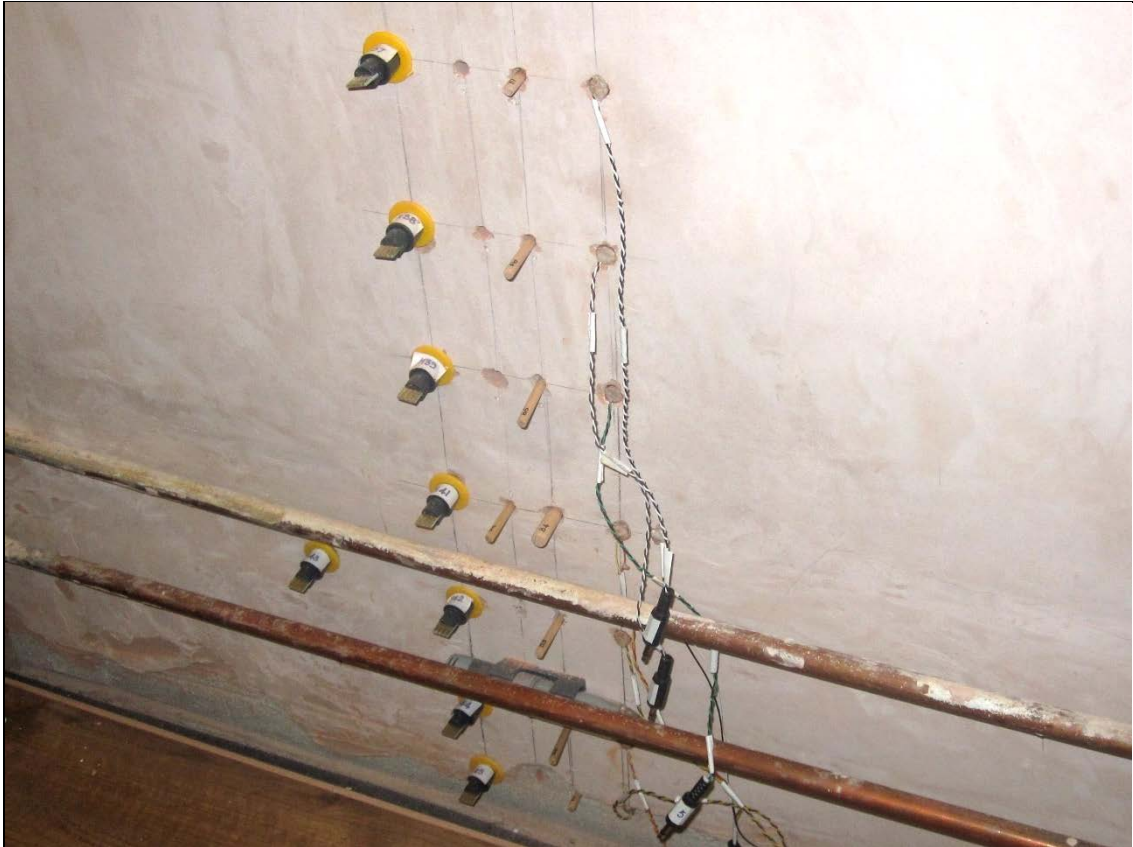
Figure 100: Panel B illustrating final configuration of the moisture measuring apparatus.

This photograph of test Panel B illustrates the final configuration of moisture measuring apparatus. The original equipment is in seven rows with each row comprising a Hygrostick, two 5 mm dia. holes to accommodate the pins of the Protimeter Deep Wall Probe, and a Timber Probe Type 1. In Panel B, an extra Hygrostick had been installed in row 3, an additional Timber Probe Type 1 and 9 mm dia. plain softwood dowel in row 4, and 5 mm dia. plain hardwood dowels inserted into one of each pair of the central holes following its enlargement to 6 mm.

Installation of the 5 mm plain hardwood dowels was undertaken on the 18 January 2013, completing the configuration of moisture measuring apparatus, as illustrated, as an example, for Panel B in Figure 100 and Figure 101 below. With the exception of periodically replacing the Hygrosticks, as discussed earlier, no further changes were made to the moisture measuring apparatus for the remainder of the monitoring period.

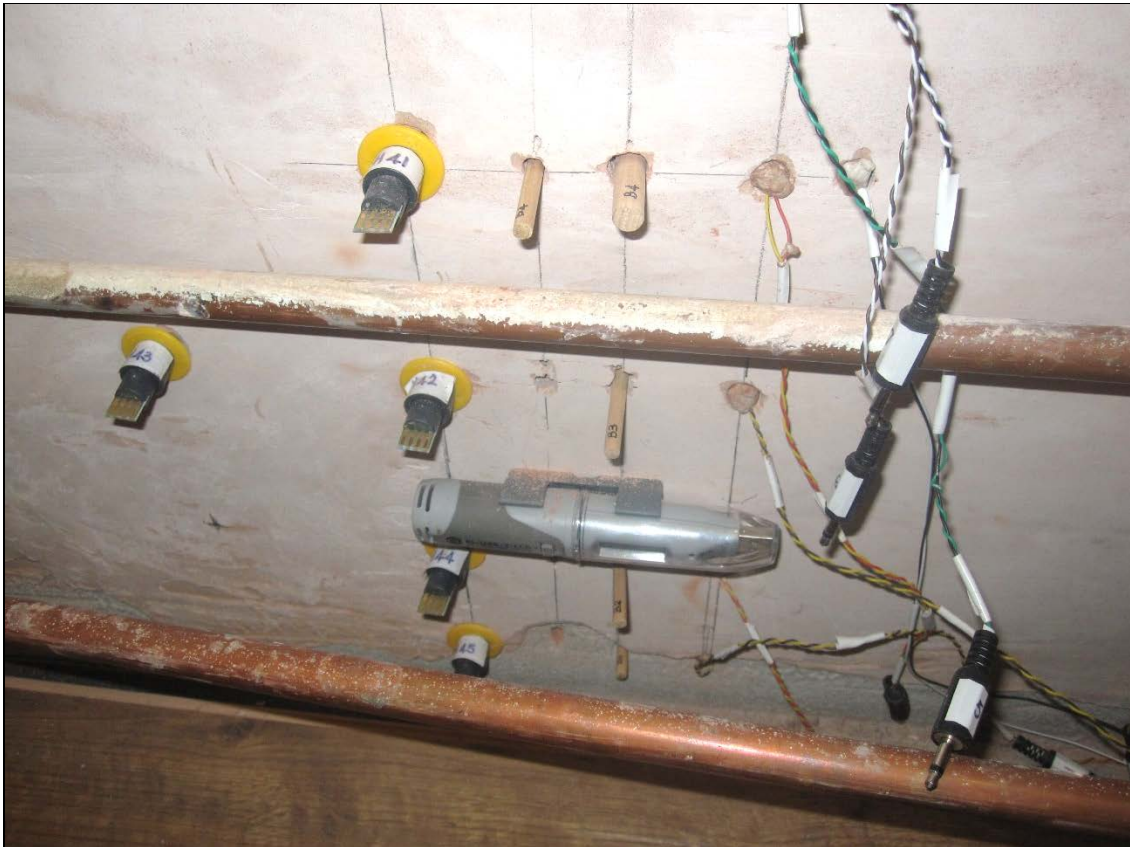
Figure 101: Panel B's additional moisture measuring apparatus.

This photograph, a close up of the base of Panel B, shows the additional Hygrostick installed in row 3, the extra Timber Probe Type 1 and 9 mm dia. plain softwood dowel in row 3, and the 5 mm dia. plain hardwood dowels.

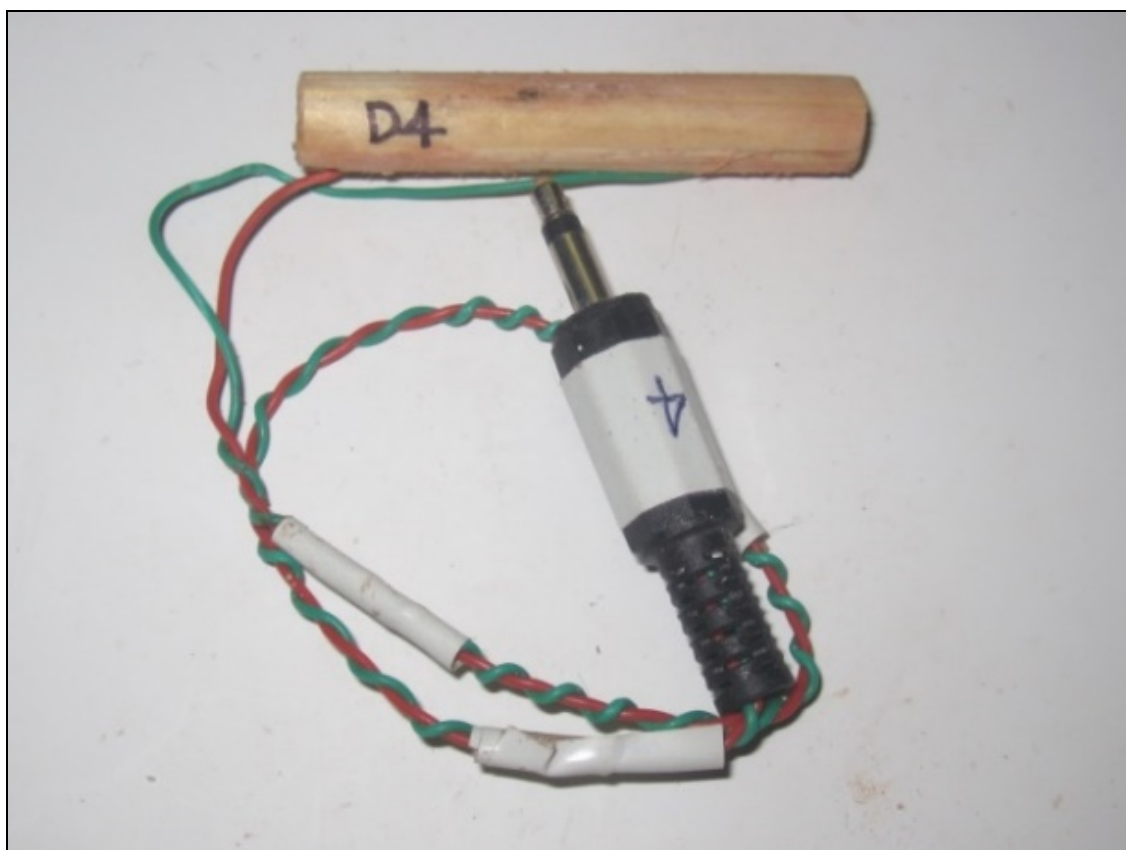
Figure 102: Timber Probe Type 1 D4 following removal from Panel D.

Dowel body of Type 1 probe D4 unaffected by discolouration or fungal decay. The condition of this dowel was typical of Timber Probes Type 1 that had been installed in the upper, drier regions of the panels.

Unsurprisingly, the dowel bodies of Type 1 probes located in dry masonry were in pristine condition; however, those that had been placed in wetter regions, essentially the bottom two rows, fared less well. For example, the dowel bodies of Type 1 probes A1, D1, D2, and E1 were discoloured, had softened, and displayed signs of fungal decay that, in the case of A1 and D1, had resulted in loss of timber. Fortunately, none of the Type 1 probes were so badly damaged to preclude examination or subsequent gravimetric moisture analyses. Illustrative examples of Timber Probes Type 1 from dry and wet regions of the panels are shown in Figure 102, Figure 103, Figure 104, and Figure 105 below.

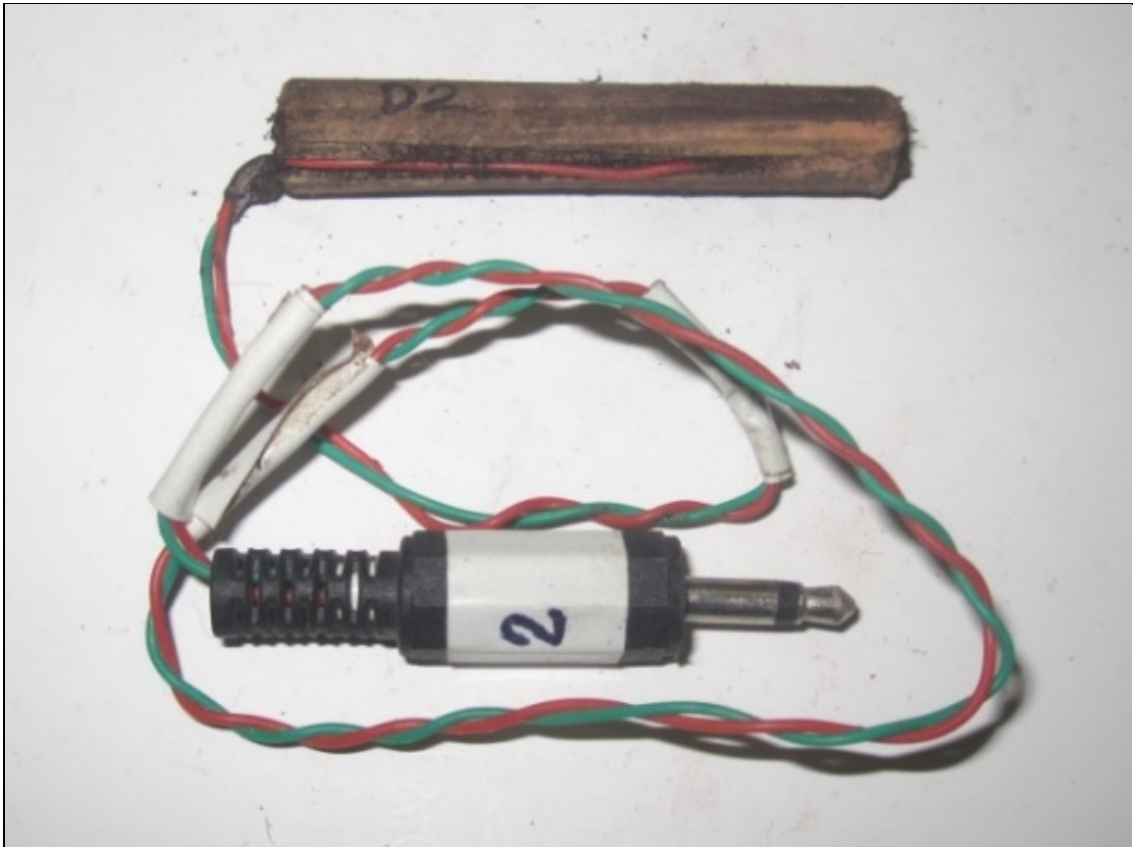
Figure 103: Timber Probe Type 1 reference D2 following removal from Panel D.

Dowel body of Type 1 probe D2 discoloured and displaying evidence of fungal decay. The condition of this dowel was typical of Timber Probes Type 1 that had been installed in the lower, wetter regions of the panels. This dowel was essentially intact, but other dowels had lost section.

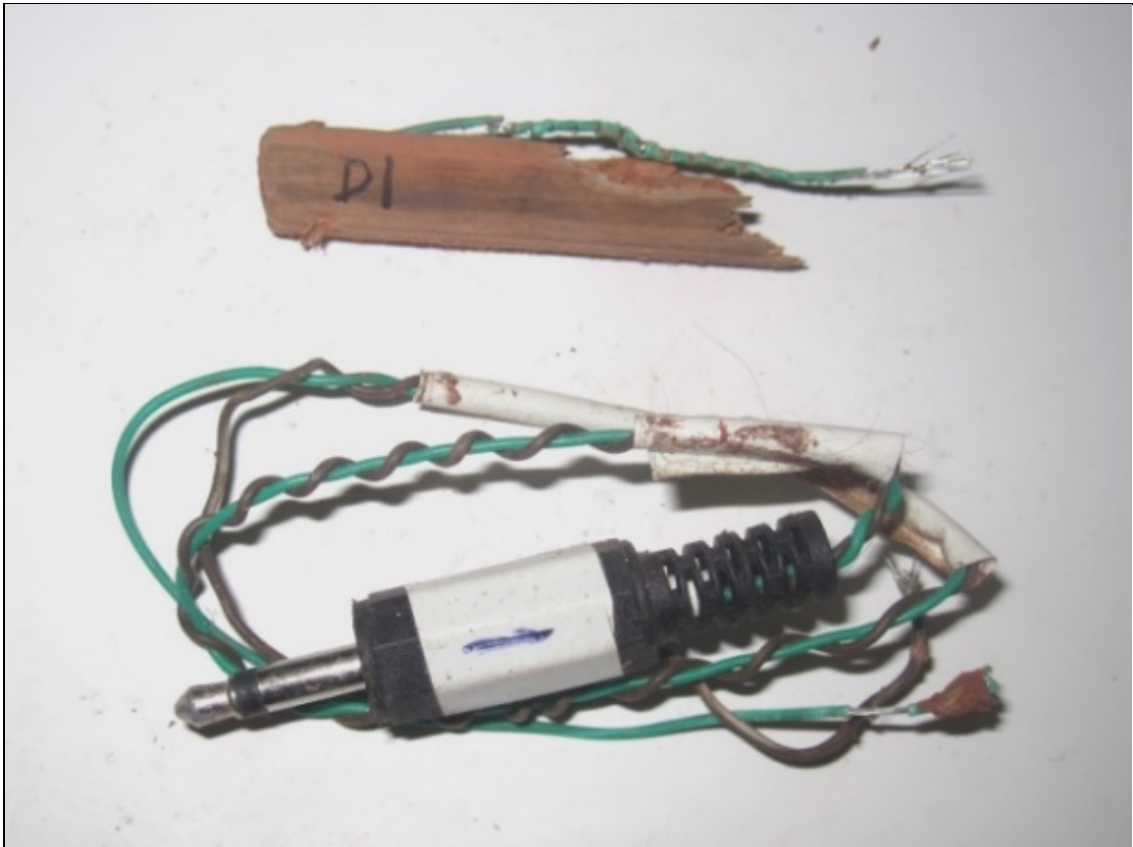
Figure 104: Timber Probe Type 1 D1 following removal from Panel D.

Dowel body of Type 1 probe D2 discoloured, decayed, and has lost timber section. Of all of the Timber Probes Type 1 installed, this dowel body was the most severely affected by fungal decay.

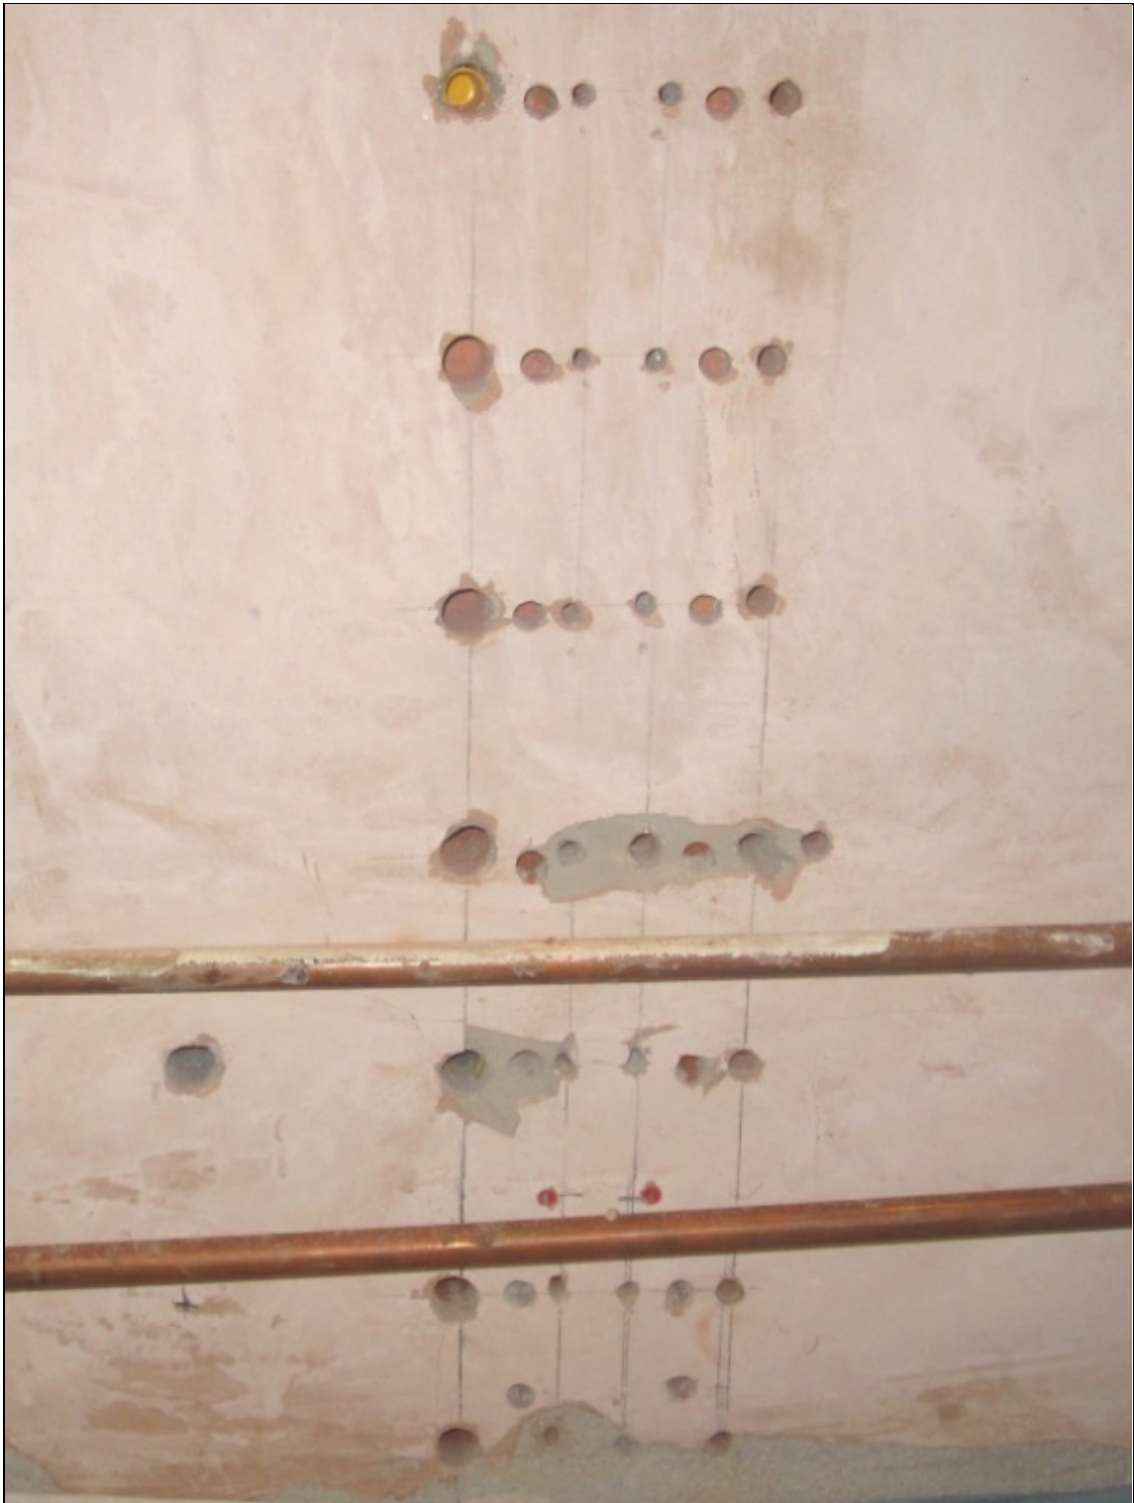
Figure 107: Test Panel B following removal of final masonry samples.

Panel B on completion of the drilling required to provide the final masonry samples. Using a 9 mm dia. drill bit, two sample sets were removed at each row position from the region of the panel between the former inner and outer holes, which had been purposely spaced for this reason.

having been spaced sufficient apart for this purpose, as illustrated for Panel B, by way of example, in Figure 106 and Figure 107 below.

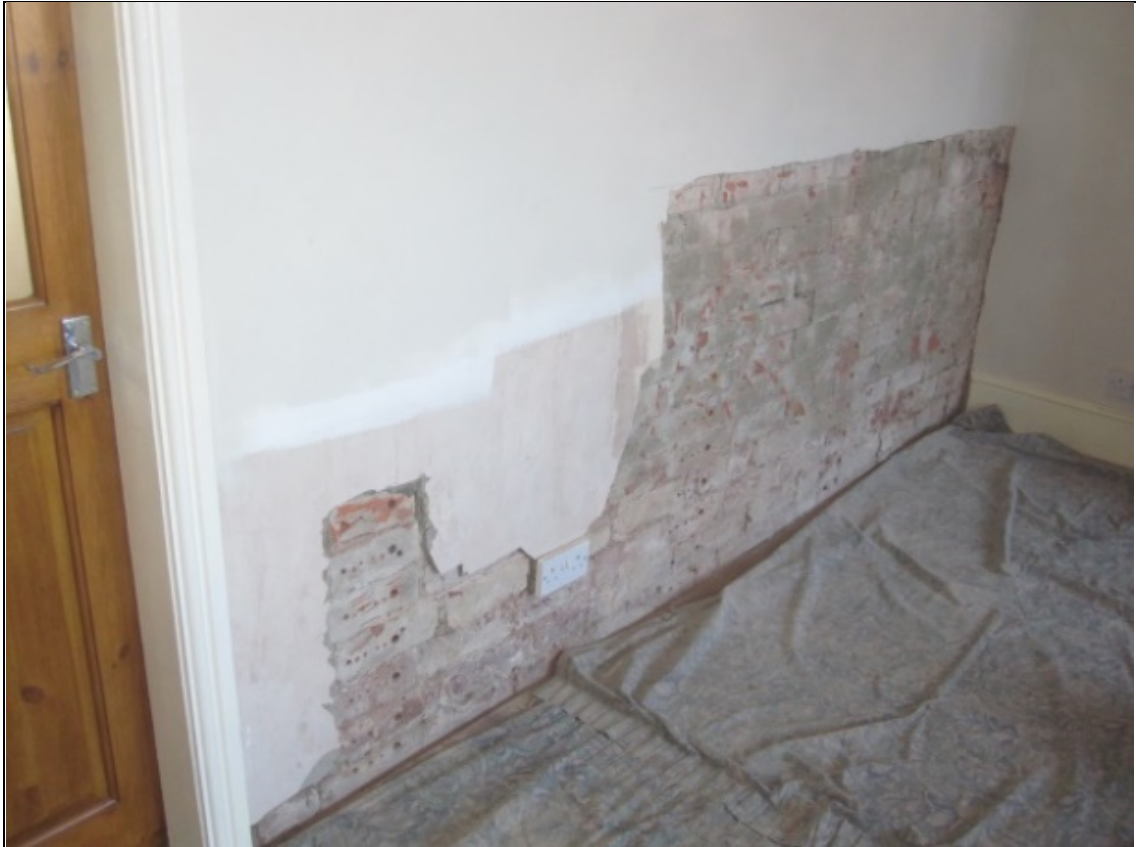
Figure 108: Test Panels C, D, and E with plasterwork removed to facilitate masonry sampling.

With the plaster removed, samples could be removed from the brick units with certainty. In practice, the entire base of the living room rear wall and the understairs cupboard right-hand side wall, those ground floor wall parts used for the test panels, were stripped and replastered.

Thus final sampling was split into two parts: an initial drilling to obtain samples of the plasterwork³⁵ and, following its removal, a second drilling to remove samples from the underlying brick units. Figure 108 below illustrates the living room rear wall at the mid-point of this sampling process and Figure 109 the same wall following reinstatement work, which was completed on 22 January 2014 and concluded the on-site work.

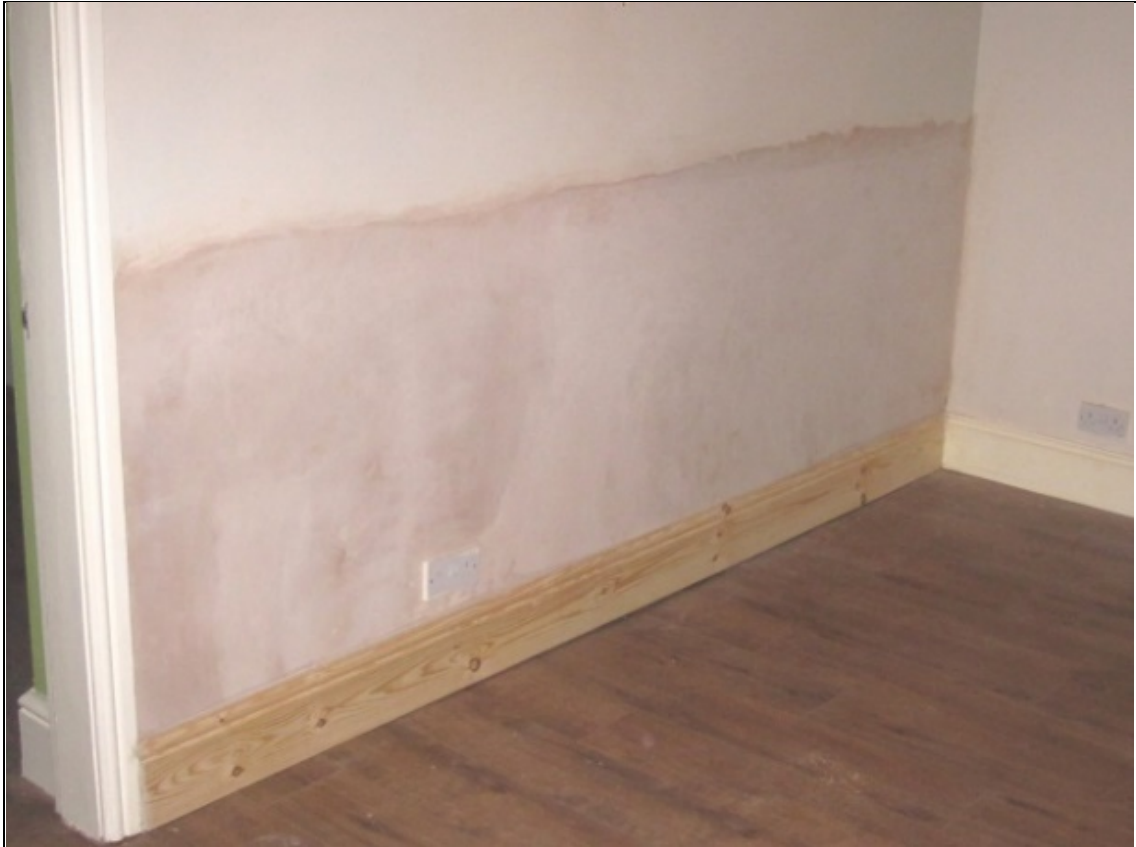
Figure 109: Test Panels C, D, and E following completion of reinstatement works.

Panels C, D, and E following completion of plastering and skirting board reinstatement. When wall decorations were subsequently applied, no visible evidence of the on-site work remained.

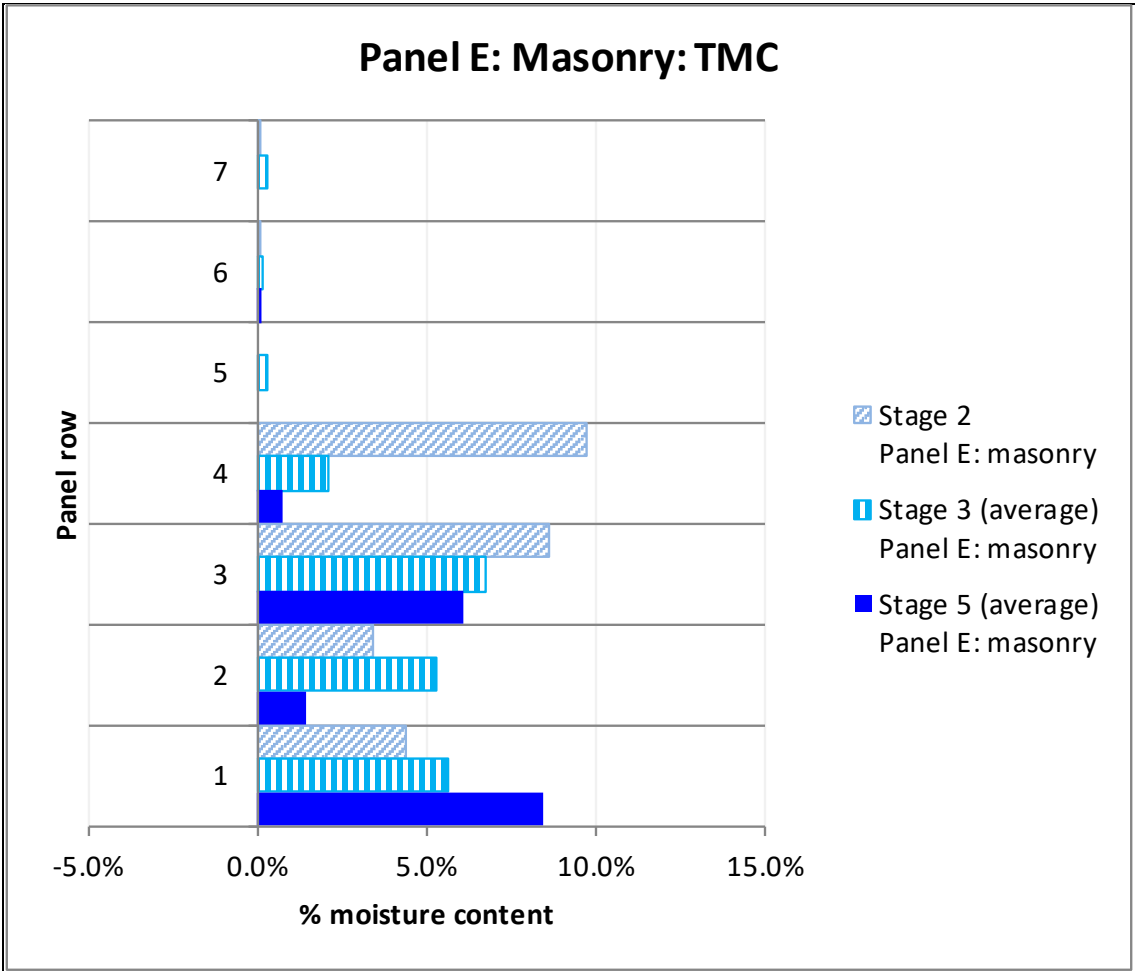
Figure 110: Panel E total moisture content of masonry at Stages 2, 3, and 5.

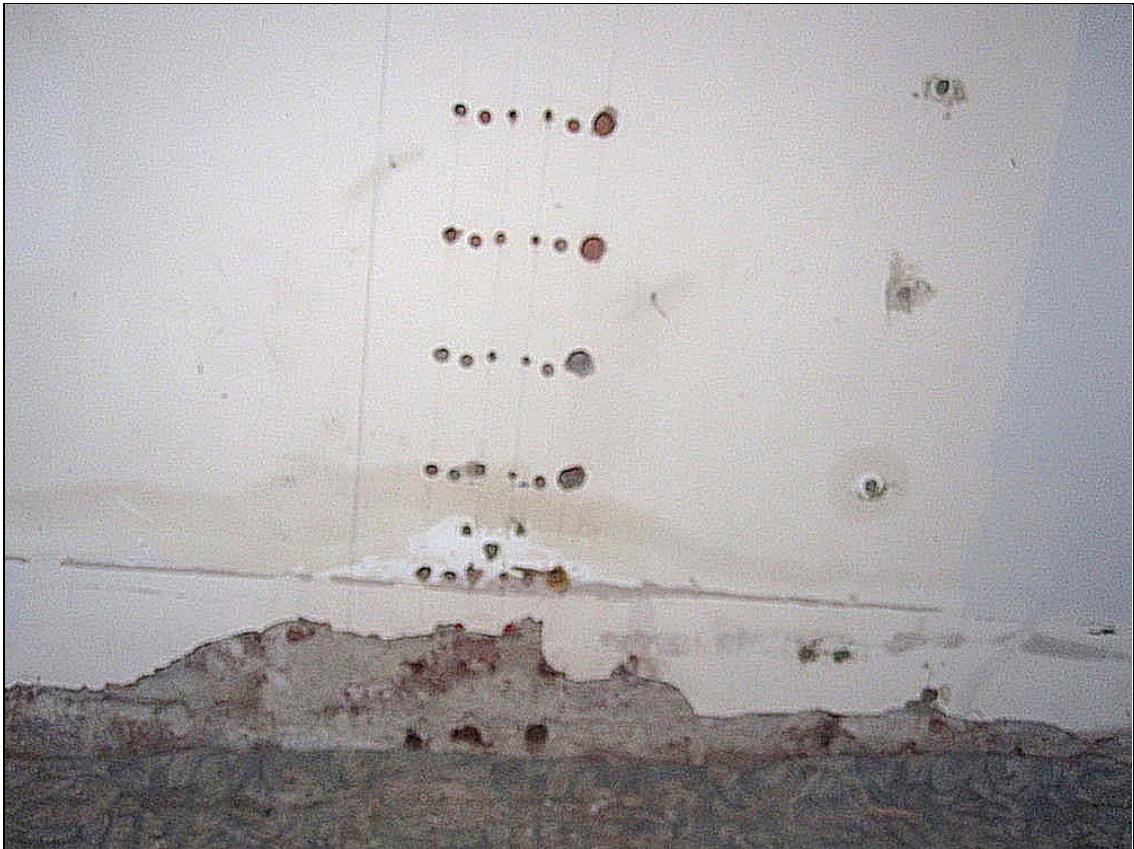
Figure 113: Panel E at Stage 5.

Panel E following removal of Stage 5 samples. The damp staining resulting from hygroscopic contamination is clearly visible in the region between rows 3-4.

The results from the plasterwork are unsurprising. The original plaster had not been removed from Panel E, so no significant change in its HMC was expected over the monitoring period. Indeed, as shown in Figure 113 below, a photograph of Panel E after the Stage 5 samples had been taken, hygroscopic contamination of the plasterwork, in the form of visible damp staining, was apparent in the region of rows 3 and 4.

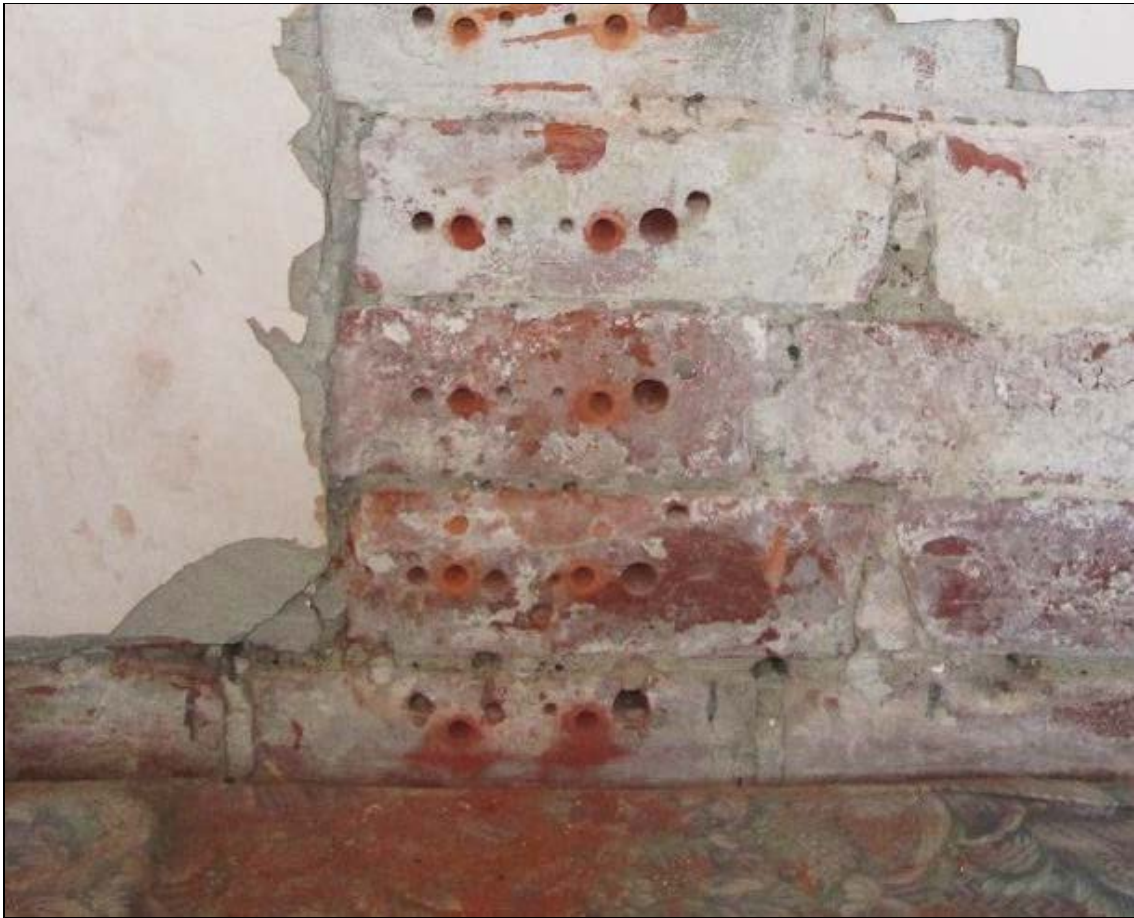
Figure 127: Panel C sampling positions at Stages 2, 3, and 5.

Base of Panel C following removal of the low-permeability render. The close proximity of the masonry sampling holes for Stages 2, 3, and 5 can be seen. In row 1 (the lowest brick), the two centrally located, freshly drilled holes are those made for the Stage 5 masonry samples and are essentially directly adjacent to the earlier sampling holes.

Given that all of the samples removed for analyses were taken from a relatively narrow, 100 mm wide strip of the panels' central section, it seems improbable that Panel C's row 1 Stage 5 samples would inadvertently have been taken from bricks unaffected by capillary moisture. This seems even more unlikely given the precise position of the sampling points of row 1 of Panel C, which indicate that the Stage 5 samples were removed from the same brick unit as that used for the Stage 2 and Stage 3 samples, as shown in Figure 127 below.

Instead, the reduction in the capillary moisture content of the masonry forming row 1 of Panel C can be attributed to the effect of the damp proofing cream. As described elsewhere, this damp proofing cream was inserted into holes drilled into the horizontal mortar bed joint between the first two courses of bricks, which can be seen located between rows 1 and 2 in Figure 127 above.

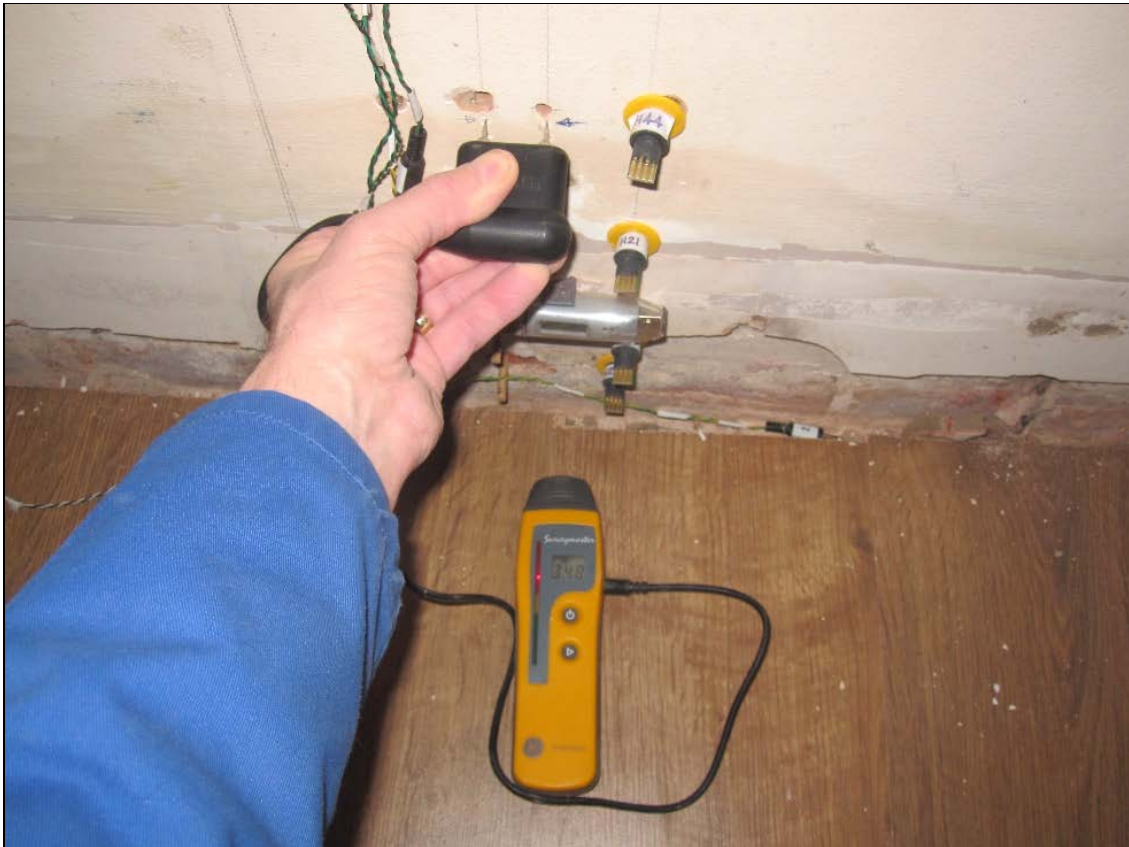
Figure 128: Panel E Protimeter measure-mode function using the Heavy Duty Probe.

Protimeter measure-mode readings obtained with the Heavy Duty Probe fell sharply from high to low values at the boundary line between the damp hygroscopic salt contaminated parts at the panel's base and the drier, uncontaminated parts above. Readings taken on this boundary, which on Panel E coincided with row 4, tended to fluctuate dependent on precisely where the needles of the probe were inserted.

For the three panel group, these readings were high in the wall base with a pronounced fall at the boundary between the hygroscopic salt contaminated plaster and the uncontaminated plaster above. Particular care was required when taking readings on this boundary as the value displayed by the meter would fluctuate depending on the precise insertion point of the Heavy Duty Probes' needles, as shown in Figure 128 above.

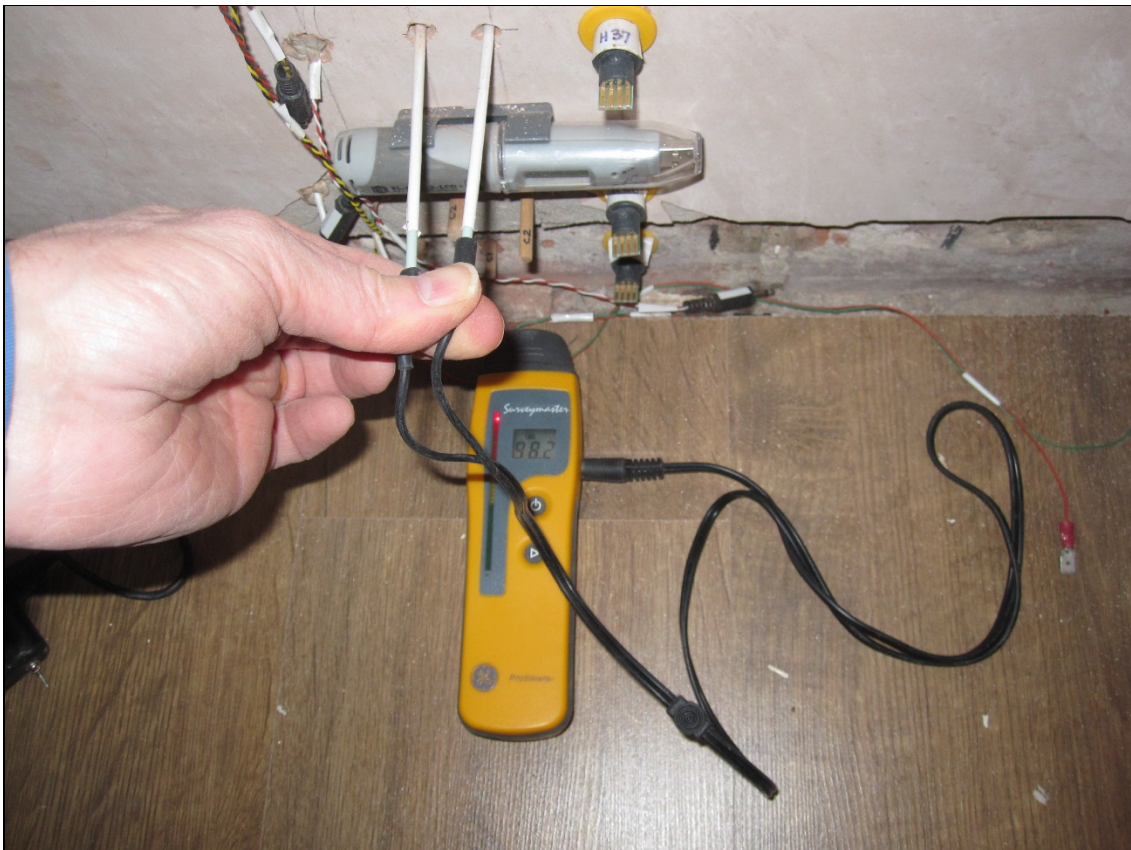
Figure 135: Panel C Protimeter measure-mode function using the Deep Wall Probes. Protimeter measure-mode readings are obtained from the substrate by inserting the needles of the Deep Wall Probes into two 5 mm dia. holes, drilled for this purpose at the mid-point of each of the seven rows of the apparatus.

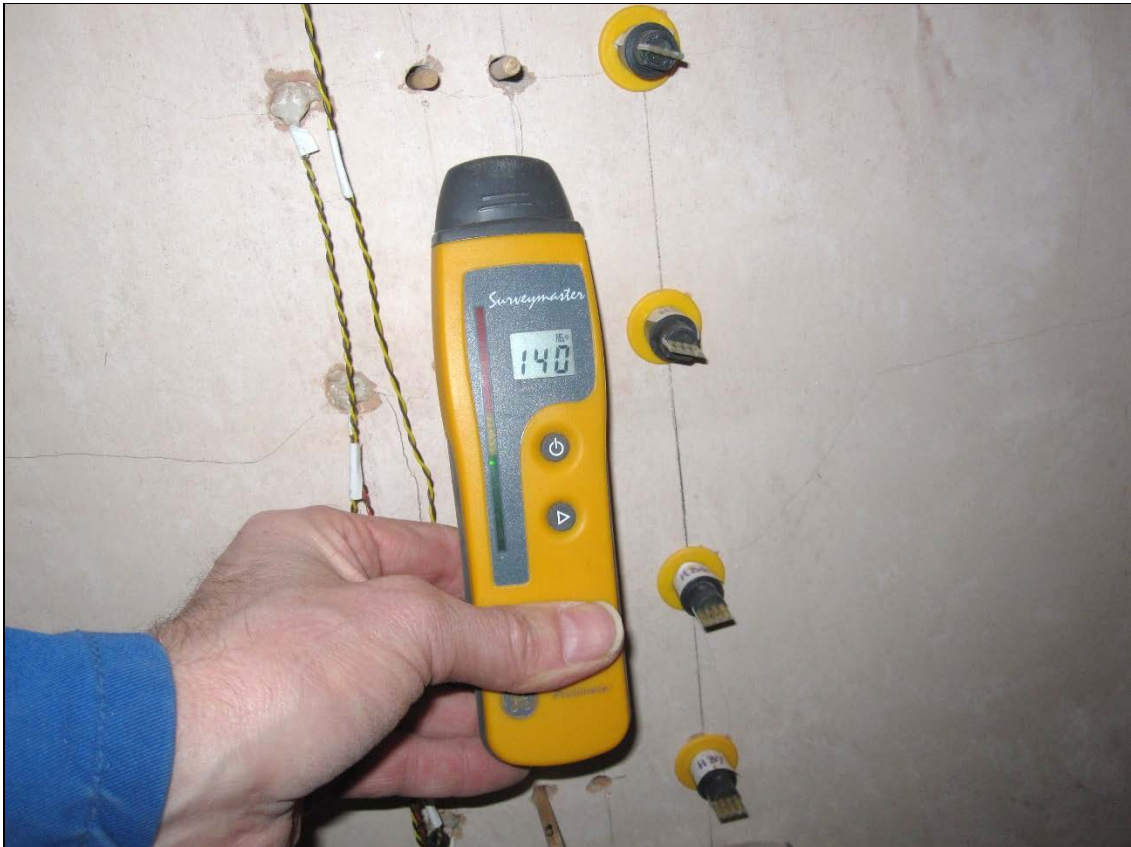
Figure 142: Panel C Protimeter search-mode function.

Protimeter search-mode reading using the Surveymaster model. The sensor on the back of the instrument is placed against the wall surface and displays a relative reading in the 60-999 range; here, displaying 140.

Like the Protimeter measure-mode function, the search-mode function, illustrated in Figure 142 below, is intended to offer a means of testing for moisture that is non-invasive, quick, and easily repeatable. The search-mode sensor, located on the back of the instrument, is placed against the surface of the material under test and, depending on the specific model used, scans to a nominal depth of 15-19 mm and displays a value on a scale of 60-999 or 0-1000⁴⁹ relative to the quantity of moisture present (GE Sensing, 2005, p. 17; 2009, p. 3).

The search-mode function shares the same limitations as measure-mode: at best the readings reflect the total moisture content of the material under test with no indication as to the individual hygroscopic and capillary moisture contents; at worst they reflect the material's conductivity independently of its moisture content.
