RISING DAMP EVALUATION AND TREATMENT A QUASI-EXPERIMENTAL CASE STUDY

Submitted in Partial Fulfilment of the Requirements of
the Degree of Doctor of the Built Environment, May 2017

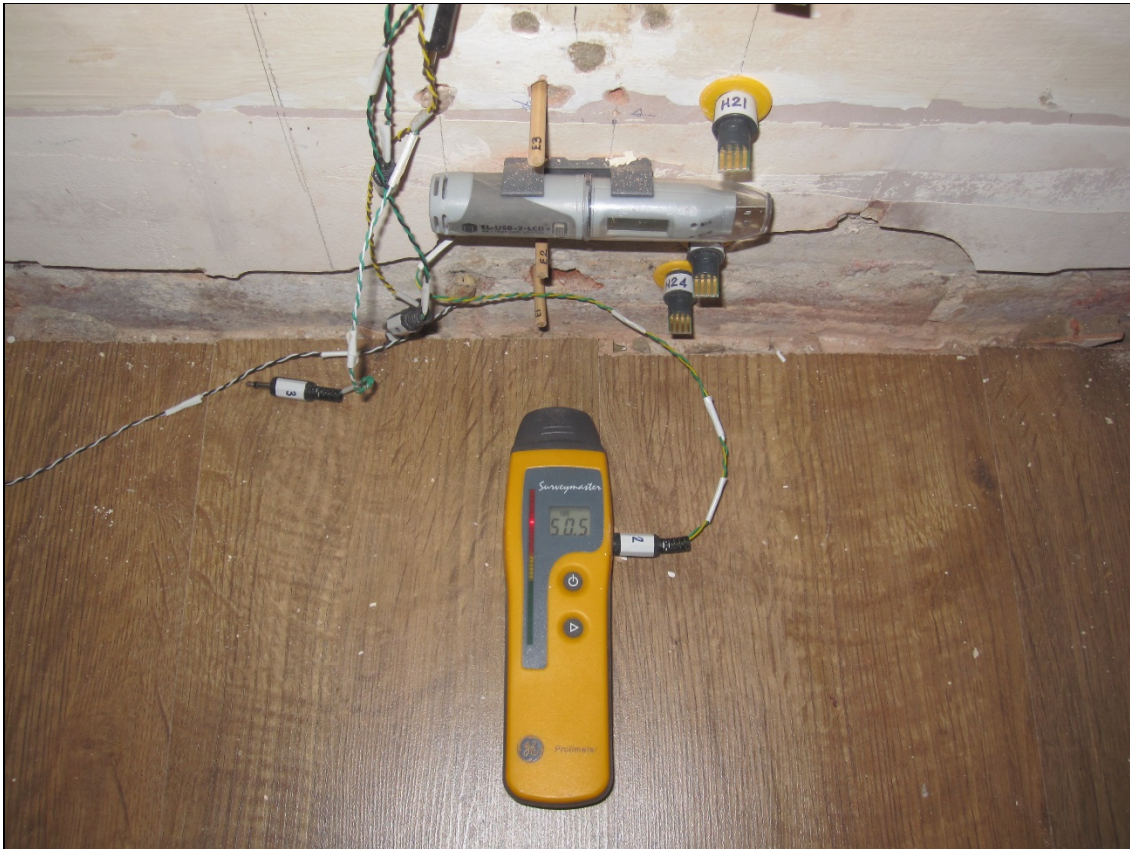
Figure 146: Panel E measure-mode reading of a Timber Probe Type 1.
Timber Probes Type 1 read using the measure-mode function of the Protimeter.

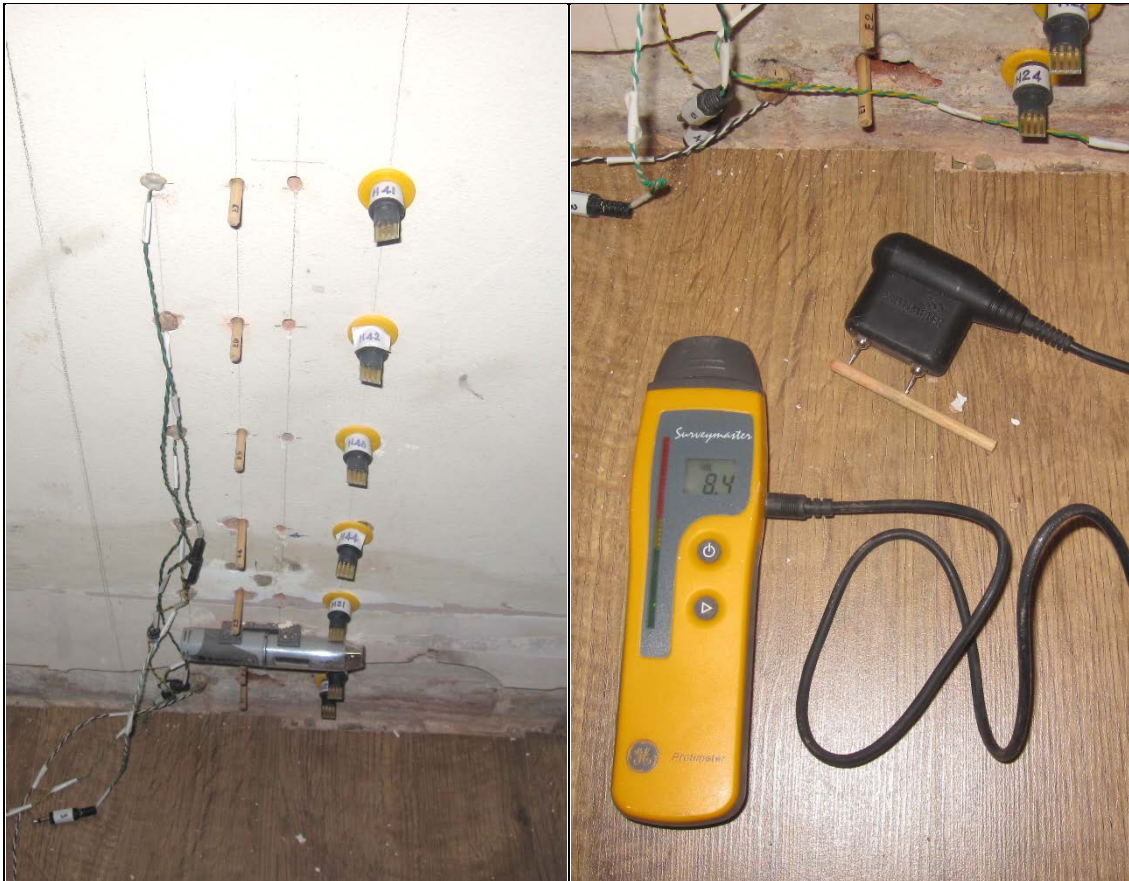
Figure 152: Panel E 5 mm diameter plain hardwood dowels.

5 mm dia. plain hardwood dowels, inserted into one of the pairs of the central pairs of holes, were removed and measure-mode readings obtained by inserting the needles of the Heavy Duty Probe into their bodies.

Three plain 9 mm diameter softwood dowels were initially installed, on the 1 January 2013, because of concerns regarding the integrity of measure-mode readings obtained from the Timber Probes Type 1 at positions B4, C2, and D3. These plain dowels had to be removed from the test panels to enable their Protimeter measure-mode readings to be recorded and, therefore, any concerns with respect to the validity of the values recorded were eliminated.⁵⁰ For this reason, on the 18 January 2013, this plain timber dowel method was extended through the installation of hardwood dowels, as illustrated in Figure 152 below.

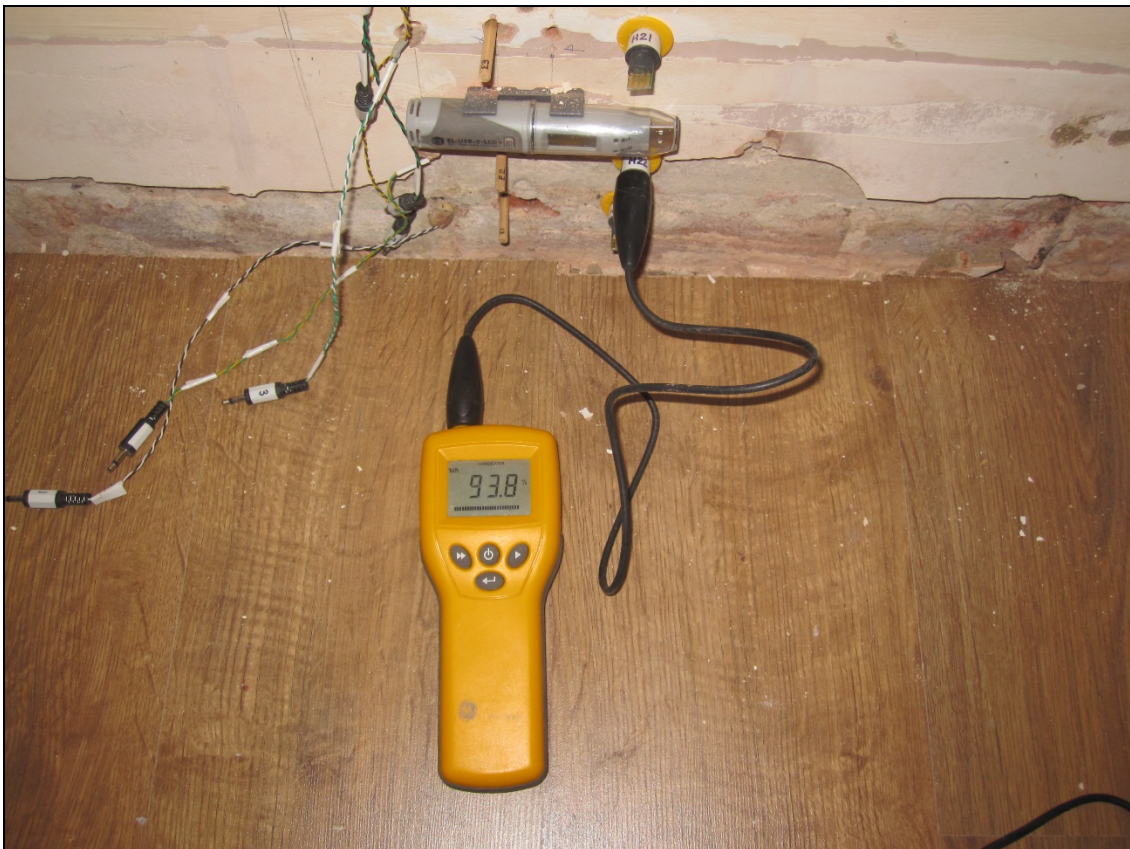
Figure 159: Panel E reading a Hygrostick.

The Hygrostick is attached to a Protimeter MMS meter with a proprietary extension lead enabling the relative humidity and temperature of the pocket of air within the Humidity Sleeve to be read.

The principal underpinning the use of Hygrosticks, shown in Figure 159 below, is that measuring changes in the moisture content of the pocket of air within the Humidity Sleeves in which they are inserted will by extension enable changes in the moisture changes of the surrounding masonry to be tracked.
