Chernobyl radiation spikes are not due to military vehicles disturbing soil

ABSTRACT

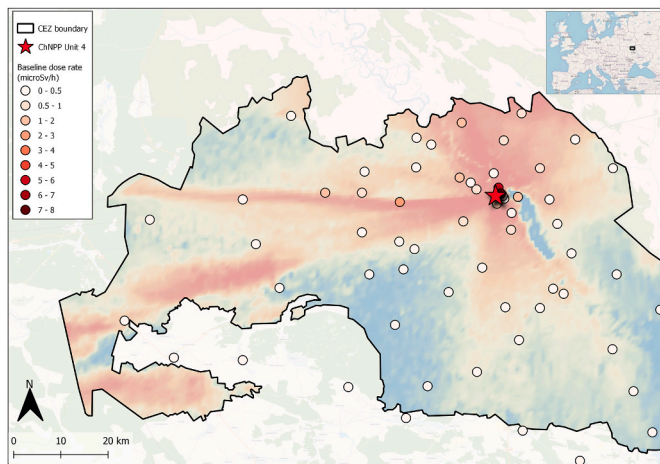
Fig. 1. Gamma radiation baseline dose rates ($\mu\text{Sv h}^{-1}$) reported by the CRMS detector network that monitors the 2600 km² Ukrainian part of the Chornobyl Exclusion Zone (CEZ). Note that the dose rate categories presented and the associated colour scheme are different to subsequent figures to better present the spatial variability in baseline gamma dose rates across the CEZ. These baseline dose rate data were obtained from saveecobot.com for the week prior to the dose rate increases on 24th and 25th February 2022. Belarus is located directly to the north of the CEZ and Kyiv is approximately 100 km south. The detector towards Slavutych (to the east of the CEZ) are not shown and did not report dose rate increases. The base map colouration within the CEZ boundary shows ¹³⁷Cs deposition, decay corrected to present, from the 1986 accident at Unit 4 of the Chornobyl Nuclear Power Plant (ChNPP); light blue is low deposition (tens of kBq m⁻²) and darkest red is highest deposition (thousands of kBq m⁻²). Base map and data from OpenStreetMap and OpenStreetMap Foundation, which is made available under the Open Database License (CC BY-SA 2.0); © OpenStreetMap contributors. (For interpretation of the references to colour in this figure legend, the reader is referred to the Web version of this article.)

The Comprehensive Radiation Monitoring and Early Warning System (CRMS) for Chernobyl includes a network of 67 gamma detectors, predominantly within the CEZ (Fig. 1); one of these detectors appears to

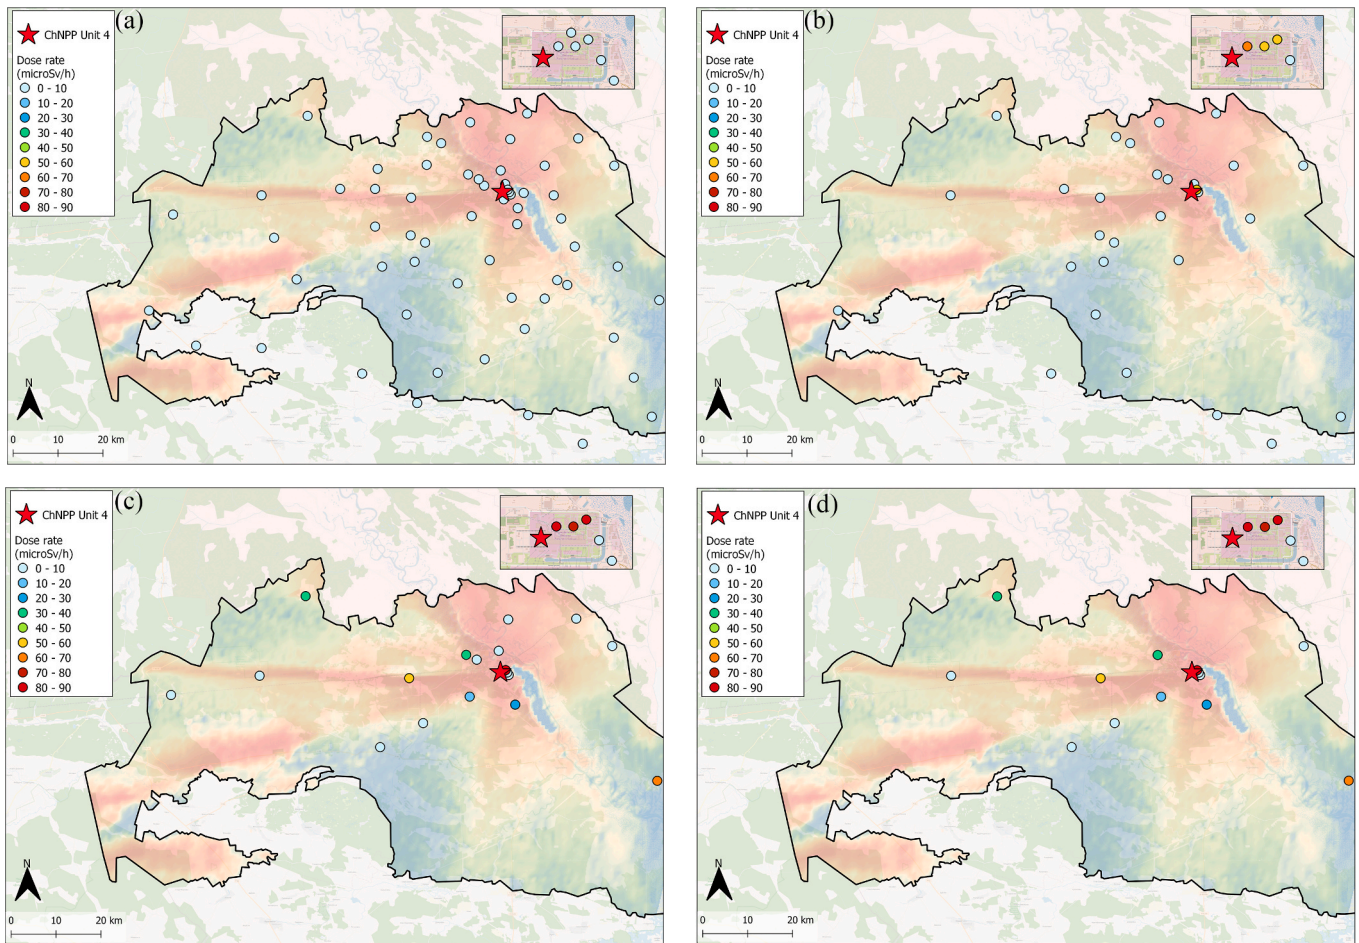
Fig. 2. Dose rates ($\mu\text{Sv h}^{-1}$) reported by CRMS network, shown using the same scale to facilitate comparison for: (a) baseline; (b) increase over baseline on 24th February 2022; (c) increase over baseline on 25th February 2022; and (d) increase above baseline between 09:20 and 10:50 on 25th February 2022. Inset maps show results for detectors closest to the Chernobyl Nuclear Power Plant. Base map and data from OpenStreetMap and OpenStreetMap Foundation, which is made available under the Open Database License (CC BY-SA 2.0); © OpenStreetMap contributors.

whereas neighbouring detectors did not (Figs. 2 and 4). The highest increase (approaching 600-fold) was at Ladyzychi, along a minor road that only provides access to this and one other location. Therefore, there is no logical explanation as to why there would be significant military activity at this site. Also, if the changes were due to military-related electromagnetic interference directly affecting the detectors, anomalous readings would be expected across other detector networks in Ukraine where military activity has occurred. However, this was not observable in detector dose rates reported for those other networks on the www.saveecobot.com website.

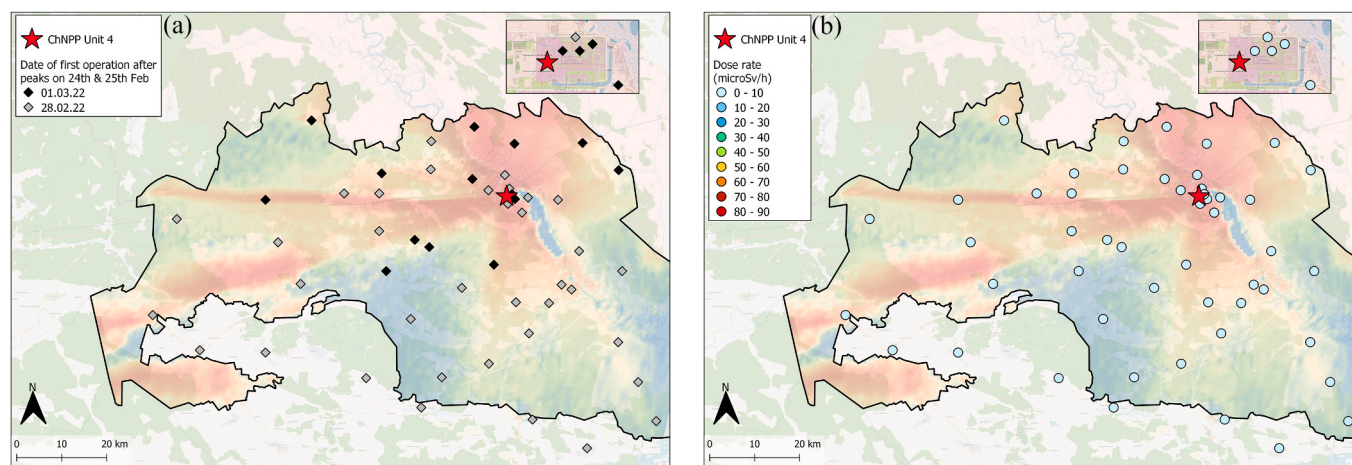
Fig. 3. CRMS detector network after 25th February 2022, showing: (a) the date each detector first reported dose rate data after the network went offline on 25th February 2022; and (b) gamma dose rates reported ($\mu\text{Sv h}^{-1}$), using the same scale categories as Fig. 2. Base map and data from OpenStreetMap and OpenStreetMap Foundation, which is made available under the Open Database License (CC BY-SA 2.0); © OpenStreetMap contributors.

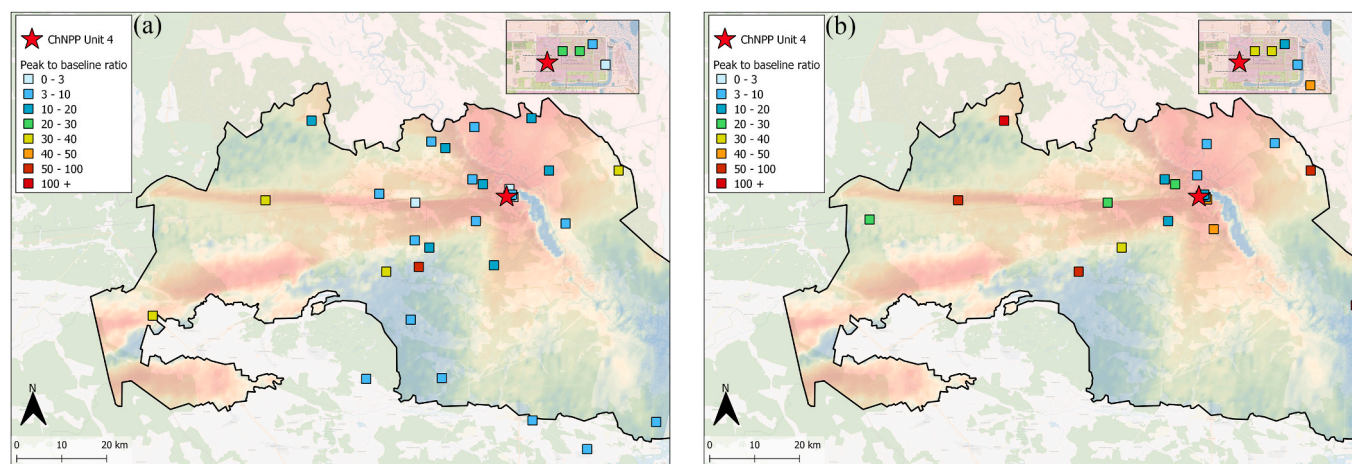
Fig. 4. Peak to baseline gamma dose rate ratio on: (a) 24th February 2022; and (b) 25th February 2022. Our analysis shows that anything above a ratio of three (0–3 is the first category on the figure scale) cannot be explained by resuspension of contaminated soil due to military vehicle movements. Base map and data from OpenStreetMap and OpenStreetMap Foundation, which is made available under the Open Database License (CC BY-SA 2.0); © OpenStreetMap contributors.

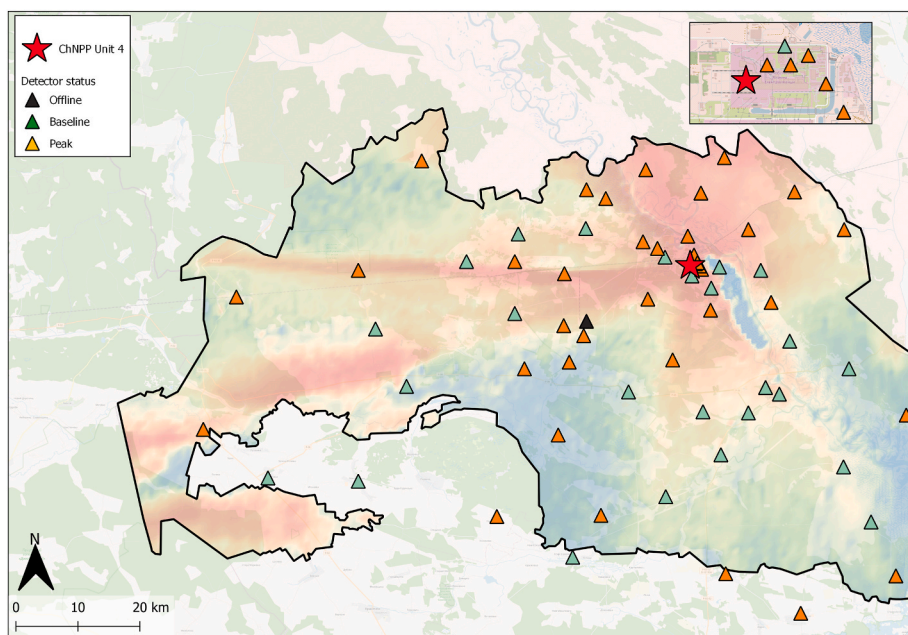
Fig. 5. Status of detectors within the CRMS network during the period of anomalous readings. One detector towards the centre of the CEZ was offline throughout this period. Detectors that reported increased (peak) dose rates were interspersed with detectors that only reported baseline dose rates. Inset maps show results for detectors closest to the Chernobyl Nuclear Power Plant. Base map and data from OpenStreetMap and OpenStreetMap Foundation, which is made available under the Open Database License (CC BY-SA 2.0); © OpenStreetMap contributors.
