**Archaeological  
Building Survey:**

Woods Mill, The  
Narrow Spinning  
Mill, Glossop

**Report No:**  
2015/25

**Document Type:** Archaeological Building Survey

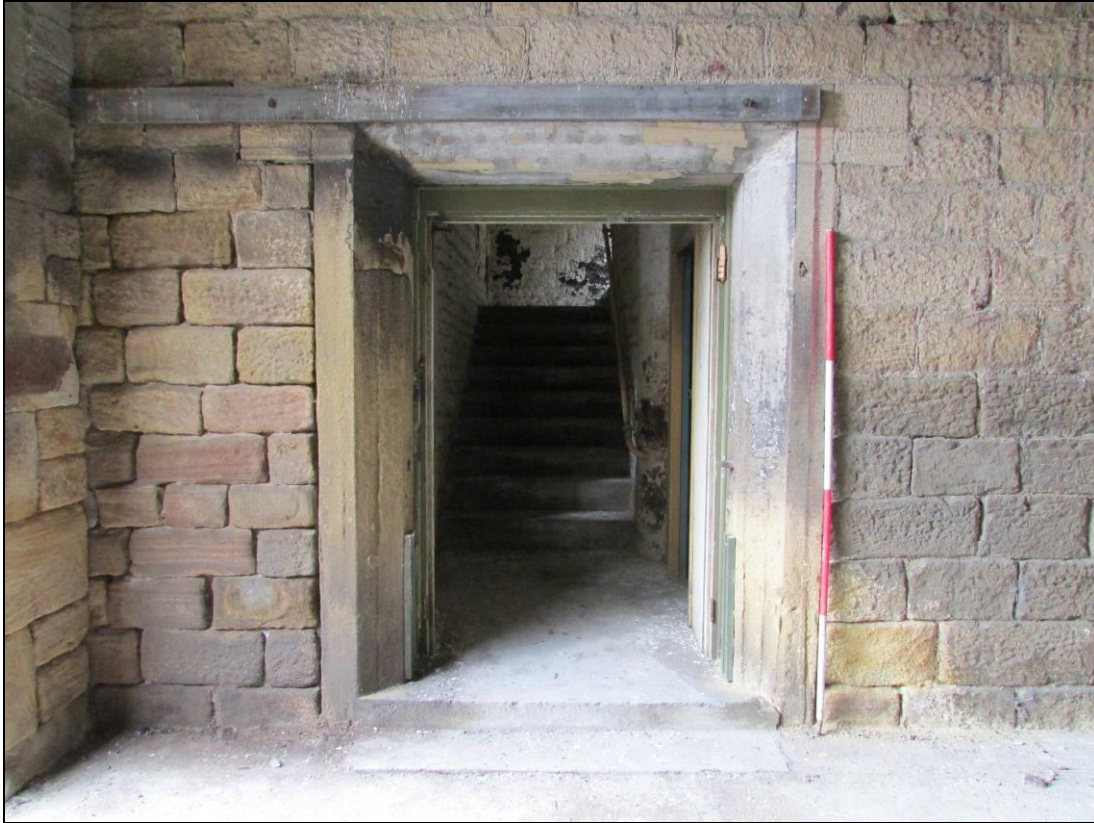
**Plate 4 Original entrance into the mill, via the stair tower**

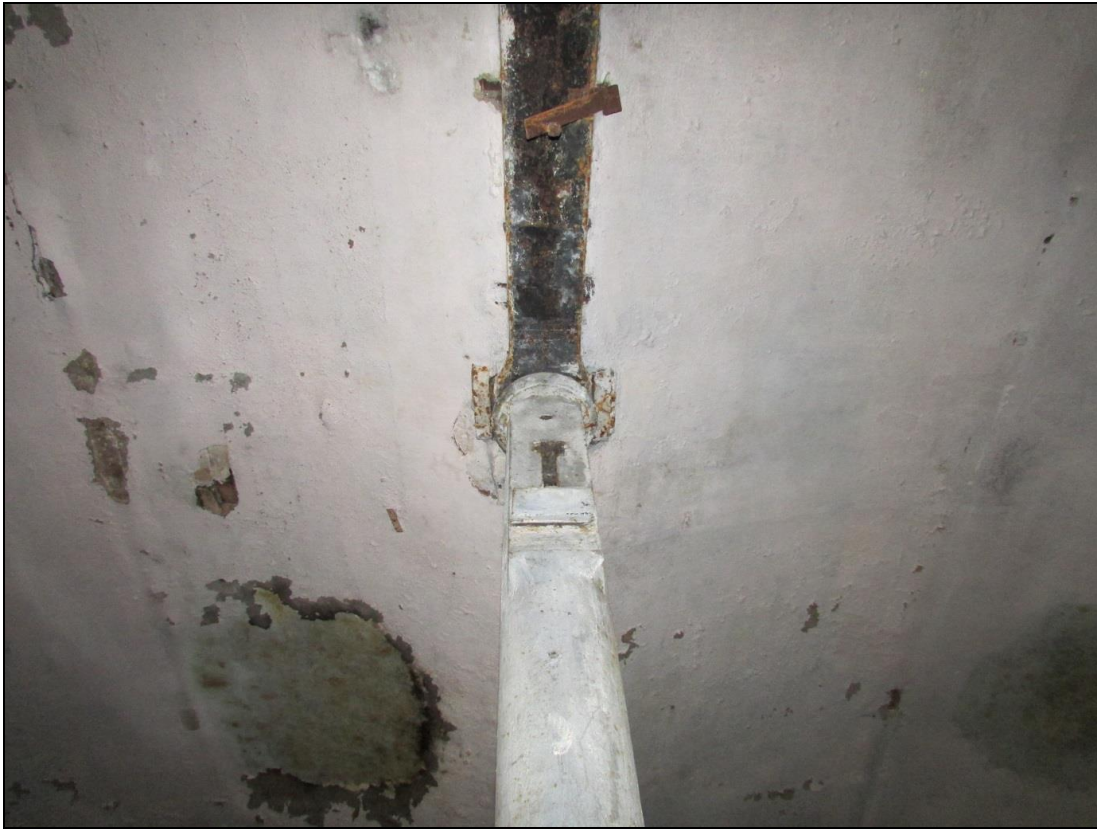
Internally, two east/west axial runs of iron columns supported single-span iron beams running north/south. This supported a fireproof ceiling, with shallow hand-made brick arches, constructed in stretcher bond, supported by what appeared to be inverted I-section iron beams. Each bay of the mill had one brick arch and the columns were located 2.75m from each other east/west and 7.65m north/south. Originally, there would have been fifteen pairs of columns with intervening beams, however on the western side, the columns have either been replaced or encased in concrete (Plate 7). The same applies to the beams, with three additional concrete beams running east/west along the western side. The ceiling has also been completely removed from this area. The surviving northern run of columns had bolting faces within them (Plate 8), probably to support the line shaft.

**Plate 8 Close up of a column with a bolting face, supporting the line shaft**

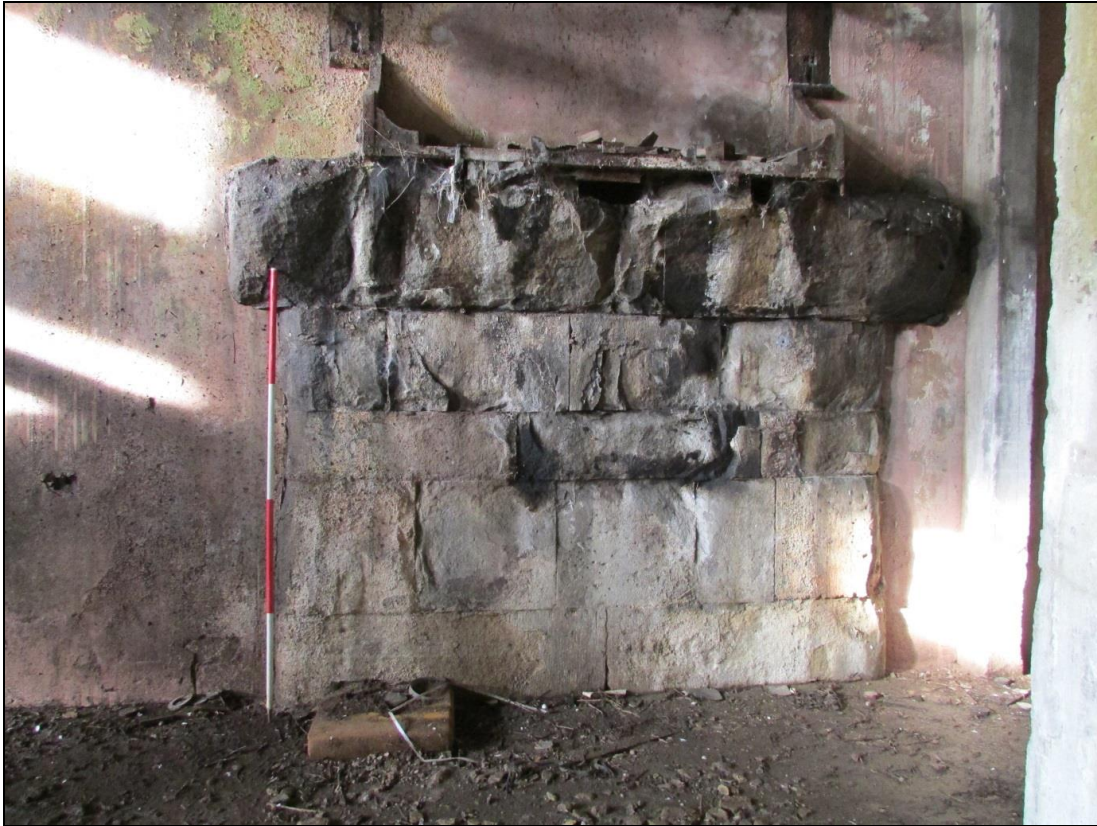
The western wall, which divided the main spinning mill from the engine house, acted as a gearing wall. It contained a number of features including a projecting pier of large rough and coursed ashlar blocks standing four courses high and supporting a large stone lintel (Plate 11). Overall this measured 2.00 x 2.50m and provided support for a footstep bearing (Plate 12). Some of the metal fittings associated with this were still visible, built into the wall although partly obscured by a later concrete beam. This beam marked where the ceiling would have been originally and ran

**Plate 11 Projecting stone pier supporting footstep bearing for driveshaft**

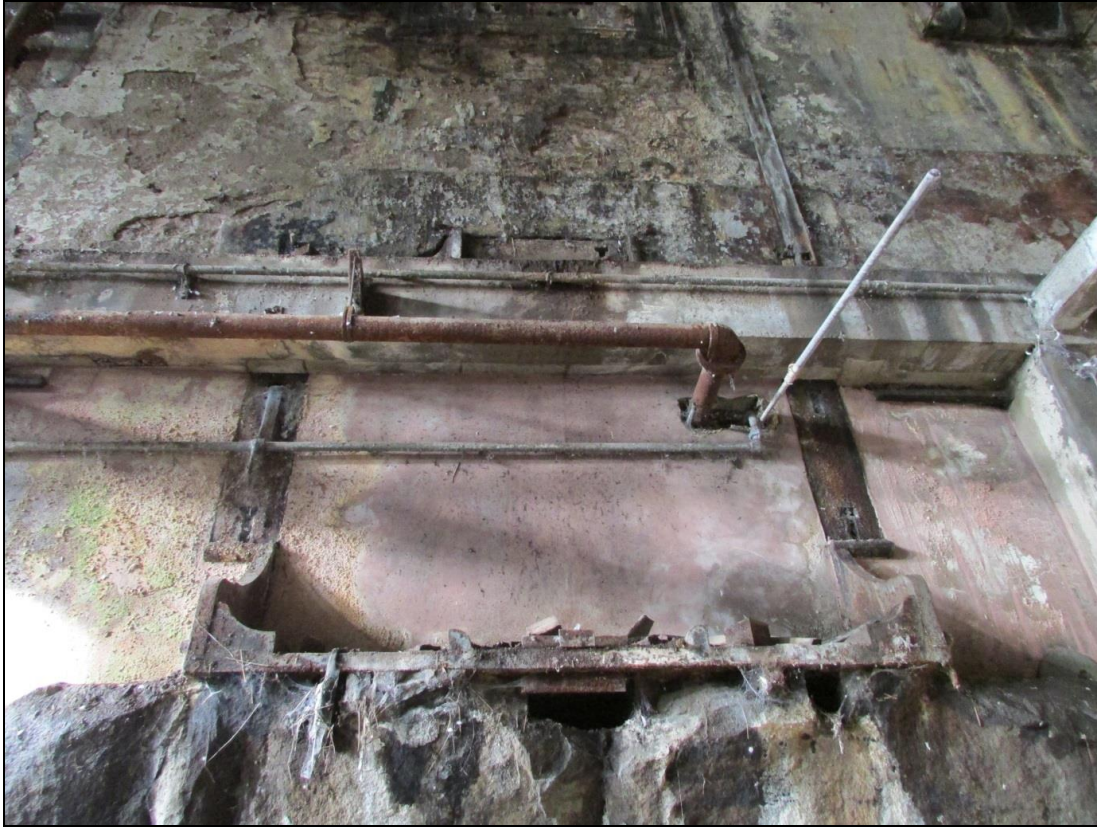
**Plate 12 Close-up of the footstep bearing for the driveshaft**

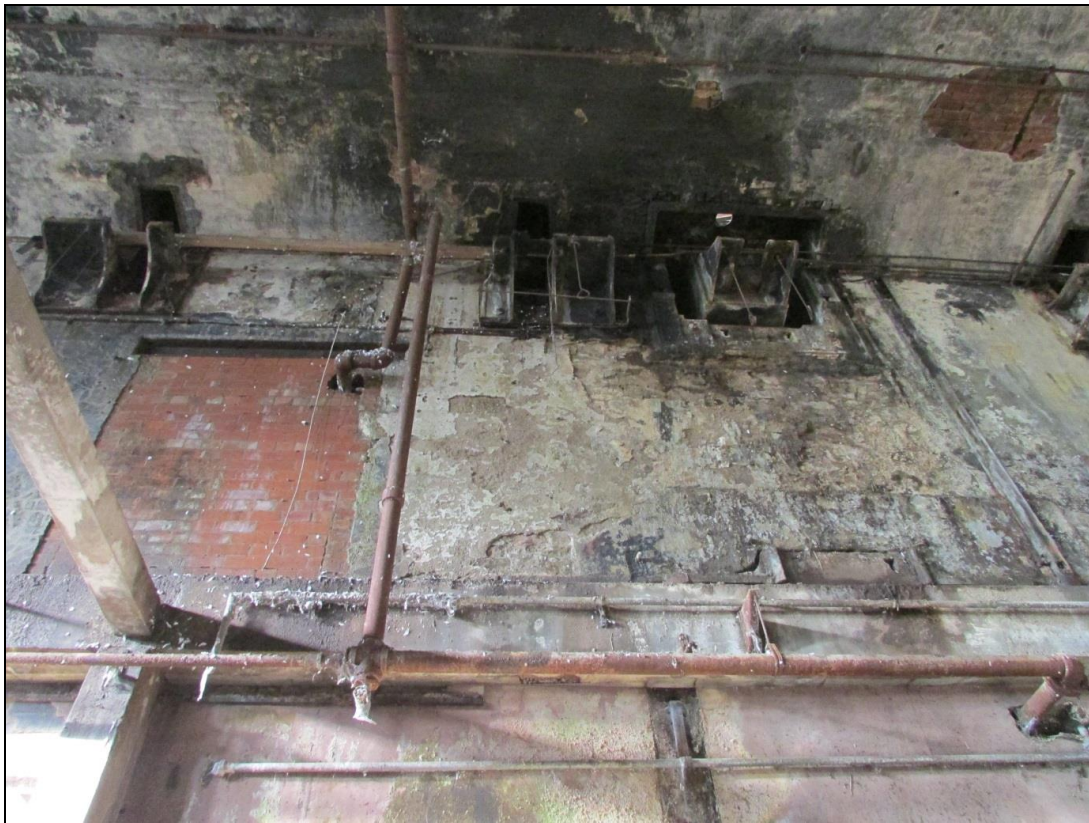
Due the removal of the floor from the western part of the mill, observations could only be made from the ground-floor. The blocked entrances are described in detail within the engine house description below. Above the footstep bearing is a supporting bracket and a small circular aperture for the driveshaft. There are another two supporting brackets for bevel gears and further shafts to the north of this and three more are located to the south (Plate 16).

**Plate 16** The bracket and aperture for the driveshaft is located to the right; a blocked entrance and two more brackets are shown to the left

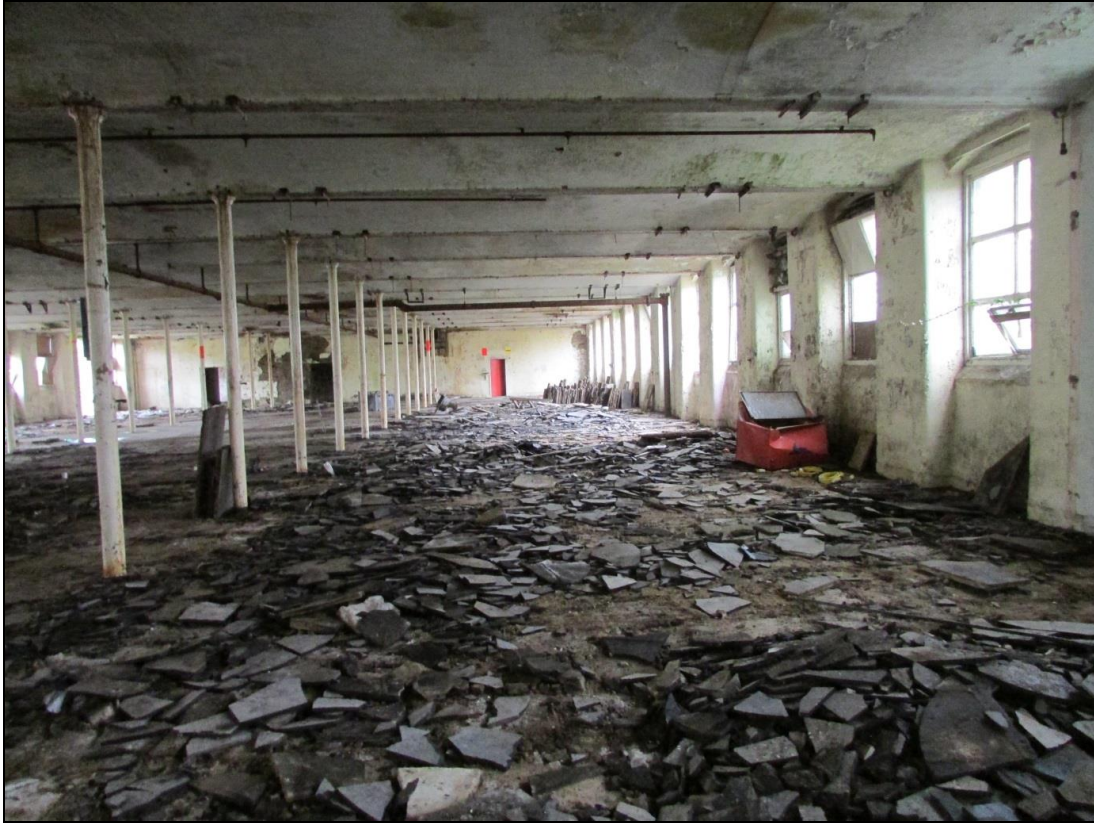
**Plate 18** Visible on the beams within the ceiling are two lines of lineshaft hangers, which helped power the machinery

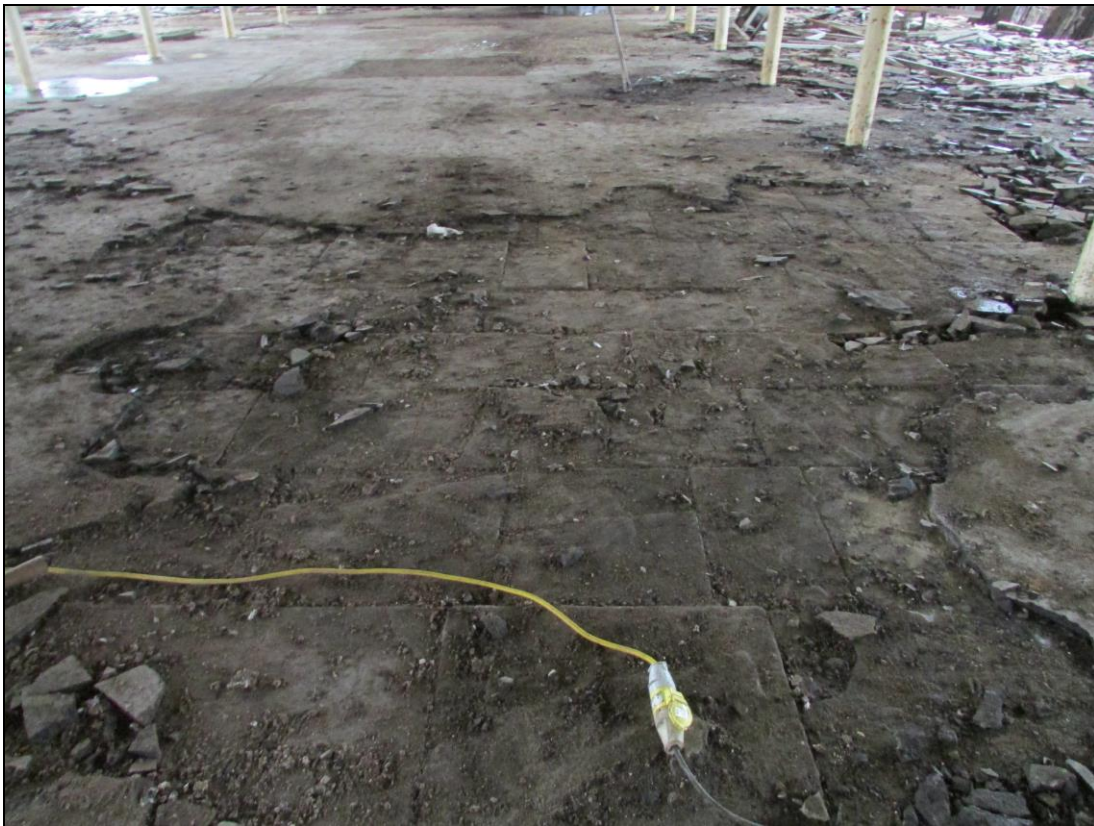
**Plate 19** Original stone flagged floor sealed below concrete skim

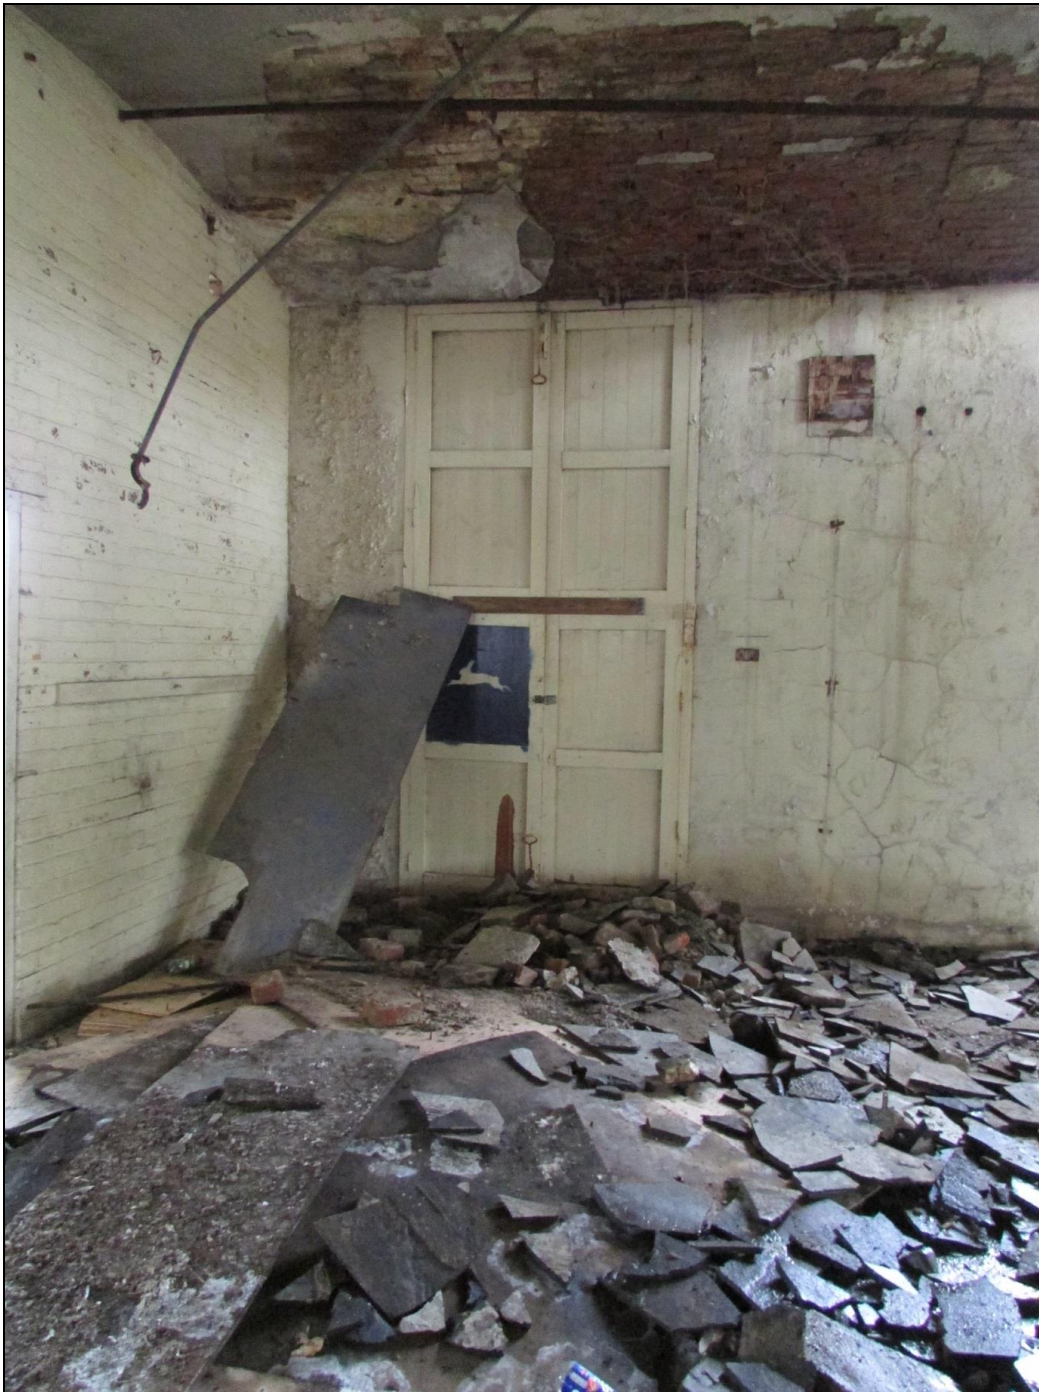
The later toilet block, as seen on other floors, was also located on this floor. A series of wooden partitions depicted on the architectural plans were not visible during the time of the survey. A wooden taking-in door was visible immediately south of the toilet block also (Plate 20). An entrance into a later extension to the privy tower led into a small room. Its function was unclear, however there was a window in the northern elevation and a recess in the southern wall with a pipe inserted near the top. Immediately south was an entrance with a dressed stone surround and led into the original privy tower, which would only have been 0.60m wide and was blocked subsequently with regularly coursed undressed stone (Plate 21).

**Plate 20** Wooden taking-in door visible immediately to the south of the later toilet block

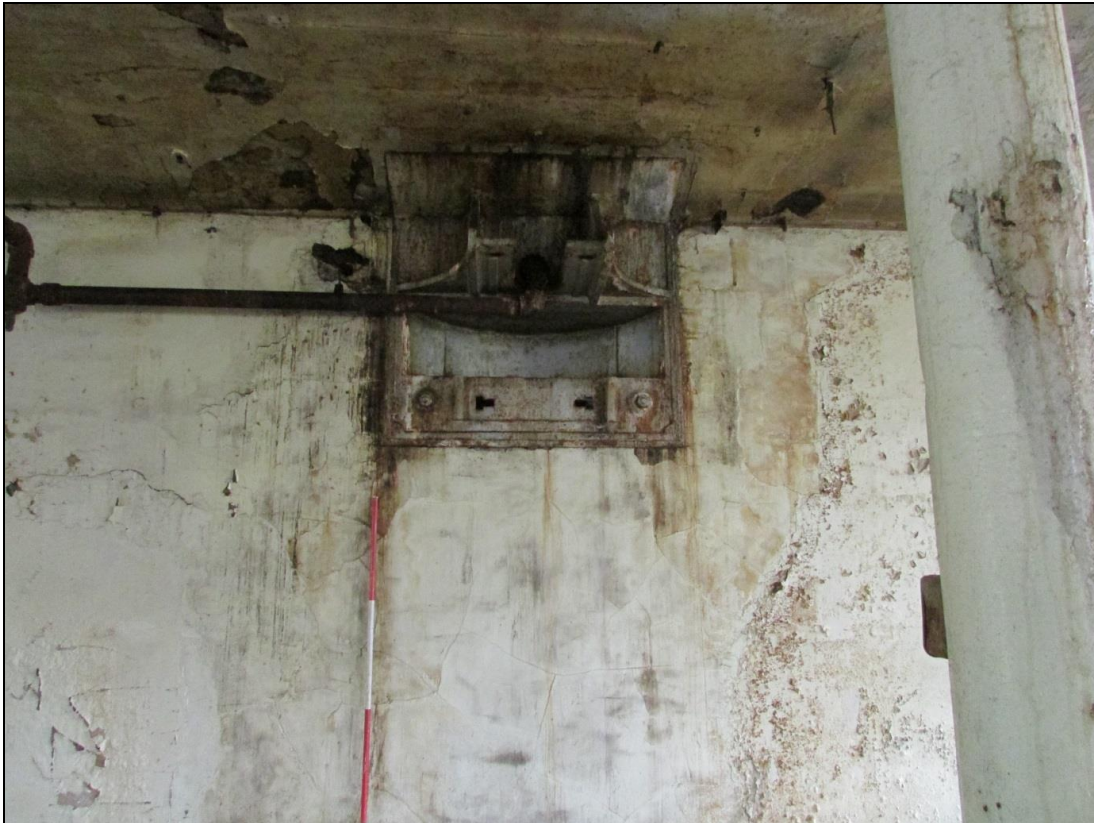
A number of features were noted within the gearing wall, including another large metal bracket which supported the upright shaft (Plate 22). A small aperture is visible in the floor below this fixture, where the upright shaft would have been located. At the southern extreme of this wall is an entrance with a dressed stone surround, blocked with machine-made brick and painted over. To the north of this was a wider entrance which appears to have been inserted at a later stage and

**Plate 22 Metal bracket on the second-floor gearing wall to support the upright shaft**

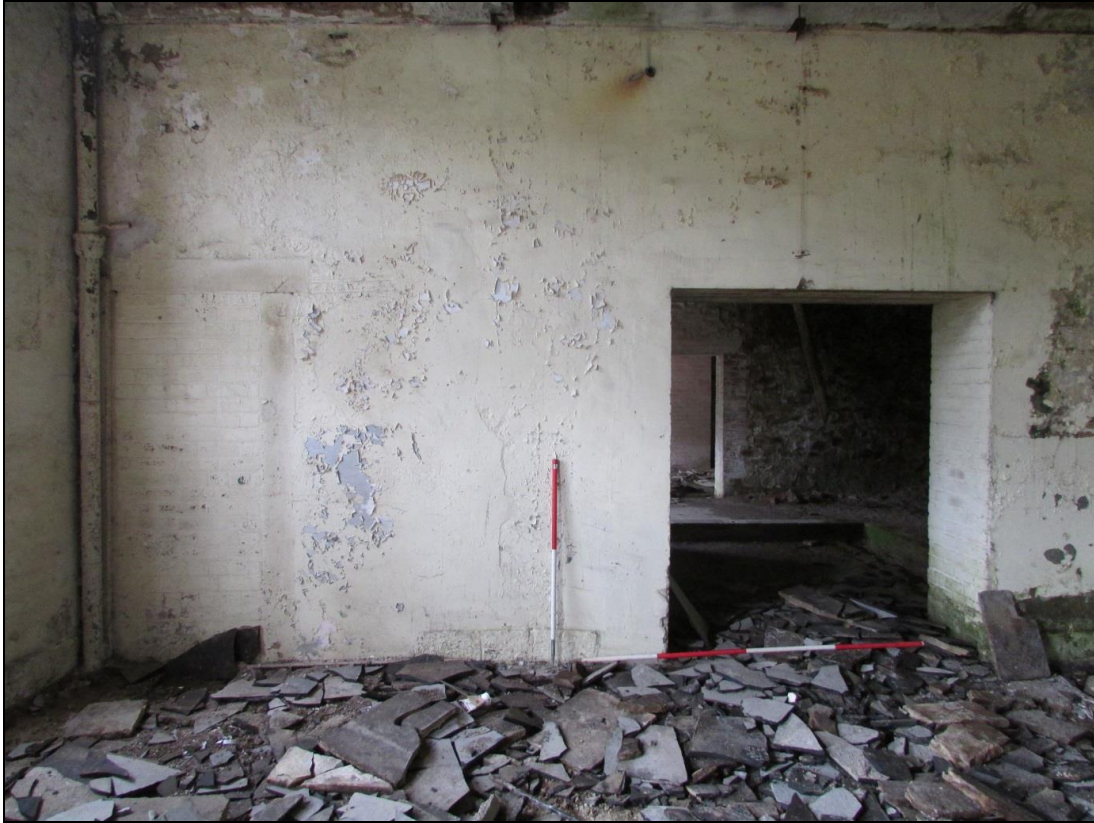
although painted over, the detail of machine-made brick lining the entrance is evident (Plate 23). This entrance appears to be solely for the lift shaft in the engine house as another entrance lies 3.75m to the north of this one. This is also a later addition although it has a stone lintel with machine-made brick squaring the entrance off. There is a third, likely inserted entrance also within this elevation leading to the northern part of the engine house (Plate 24). Although the details have been obscured by later painting, coursed brick outline is visible around the frame of this door, which is wooden and bears a close resemblance to the later, modified entrances from the stair tower.

**Plate 23** On the second-floor, the entrance on the right has been inserted at a later date, whilst the entrance to the left has been blocked

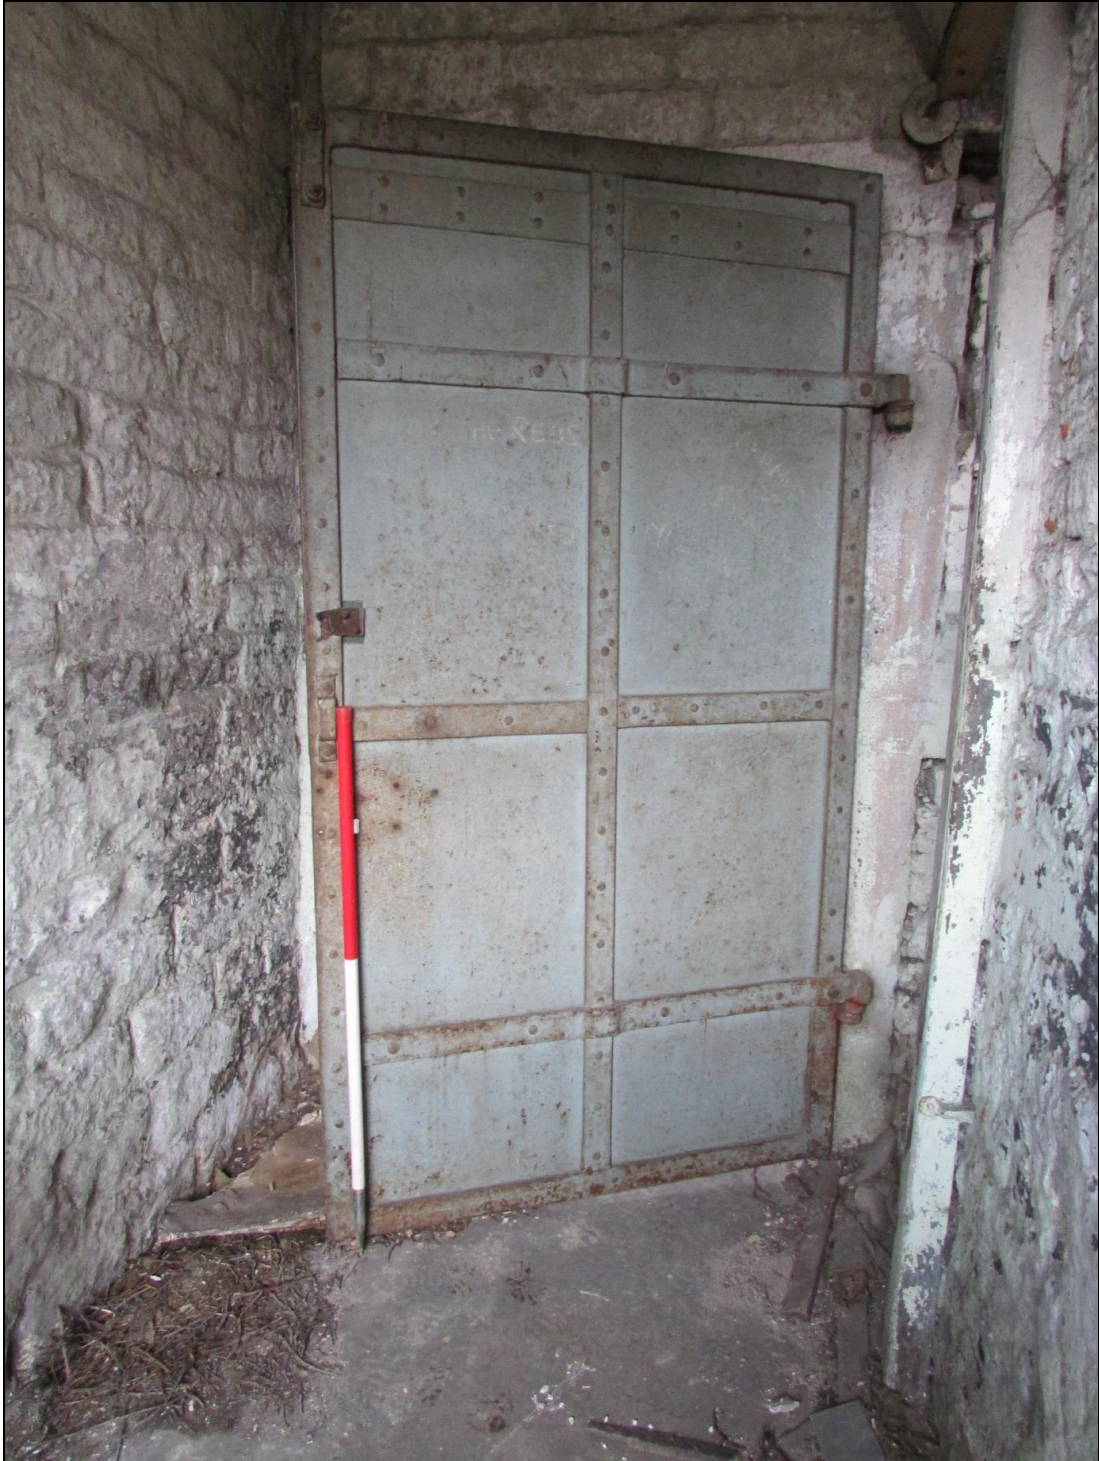
Access was as described for the floors below, except the door on this floor appears to be original with a large metal door that opened out onto the stairs (Plate 27). Many of the windows had been removed from this floor, and much of the flooring had been robbed out. The windows on this floor were smaller than the lower floors and the hand-made brick arched interior lintels were exposed throughout on this floor. As with the lower floors, two rows of 15 axial columns ran east/west supporting a timber triple pitch span roof. To support the timbers, the columns were flanged at the top to support an iron bracket housing the tie beam, which was bolted in (Plate 28). Each pitch consisted of a tie beam, supporting a king post with straight struts between the post and rafters (Plate 29). The ends of the roof trusses were supported by channel-section housings in the top of the columns.

**Plate 27 Possibly the original door leading from the stair tower onto the fourth-floor**

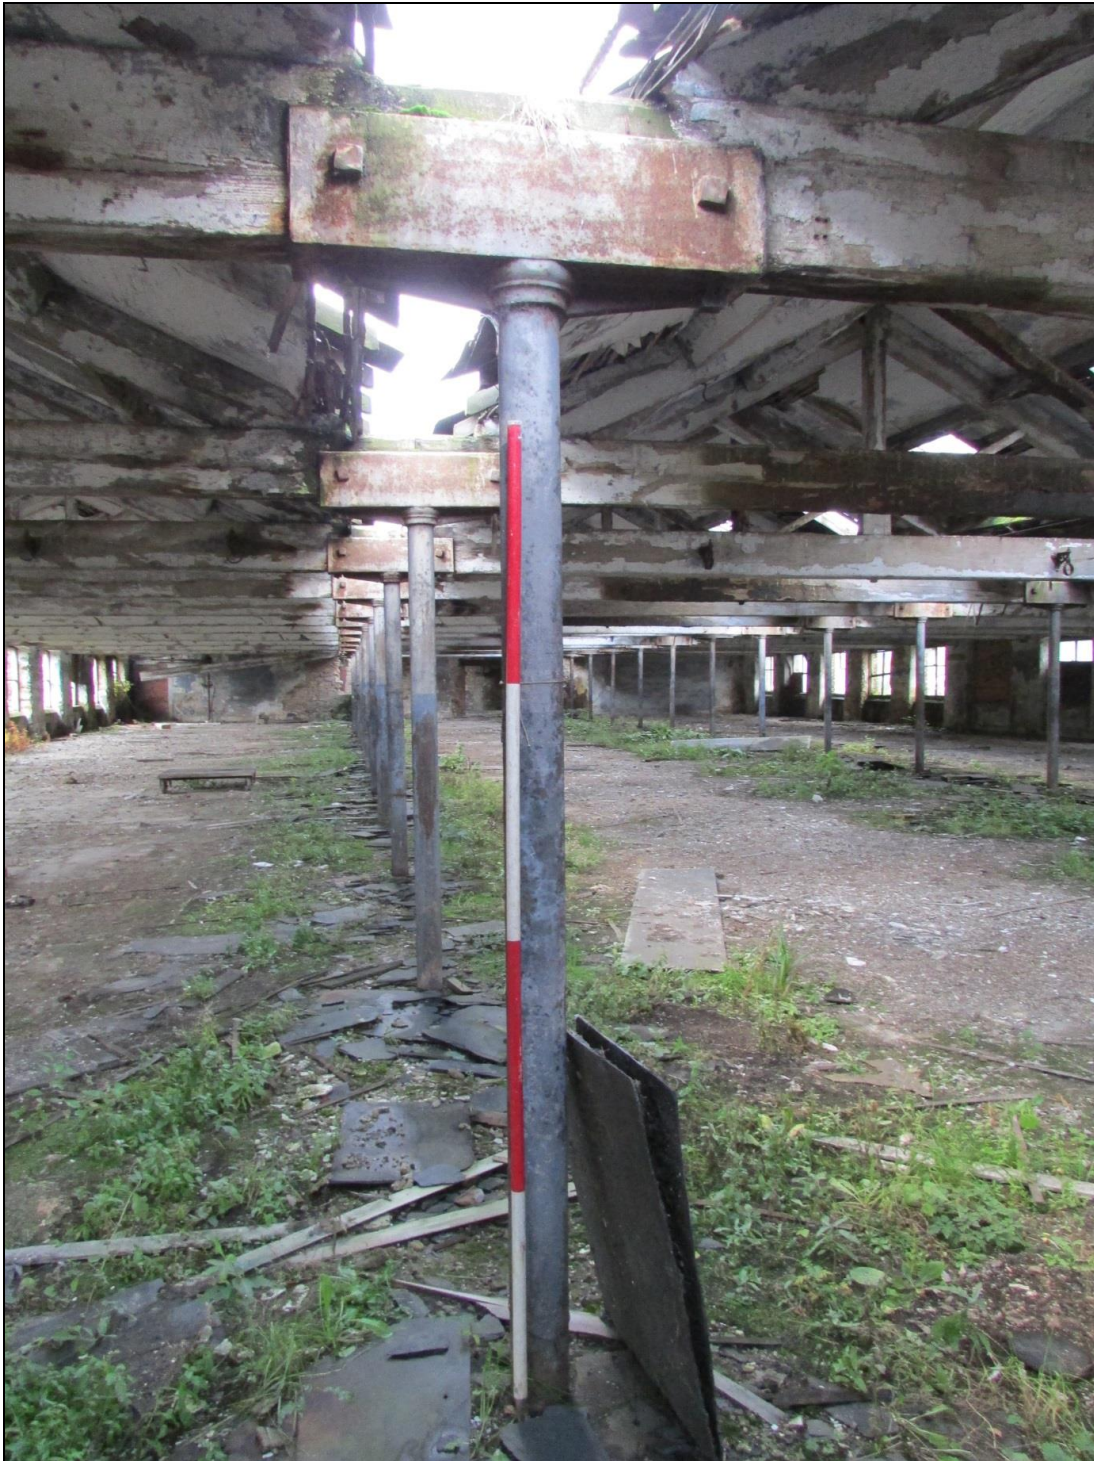
**Plate 28 Detailed shot showing how the roof was supported using the cast iron columns**

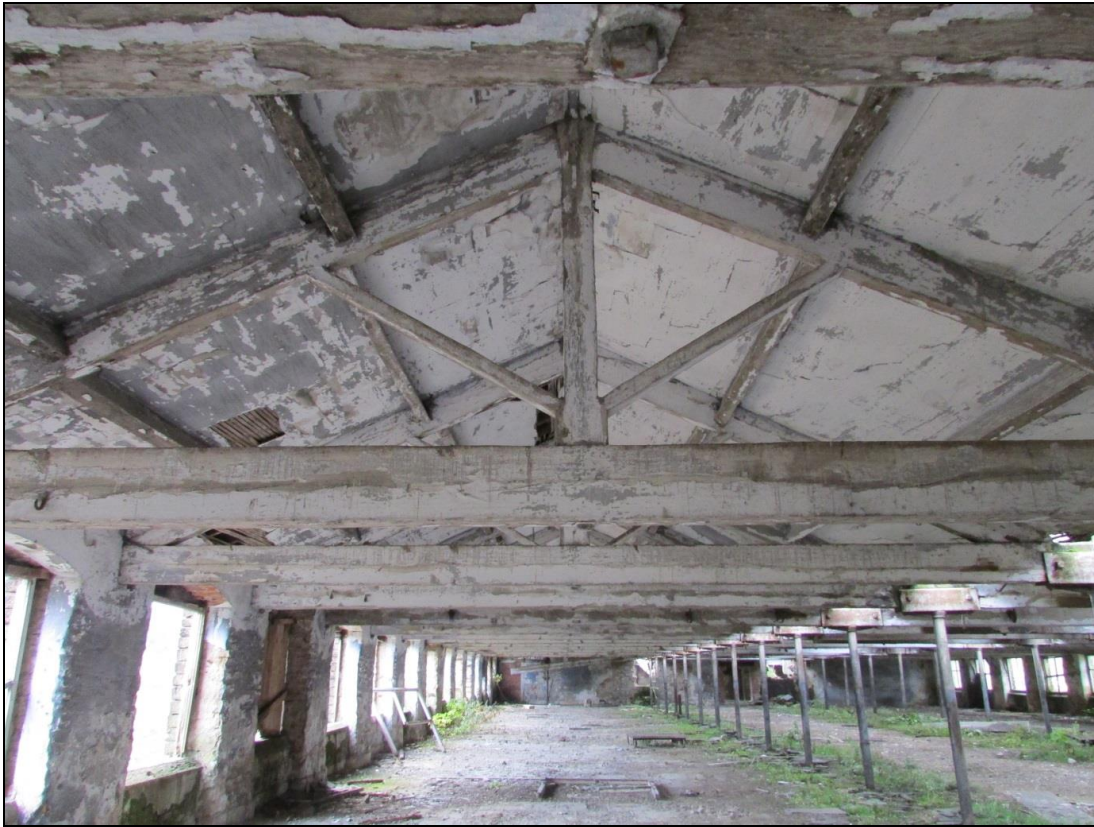
**Plate 29 One of the three pitches spanning the roof showing the king post style structure**

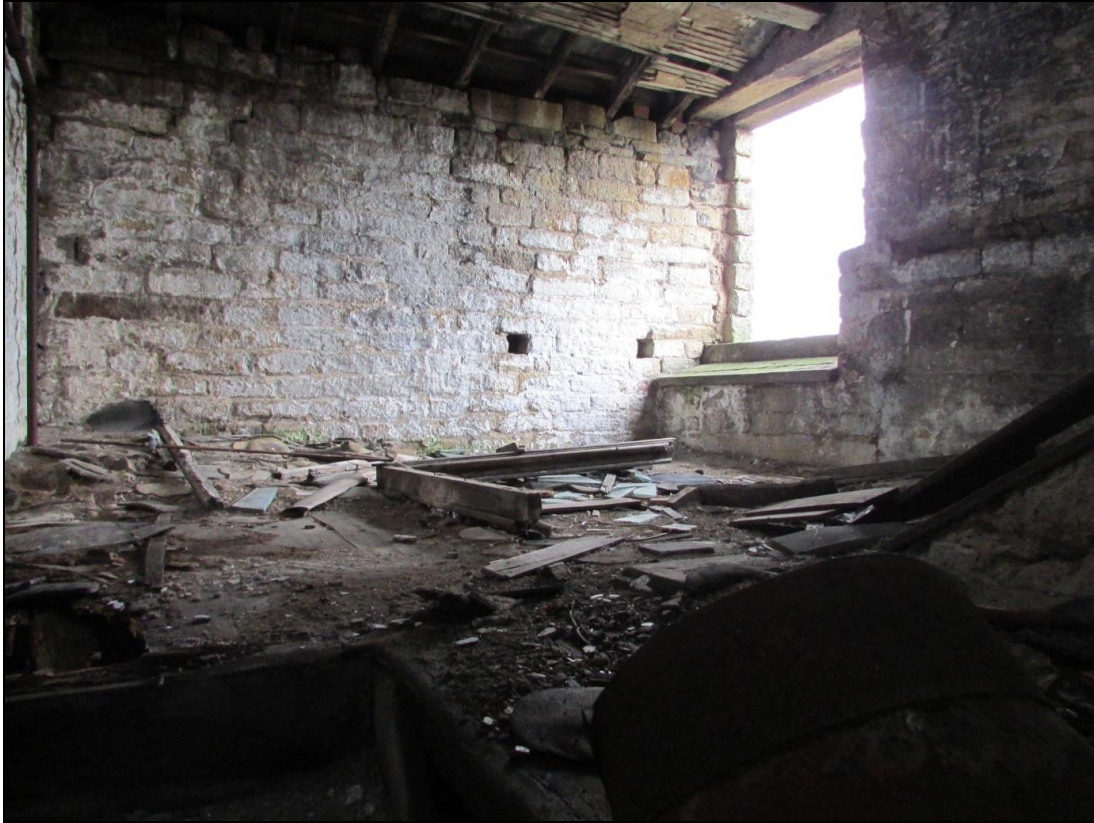
Located within the stair tower was an 'attic' space which was accessed via four timber steps (Plate 31). The timber was rotted in places therefore it could not be accessed however two apertures within the northern wall appeared to have formed timber supports. The coursed undressed stone wall forming the division was partly built around the window.

**Plate 31** A small attic space located in the stair tower and accessed from the fourth-floor

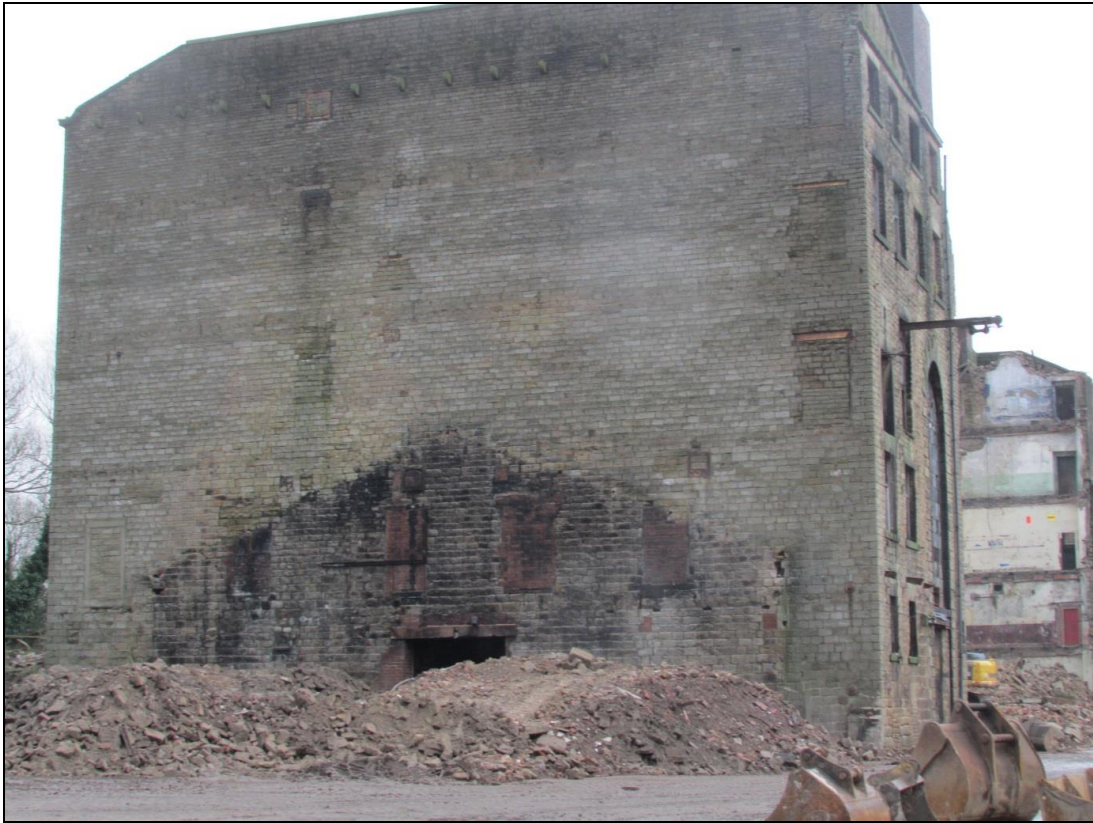
This elevation consists of six bays and contains regularly coursed roughly dressed small yellow sandstone blocks. At ground-floor level, there is a central entrance which appears to be a later insertion and partly built from machine-made brick. The metal lintel is obscured by a metal frame which appears to have been for a sliding door. On the southern side, there is a blocked doorway with one of the tie rod plates immediately south of it. On the first-floor, there are a total of five blockings with the northern one blocked with stone and two others blocked with machine-made brick. Two others are blocked with stone and brick, the brick blocking coinciding with the position of the former warehouse.

**Plate 32** General view of the Engine House western elevation, after removal of the 20th century warehouse (its former position still visible)

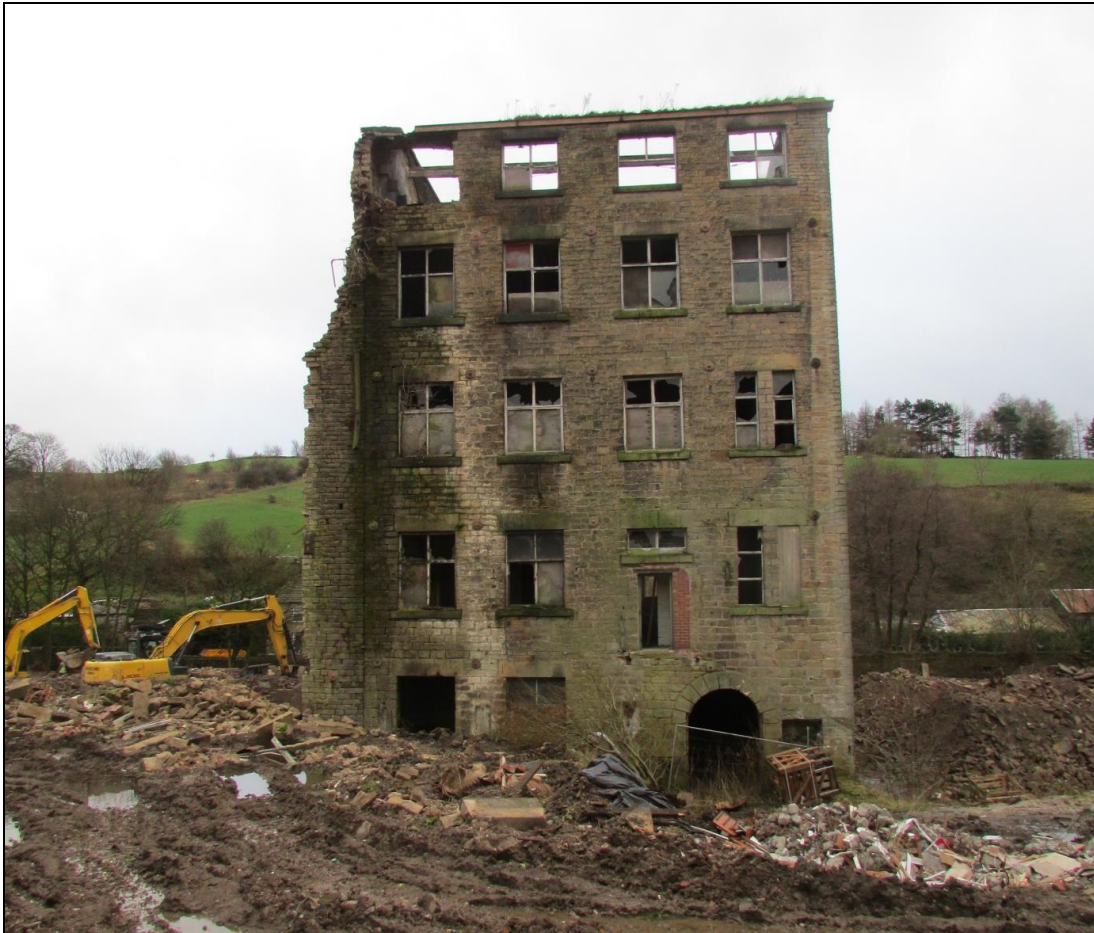
The northern elevation consists of four bays with regularly coursed, roughly dressed small yellow sandstone blocks with tie rod plates, as noted on the mill elevations, spaced centrally between the window lintels on the first, second and third-floors. The ground-floor is partially obscured by made ground to the north of the building, however two windows are visible with stone lintels on the eastern side. The western side contains a dressed stone arched entrance as well as a square gap, which appears to be later.

The first-floor contains three windows, measuring 1.80 x 1.40m with sills and lintels measuring the same as observed on the mill's northern elevation. The window at the western end had a stone pillar in the middle of the window with a slightly different window frame design. The window to the east of this one was modified and an entrance inserted with a metal lintel and machine-made brick to square it off. This appears to have been for a gangway which ran into a building which once stood to the north. The third and fourth-floor have four windows each, as described for the northern elevation of the mill. The exception is the western window which also has a stone pillar in the centre, as the floor below. The fourth-floor windows are smaller, four light windows and are as described for the northern elevation for the mill.

**Plate 34 Northern elevation of the engine house**

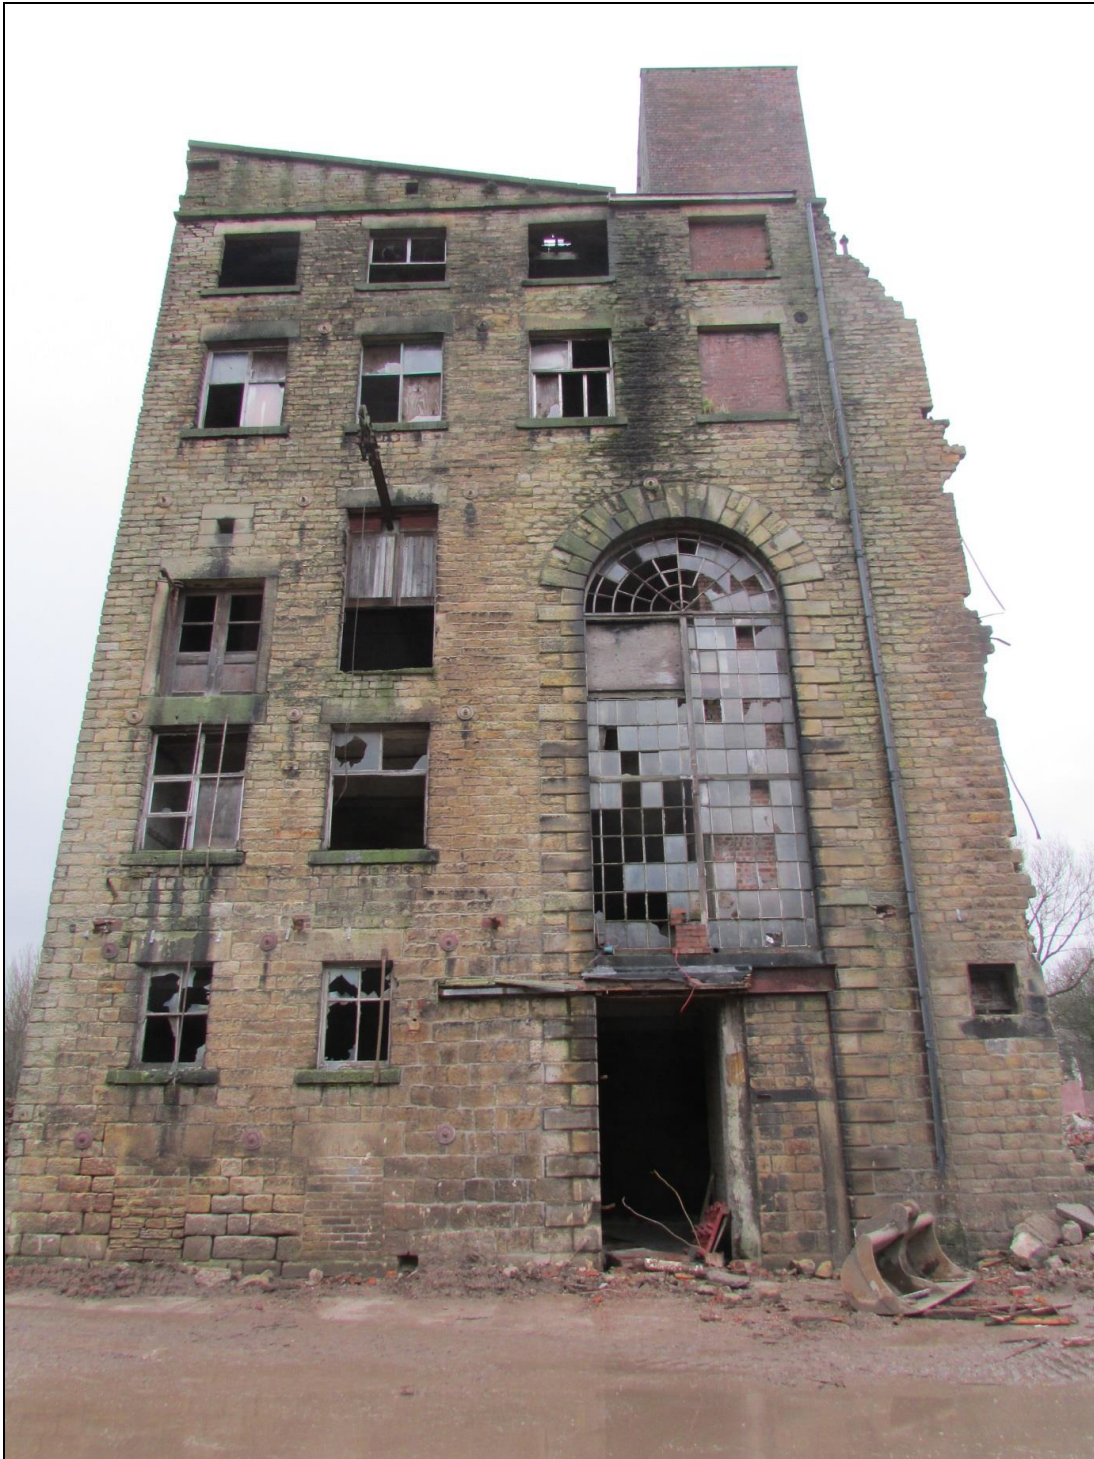
The southern elevation consists of four bays with regularly coursed, roughly dressed small yellow sandstone blocks. The window arrangement differs from the rest of the mill, with the eastern two bays dominated by a large round headed window, with fanlight and dressed rusticated quoins. This window covers the first and second-floor level although the dressed stones continue down to ground level where it defines coursed stonework on the east side and an entrance on the west side. The entrance appears to be a later modification, with a metal RSJ inserted for the lintel and fittings for a sliding door.

**Plate 35 Southern elevation of the engine house**

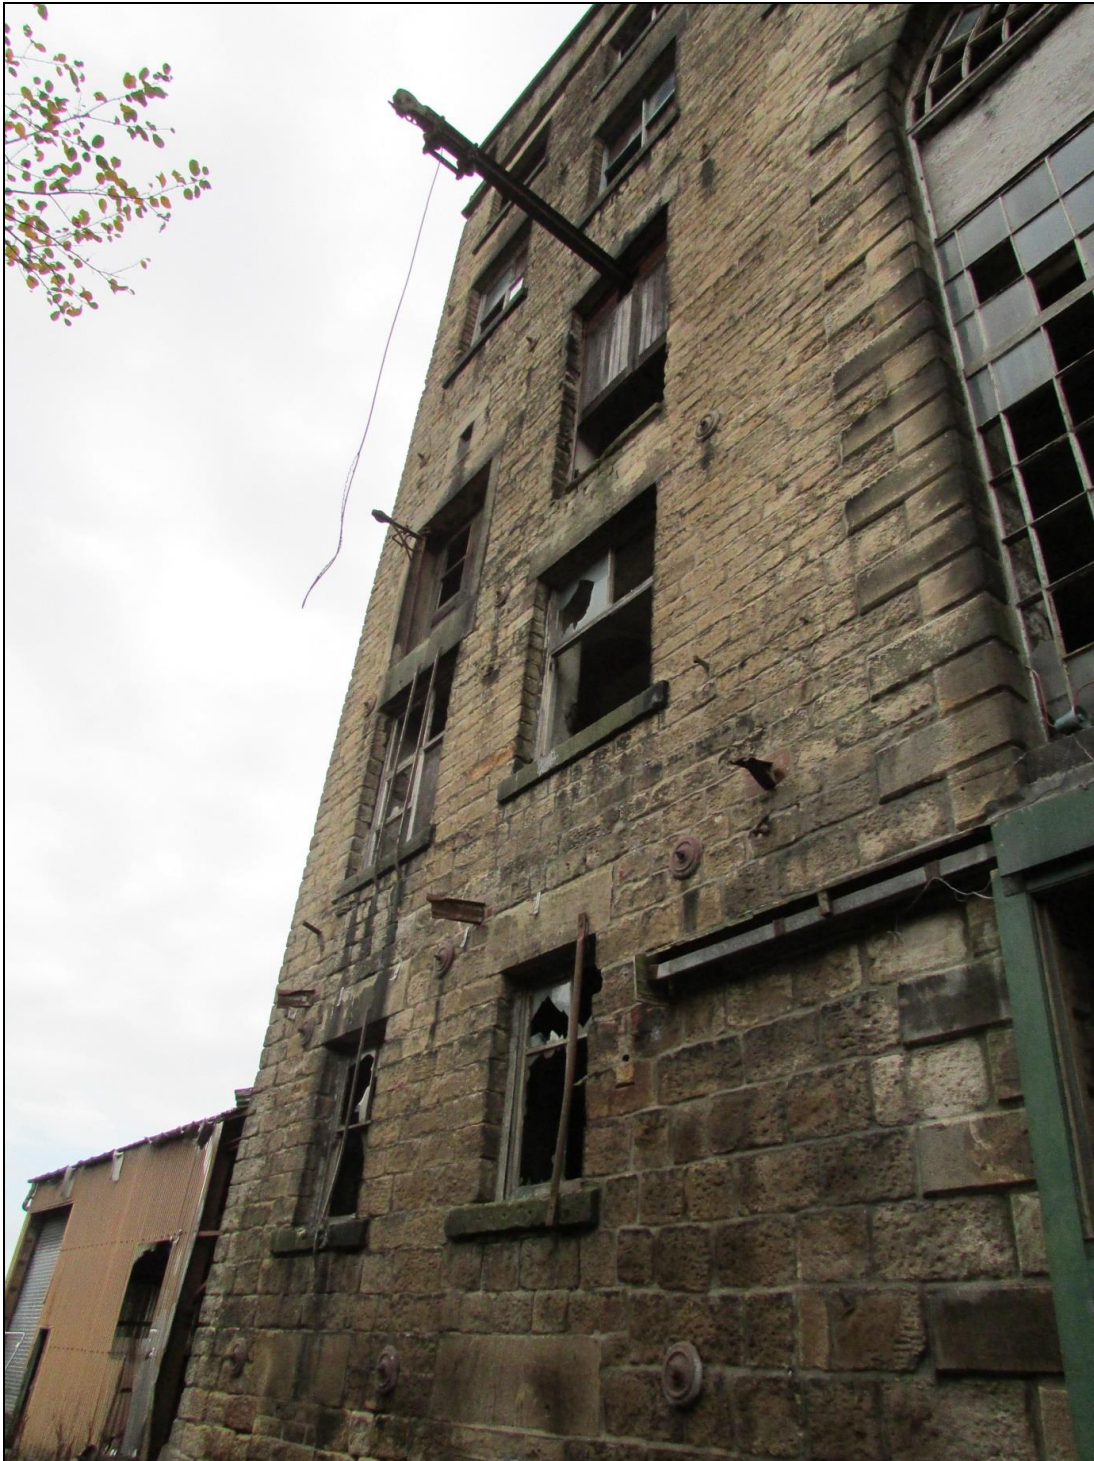
swivelling crane jib *in situ*, and the sill is also the lintel of the first-floor window (Plate 37)

**Plate 37 The western part of the engine house has taking- indoors on the third-floor including in situ cat head and swivelling crane jib**
