**Archaeological  
Building Survey:**

Woods Mill, The  
Narrow Spinning  
Mill, Glossop

**Report No:**  
2015/25

**Document Type:** Archaeological Building Survey

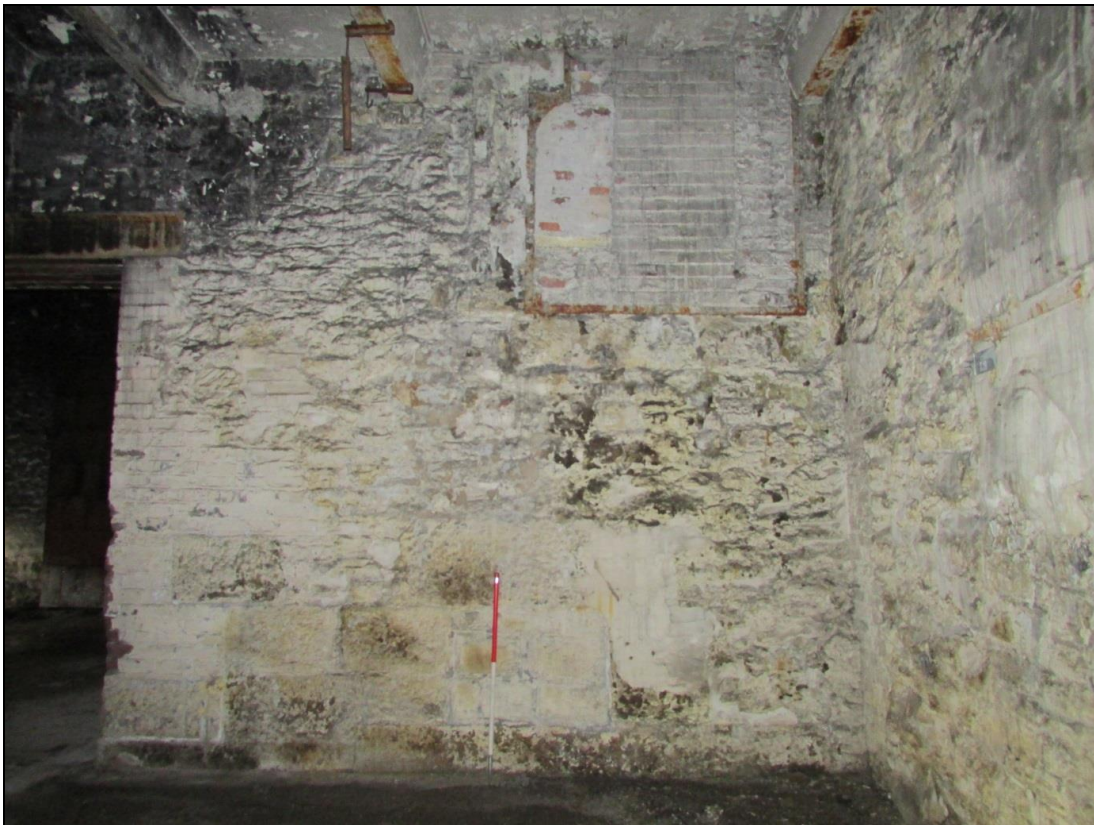
The ground-floor consisted of four separate rooms and the original access appears to have been from the north, with access from the south inserted later. A wall of random and uncoursed stone rubble was aligned north/south across the engine house. Parts of this wall incorporated large stone blocks, which had almost certainly formed the foundation bed for the original beam engine (Plate 38). The western half is divided with a machine-made brick wall which represented a later insertion. The room to the north-west can only be accessed from the arched entrance in the northern elevation. The south-west room has a fireproof ceiling with shallow brick arches and supporting iron beams running east/west. There is an entrance within the southern extreme of the dividing wall, with a stone lintel and frame and blocked with machine-made brick (Plate 39). To the north of this there was an inserted entrance with a metal lintel and shuttering, with machine-made brick constructed to square it off. Another entrance is located to the north, which was also inserted with a metal girder and machine-made brick squaring off the stone.

**Plate 38** Although plastered over, the dividing wall of the engine house consists of mixed stone coursing types, including random rubble and coursed ashlar blocks. Also shown is a bearing box for the power transmission

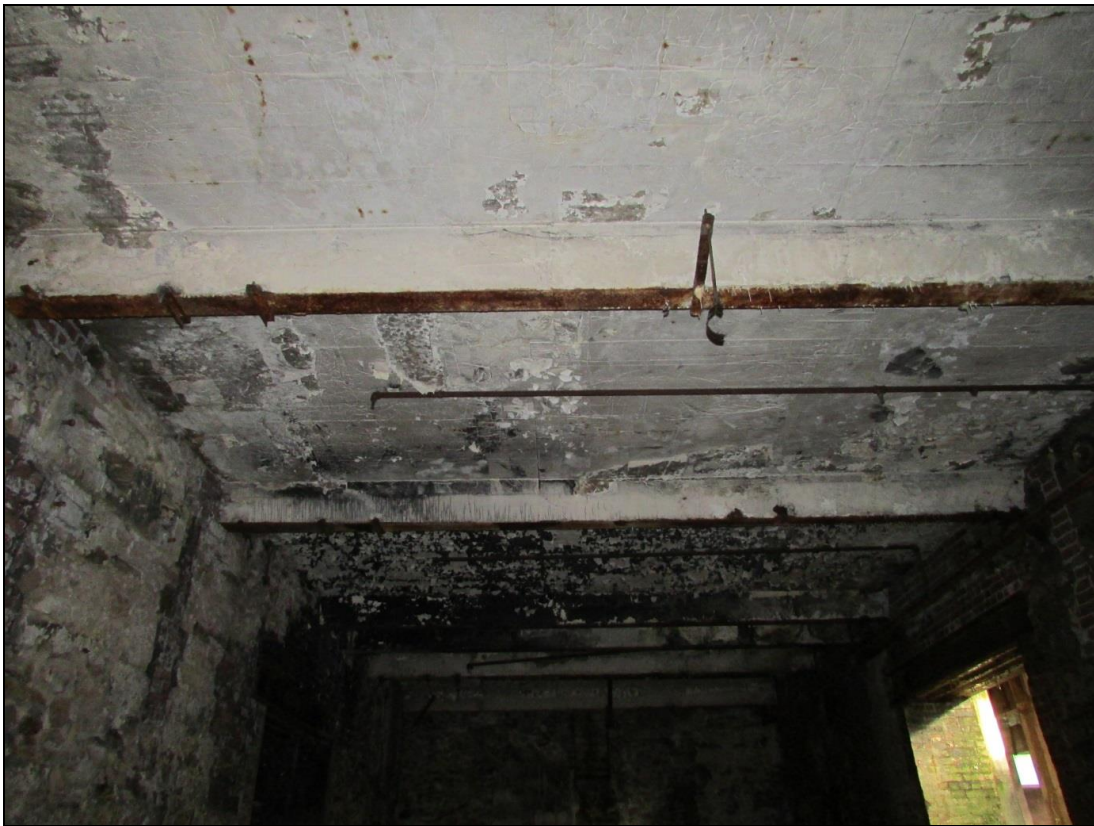
**Plate 41** The flat ceiling of the engine house ground-floor, which is probably later in date

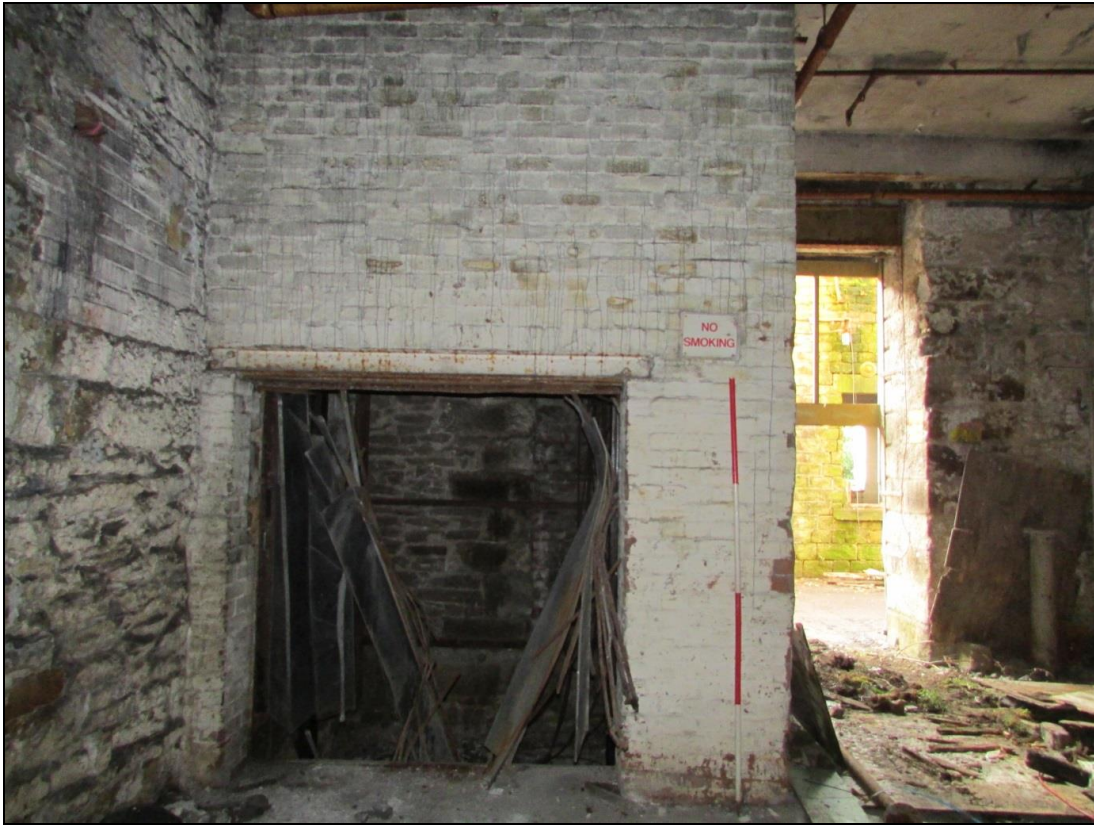
**Plate 42 Later 20th century lift shaft inserted into the engine house**

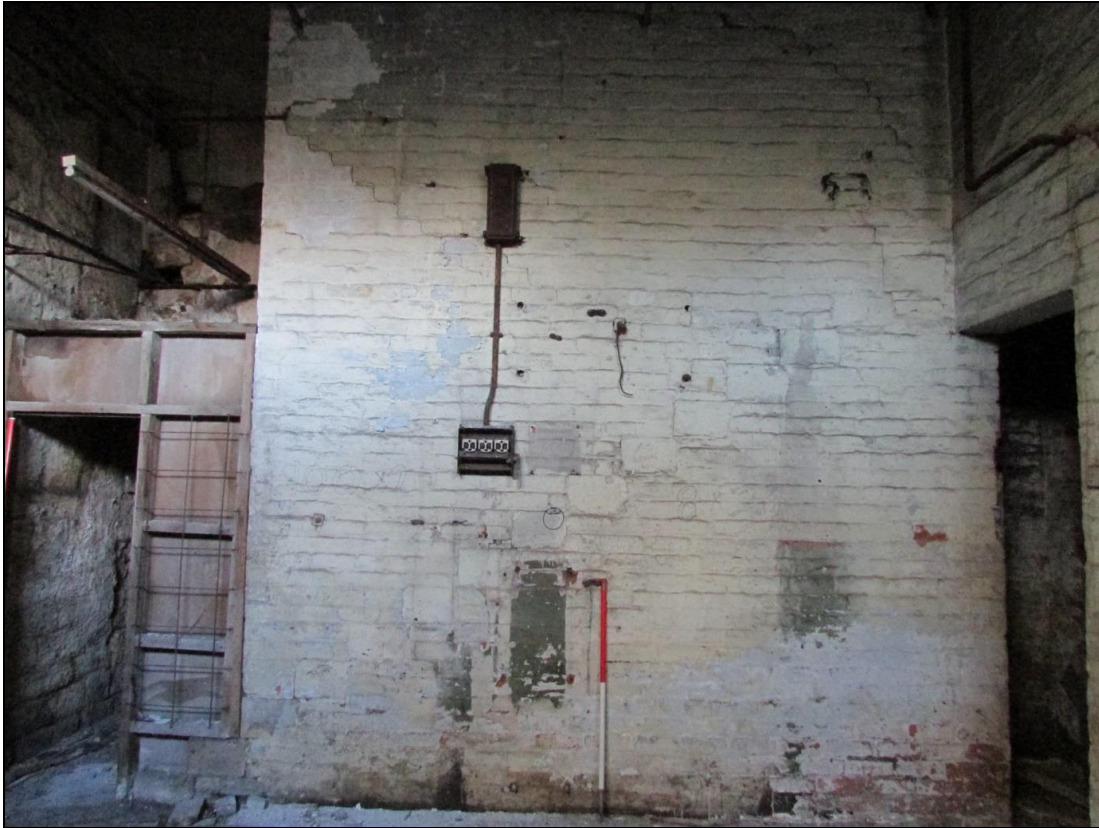
The first-floor is accessed via a series of steps which were located to the north east part of the engine house. These appear to be a later insertion as there is a machine-made brick east/west divide which has the stairs inserted (Plate 44). There is an entrance into the area under the stairs through the later wall and a square, stone lined aperture is partially built over. There are also several stone or concrete blocks which appear to represent elements of a foundation bed for later, electric motors (Plate 45). The eastern wall also contains an entrance with a dressed stone surround and blocked with machine-made brick. The ceiling is fireproof with shallow brick arches and iron beams running north/south at the northern end, with one arch per bay (Plate 46). The orientation is east/west within the rest of the room.

**Plate 44** Later staircase inserted into the engine house

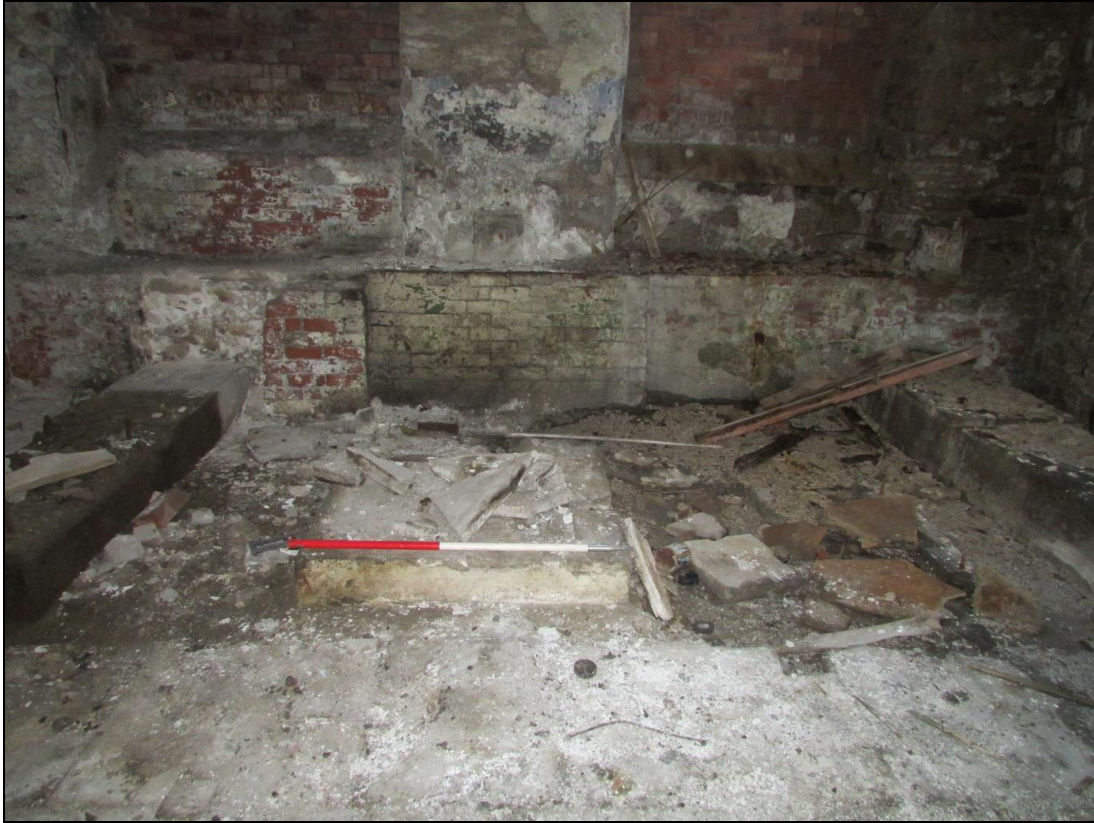
**Plate 45 Stone or concrete bedding for later electric motors**

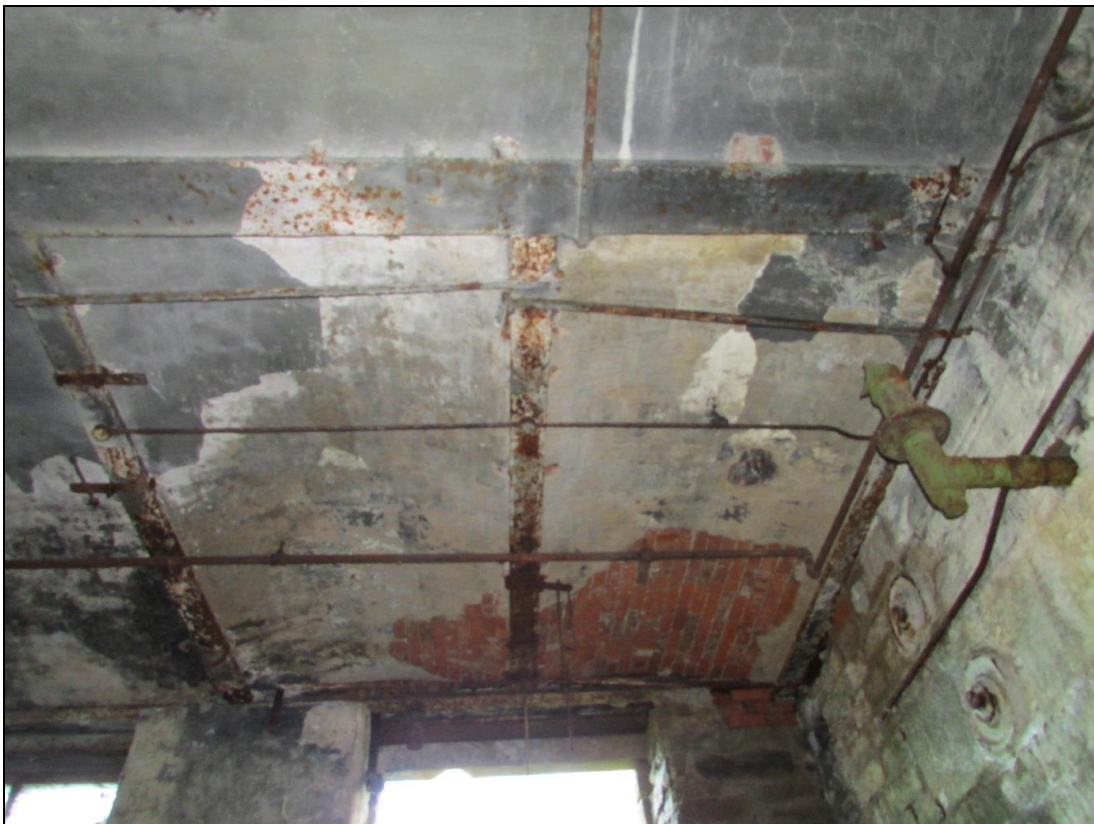
**Plate 46 Fireproof arched ceiling located above the stone/concrete beds**

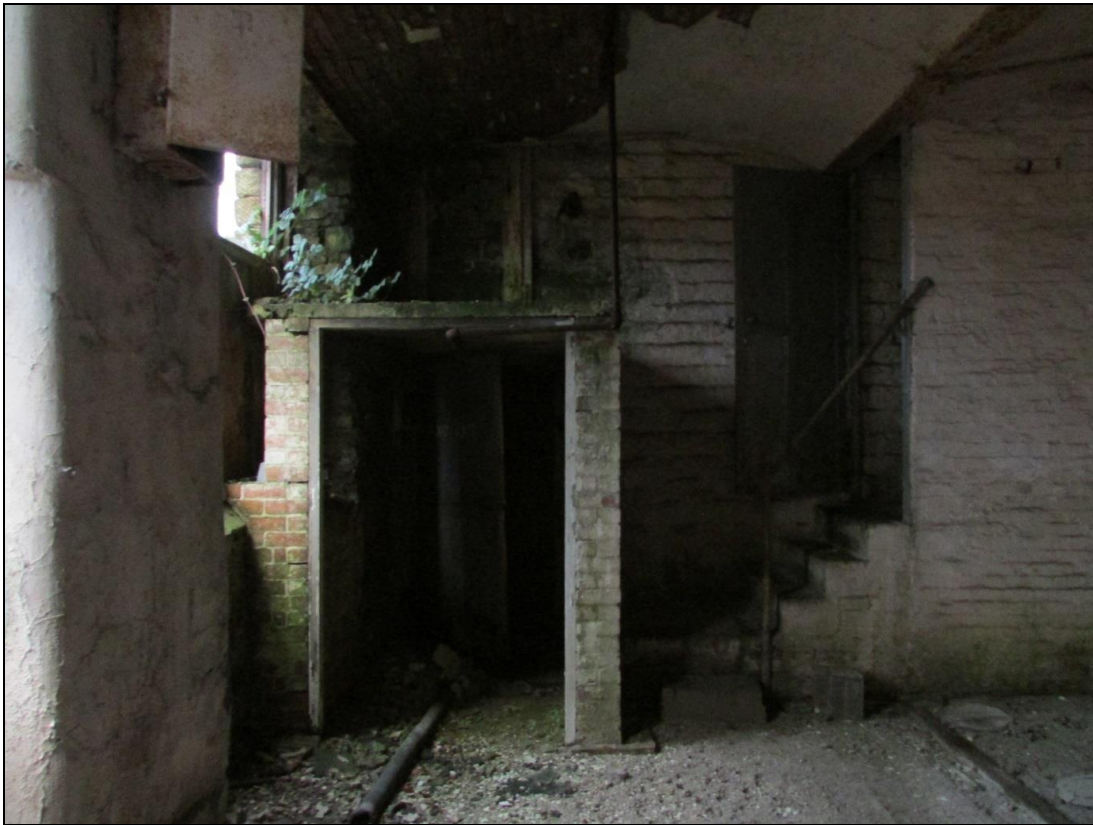
Access is via a series of steps from the ground-floor into a room in the north-eastern part of the engine house. The steps continue to the second-floor from the eastern side and are another later addition, divided with machine-made brick (Plate 47). In the north-eastern corner, there is another machine-made brick sub-division which created a covered walkway. This led to an entrance in the gearing wall, which had been blocked with machine-made brick, although a metal door was still *in situ*.

**Plate 47 Later machine made brick divisions (including the stairs to the right) within the first-floor of the engine house**

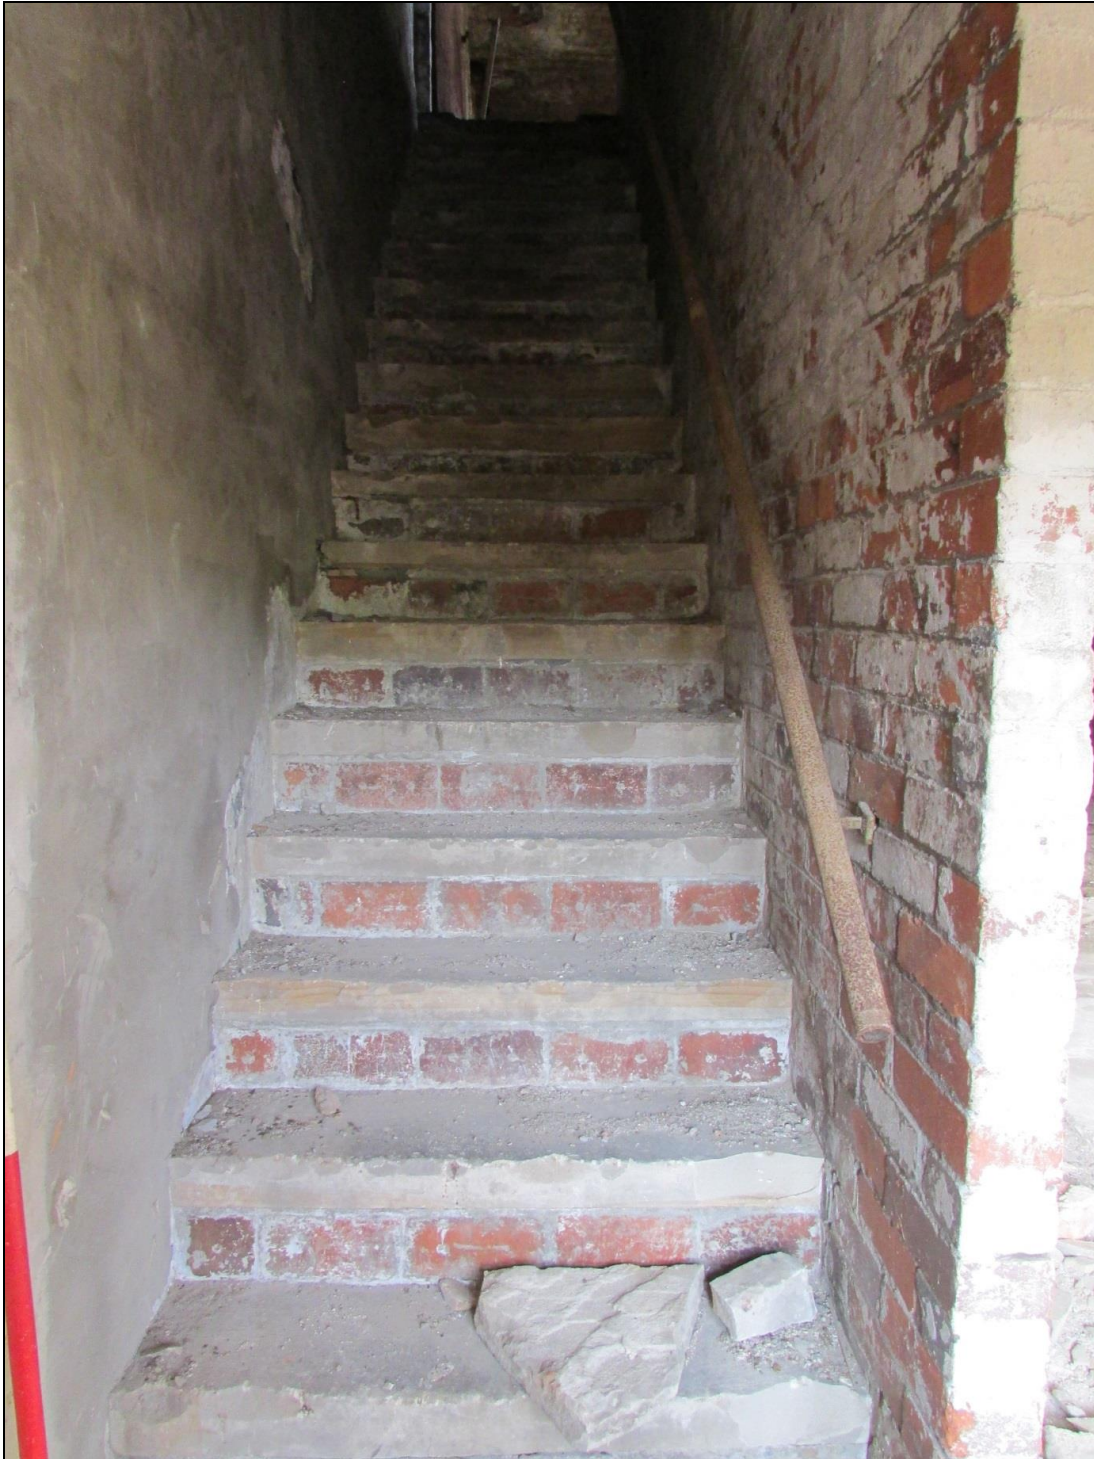
A set of stairs leading to the third-floor was inserted into the south-west corner, constructed from machine-made brick (Plate 53). This lay immediately north of an entrance with dressed stone surround, blocked with machine-made brick. Leading from the eastern taking-in door is the hoist and associated metal fittings *in situ*, which would have facilitated the movement of goods in and out of into the building (Plate 54). A further entrance located at the south end of the engine house dividing wall has been blocked with machine-made brick. To the north of this was a later

**Plate 53 Later steps leading from the second to the third-floor of the engine house**

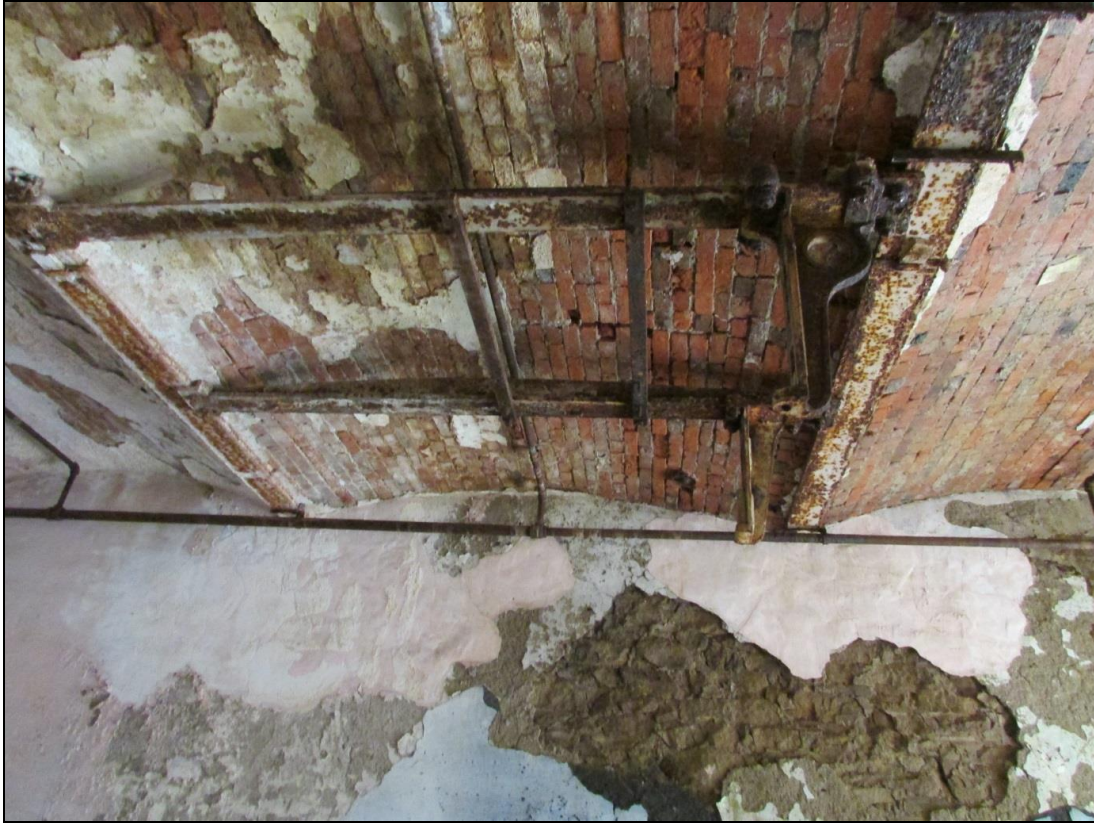
**Plate 54 Original metal fixtures associated with goods movement, fixed to the ceiling**

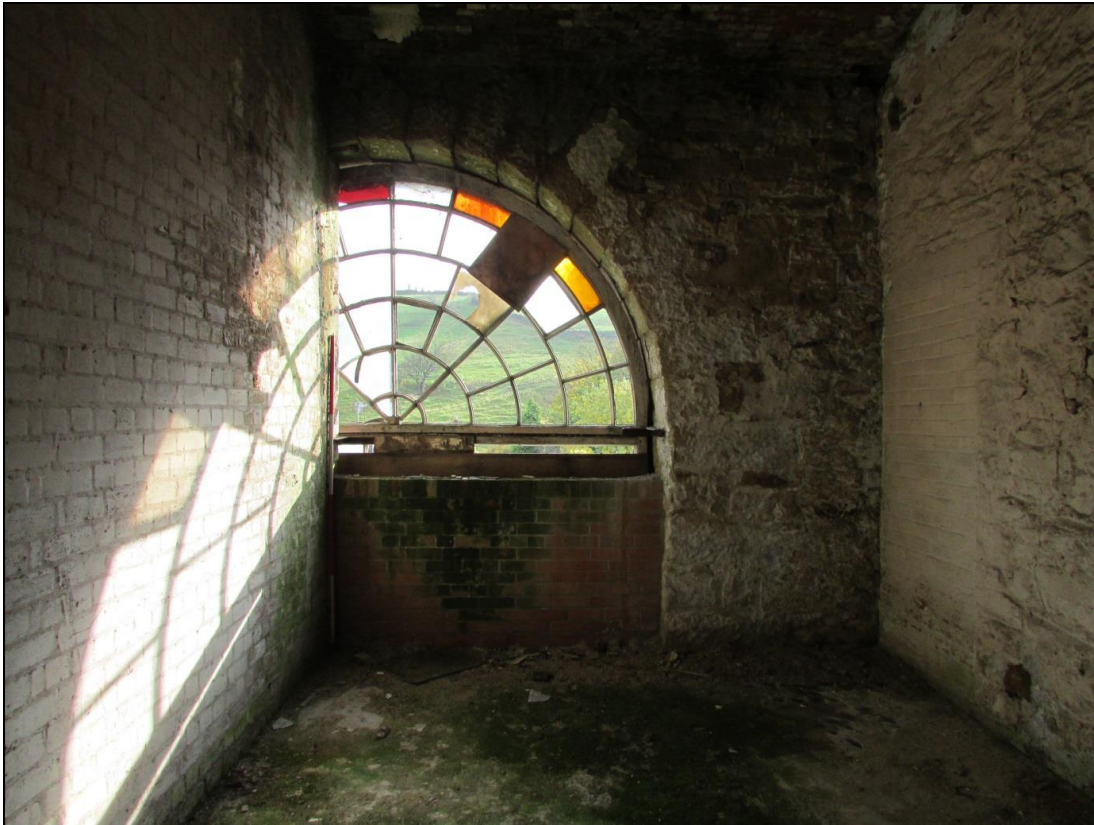
The round-headed window was partially blocked internally by the later lift shaft and also by machine-made brick on the western side to the level of the fanlight (Plate 55). The lift shaft was also partly blocked by a concrete surround with small apertures, suggesting that it had once been screened off. This also meant that anything transported in the lift shaft could only be moved into the spinning mill via an inserted entrance (Plate 56). Further metal fixtures possibly related to the original power system were visible within the gearing wall. These were set on large undressed ashlar blocks built into a wall of small undressed and coursed stone. A later pipe runs west from this through the other wall, where there is a smaller, metal-lined aperture which was blocked subsequently (Plate 57). There were also a series of metal hoist rings built into the ceiling beams, which had probably been intended to facilitate the lifting of engine components for maintenance purposes (Plate 58).

**Plate 55** The original fanlight of the engine house was blocked by the lift shaft (to the left) and a c.1.00m high brick partition

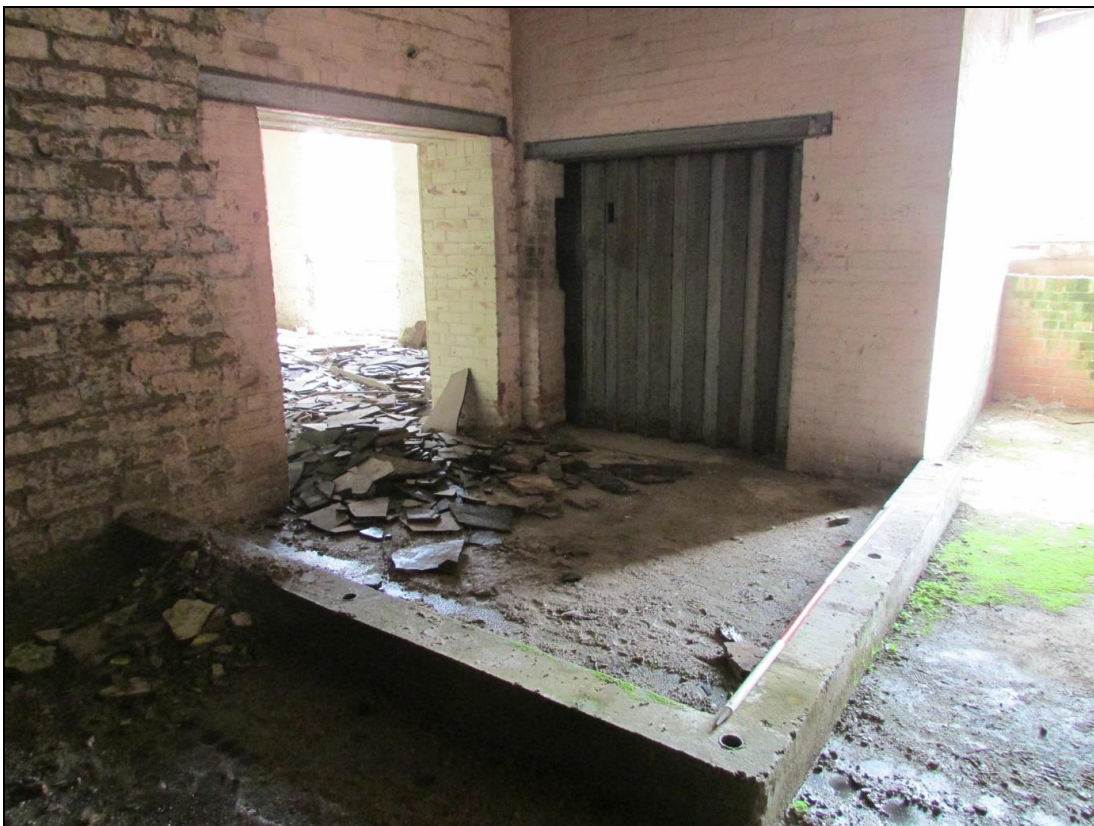
**Plate 56** A possible screen around the lift shaft forces movement through the later entrance

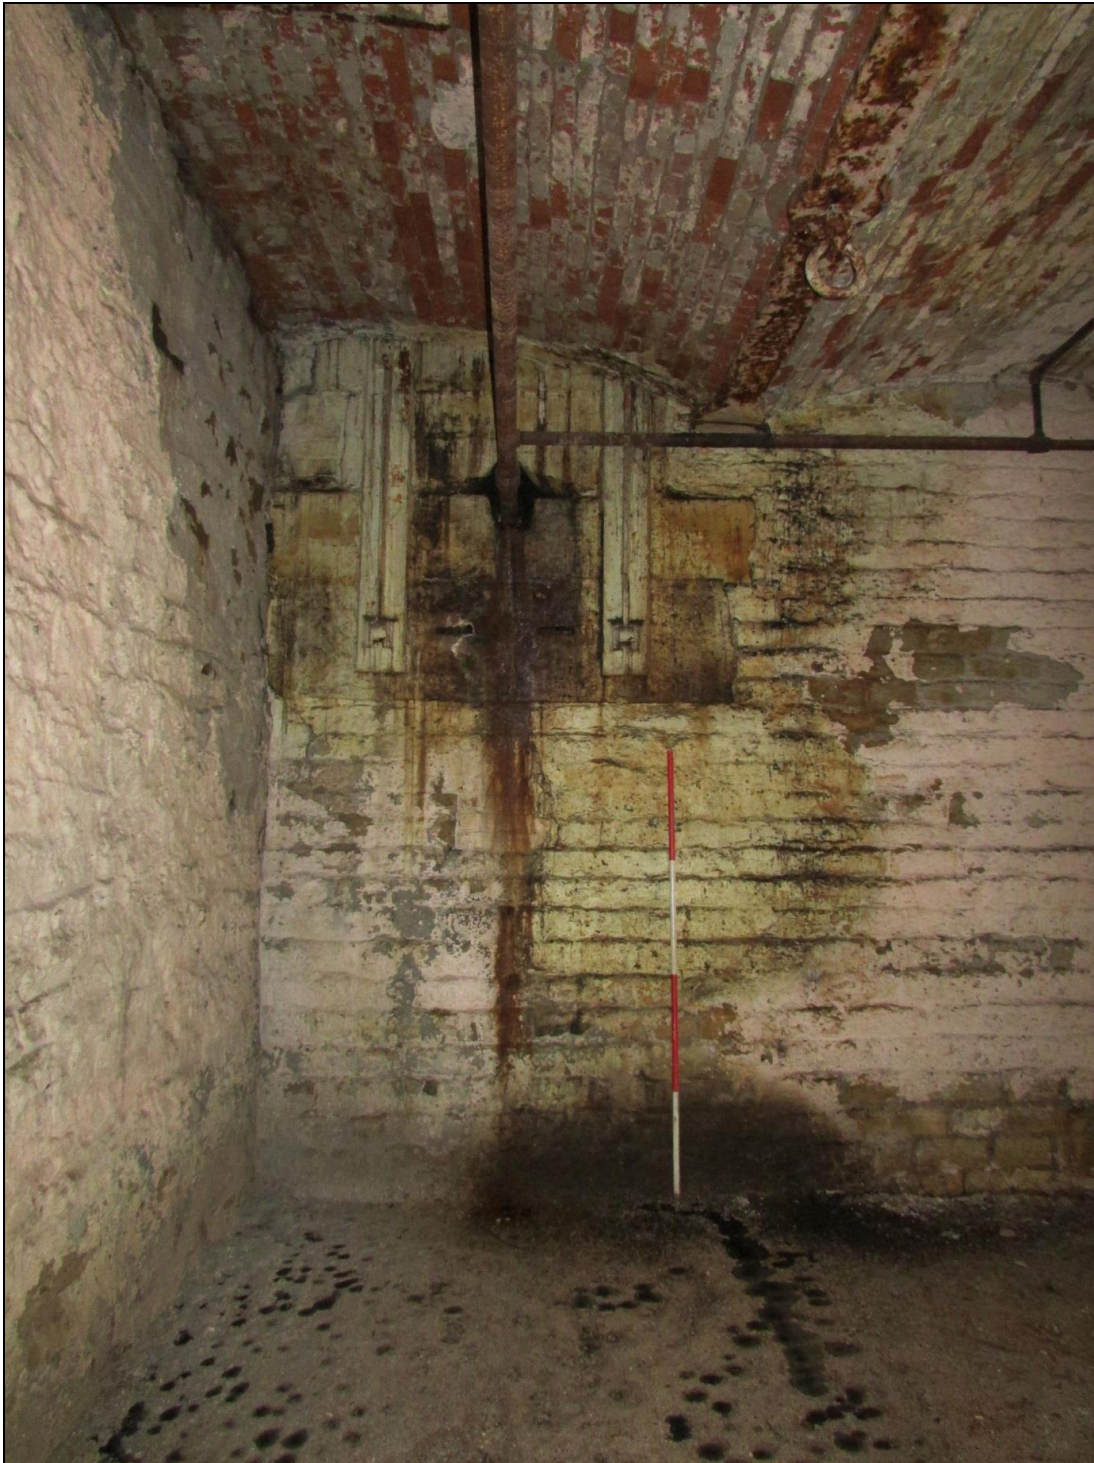
**Plate 57 Original metal brackets supporting the power transmission system, later adapted for a sprinkler system.**

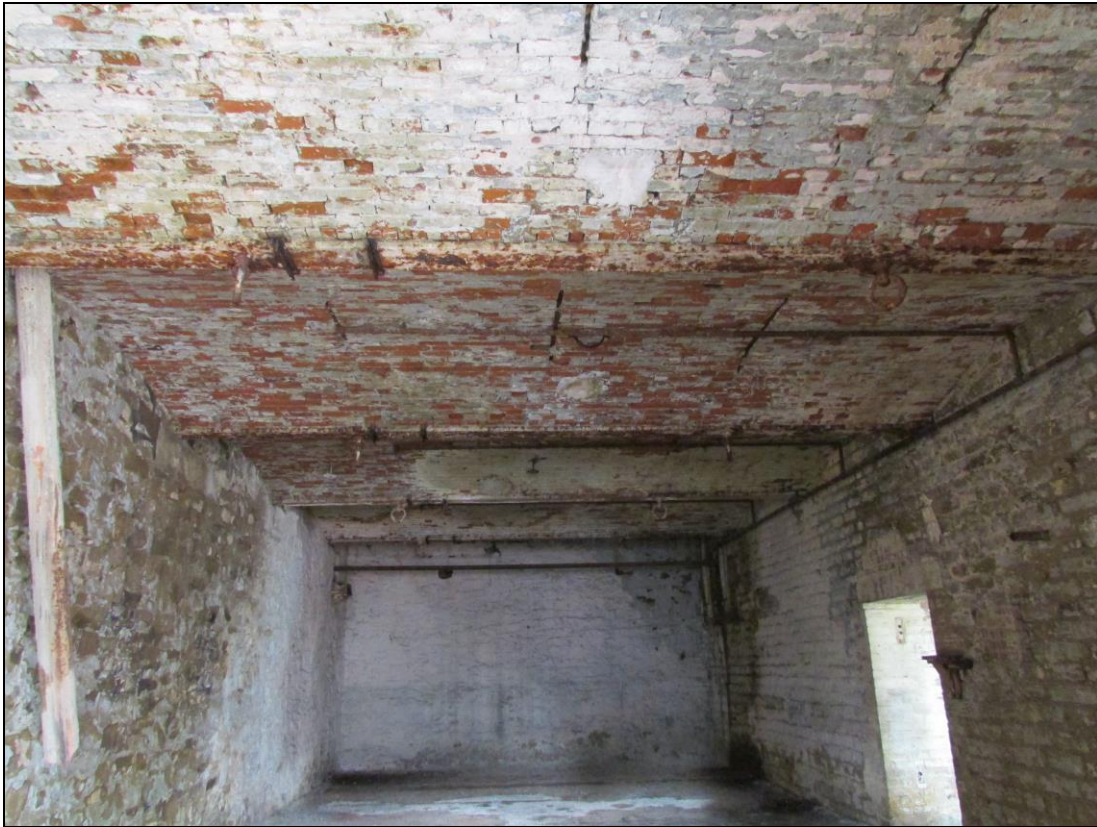
**Plate 58 Metal fixtures, including hoist rings, would have been used to lift components vital to maintaining the engine**

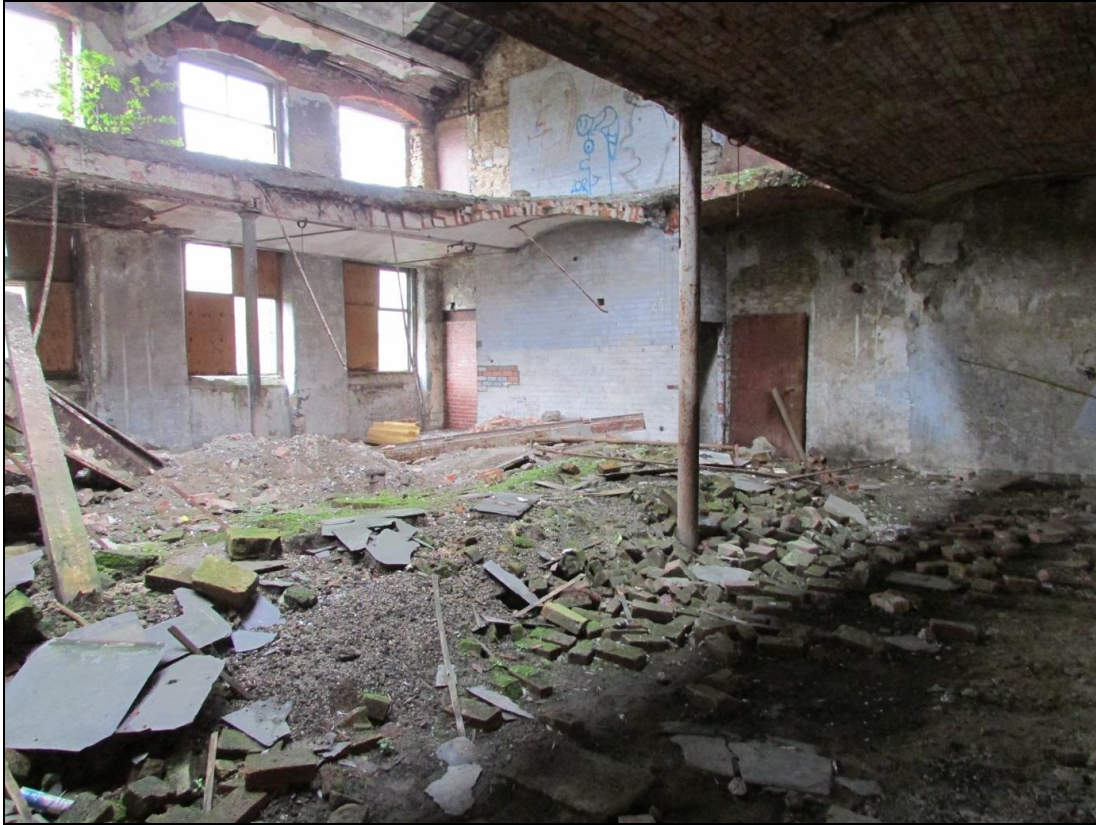
The southern part of this floor could not be accessed due to ceiling collapse (Plate 59) however, unlike the lower floors, this floor was open. As there were no subdividing walls, there is an axial run of iron columns running north/south supporting a fireproof ceiling with shallow brick arches (one per bay) on iron beams running east/west (Plate 60). Visible in the south-west corner was an entrance blocked with machine-made brick, with the later stairs continuing from the floor below immediately north of this. The machine-made brick division continued onto this floor, again with a small projection along the eastern face and the entrance blocked to the south, except on this floor it does not run to meet the northern wall. The lift shaft also continued onto this floor.

**Plate 59 Ceiling collapse on the third-floor of the engine house**

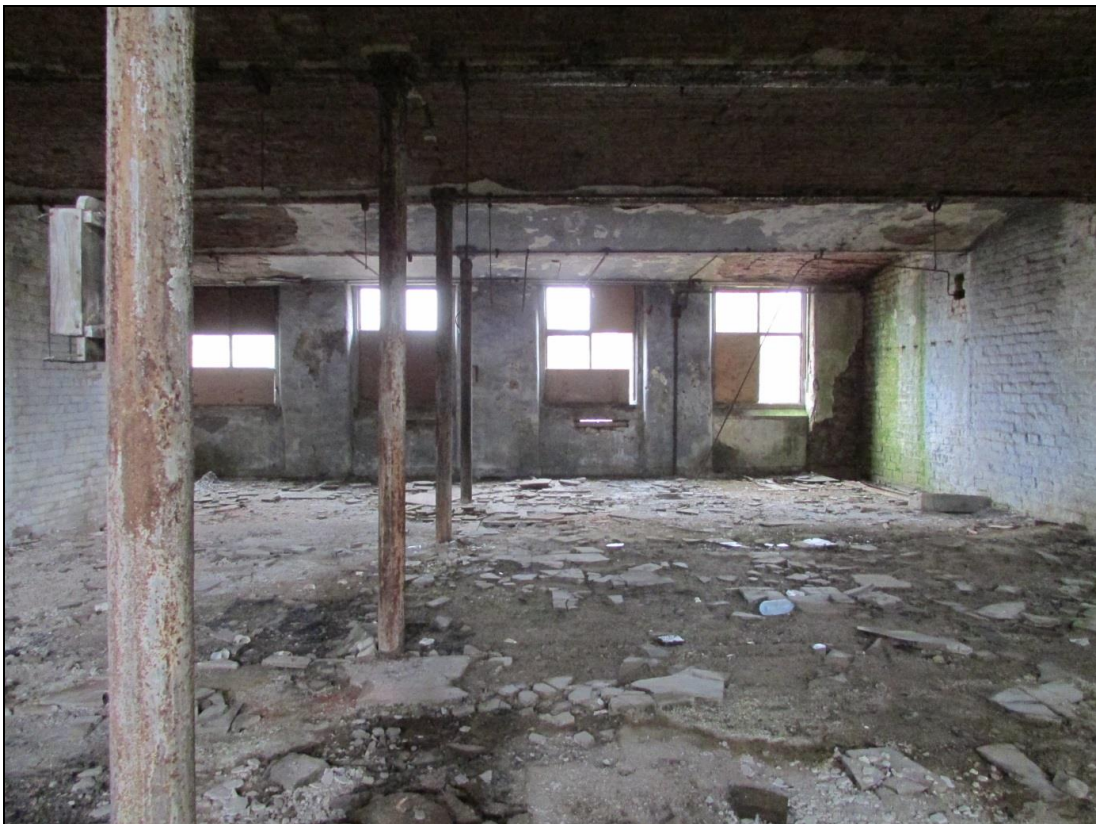
**Plate 60 Instead of a dividing wall, the third-floor of the engine house had a run of axial columns supporting a fireproof ceiling**

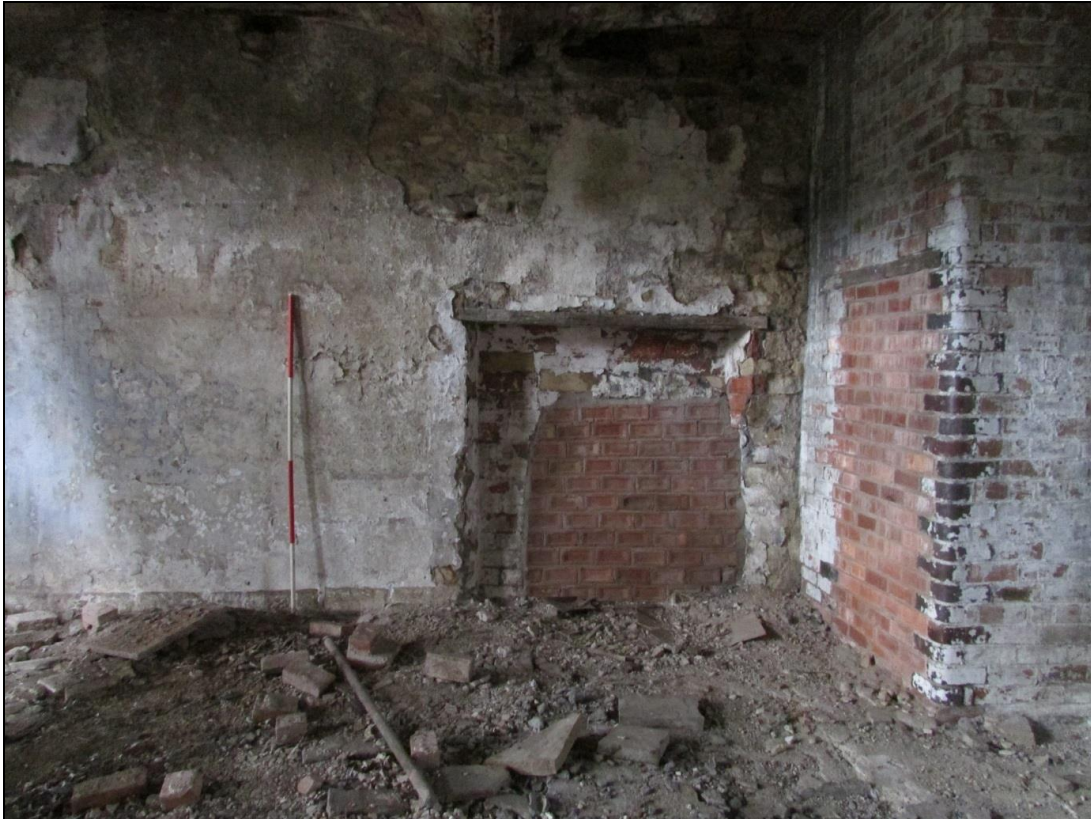
Within the western wall was a recessed feature, partly constructed of hand-made brick and stone and blocked subsequently with machine-made frogged brick. It was supported by a large, flat stone lintel but does not appear to have been an entrance as there is no counterpart blocking visible on the western elevation (Plate 61). Within the eastern wall there are metal brackets, probably associated with the power-transmission system. At the north-east corner of the room was a thin void within the floor measuring 3.30 x 0.80m and appears to have originally been surrounded by stone, although much of it was robbed out. It was lined with iron with a central beam running north/south (Plate 62).

**Plate 61 Blocked recess on the third-floor of the engine house. To the right is the blocked entrance into the void**

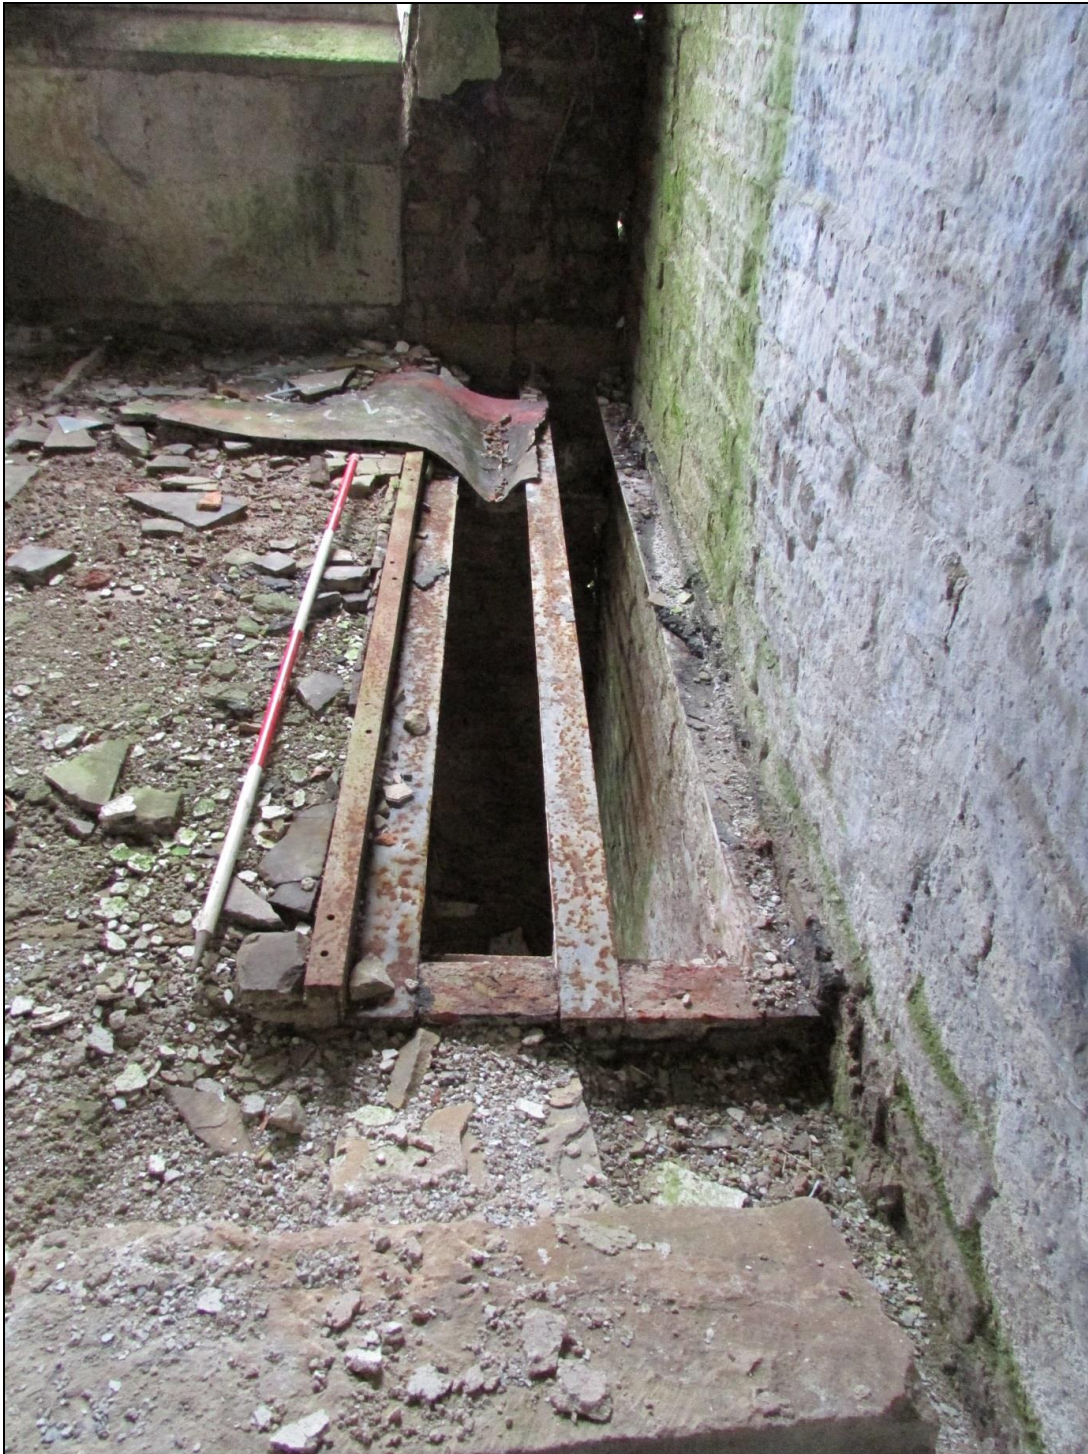
**Plate 62 Cast iron lined aperture within the engine house**

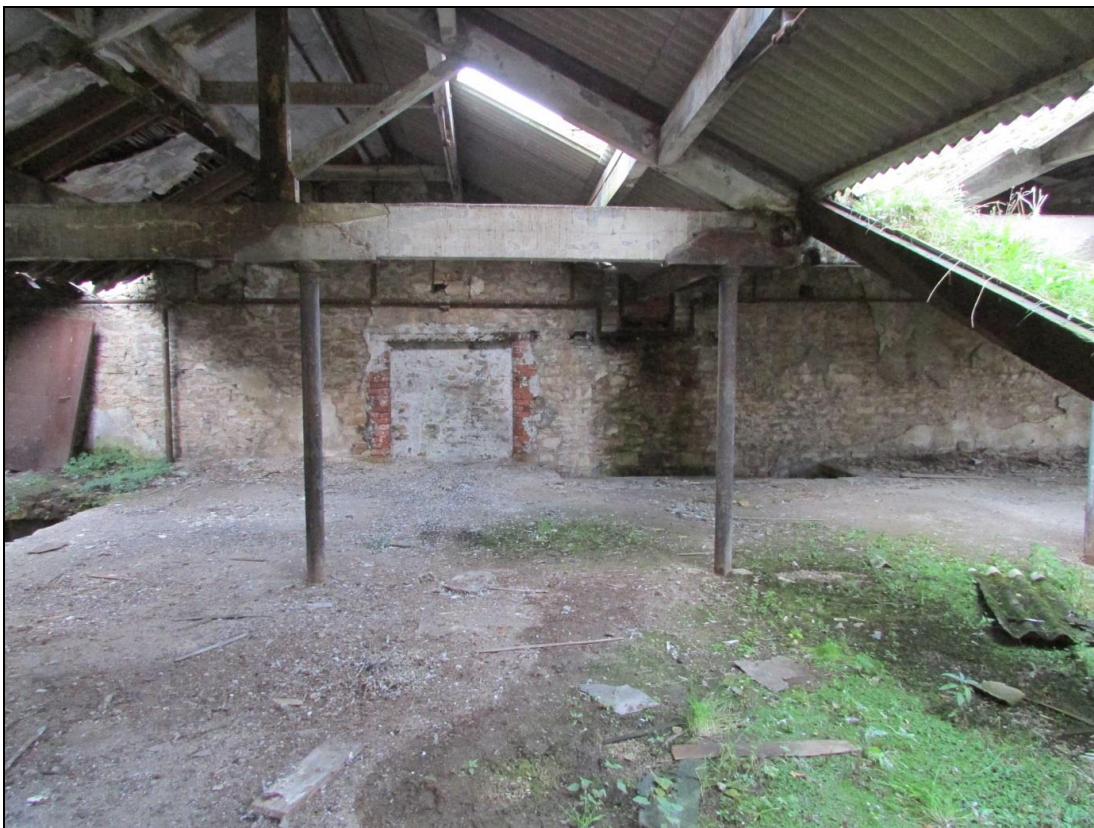
This floor could not be accessed due to health and safety issues, therefore observations and photographs were taken from the gearing wall entrance. Both the floor and roof had collapsed at the southern end of this building and the roof had collapsed at the northern end of the building. This room was again open, therefore there was an axial run of iron columns running north/south supporting the triple-pitched span roof.

**Plate 63 General view of the fourth-floor of the engine house**

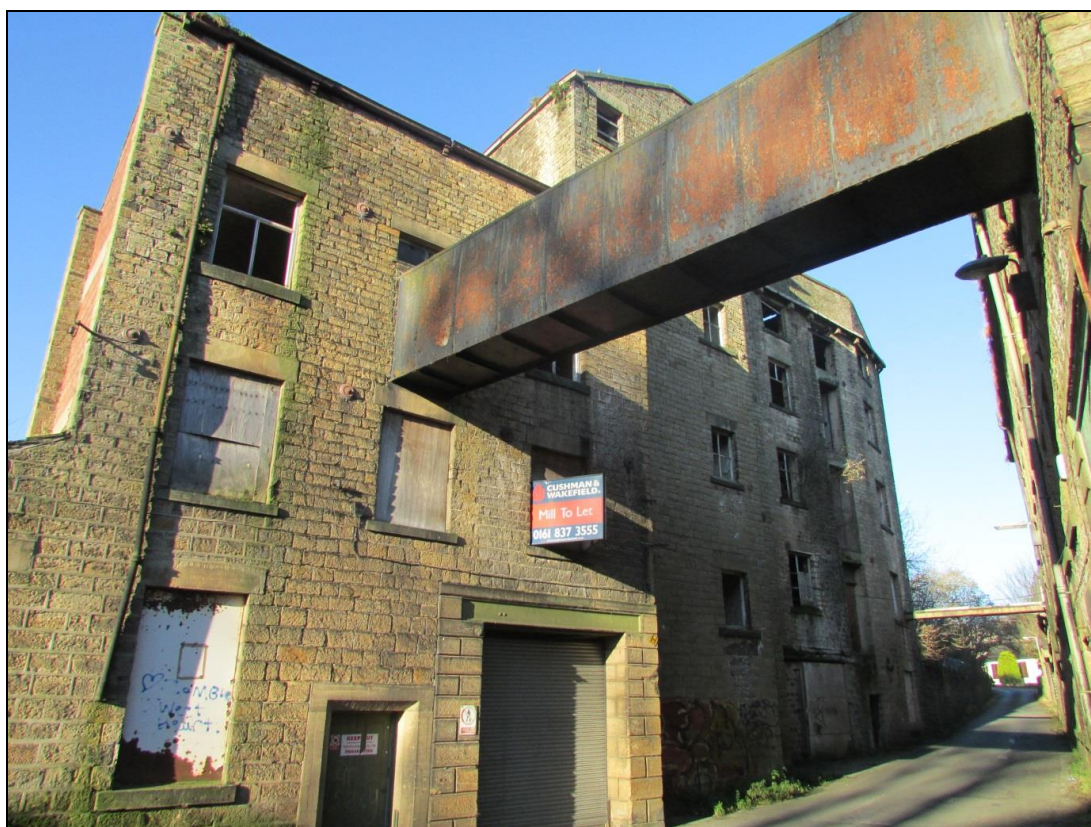
**Plate 64 Eastern elevation of the office block, with the later metal walkway visible (access was not possible during the survey – this photo dates to December 2014)**

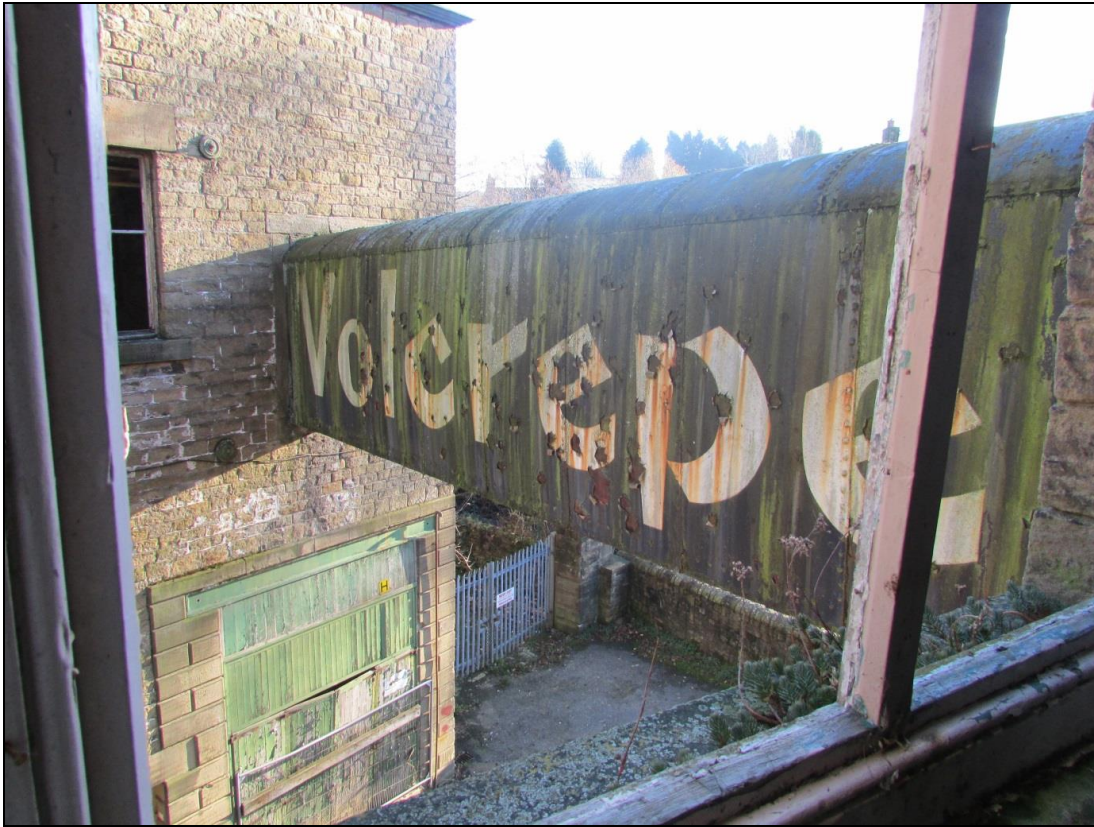
**Plate 65 Metal walkway with the Volcrepe logo still in good condition**
