**Archaeological  
Building Survey:**

Woods Mill, The  
Narrow Spinning  
Mill, Glossop

**Report No:**  
2015/25

**Document Type:** Archaeological Building Survey

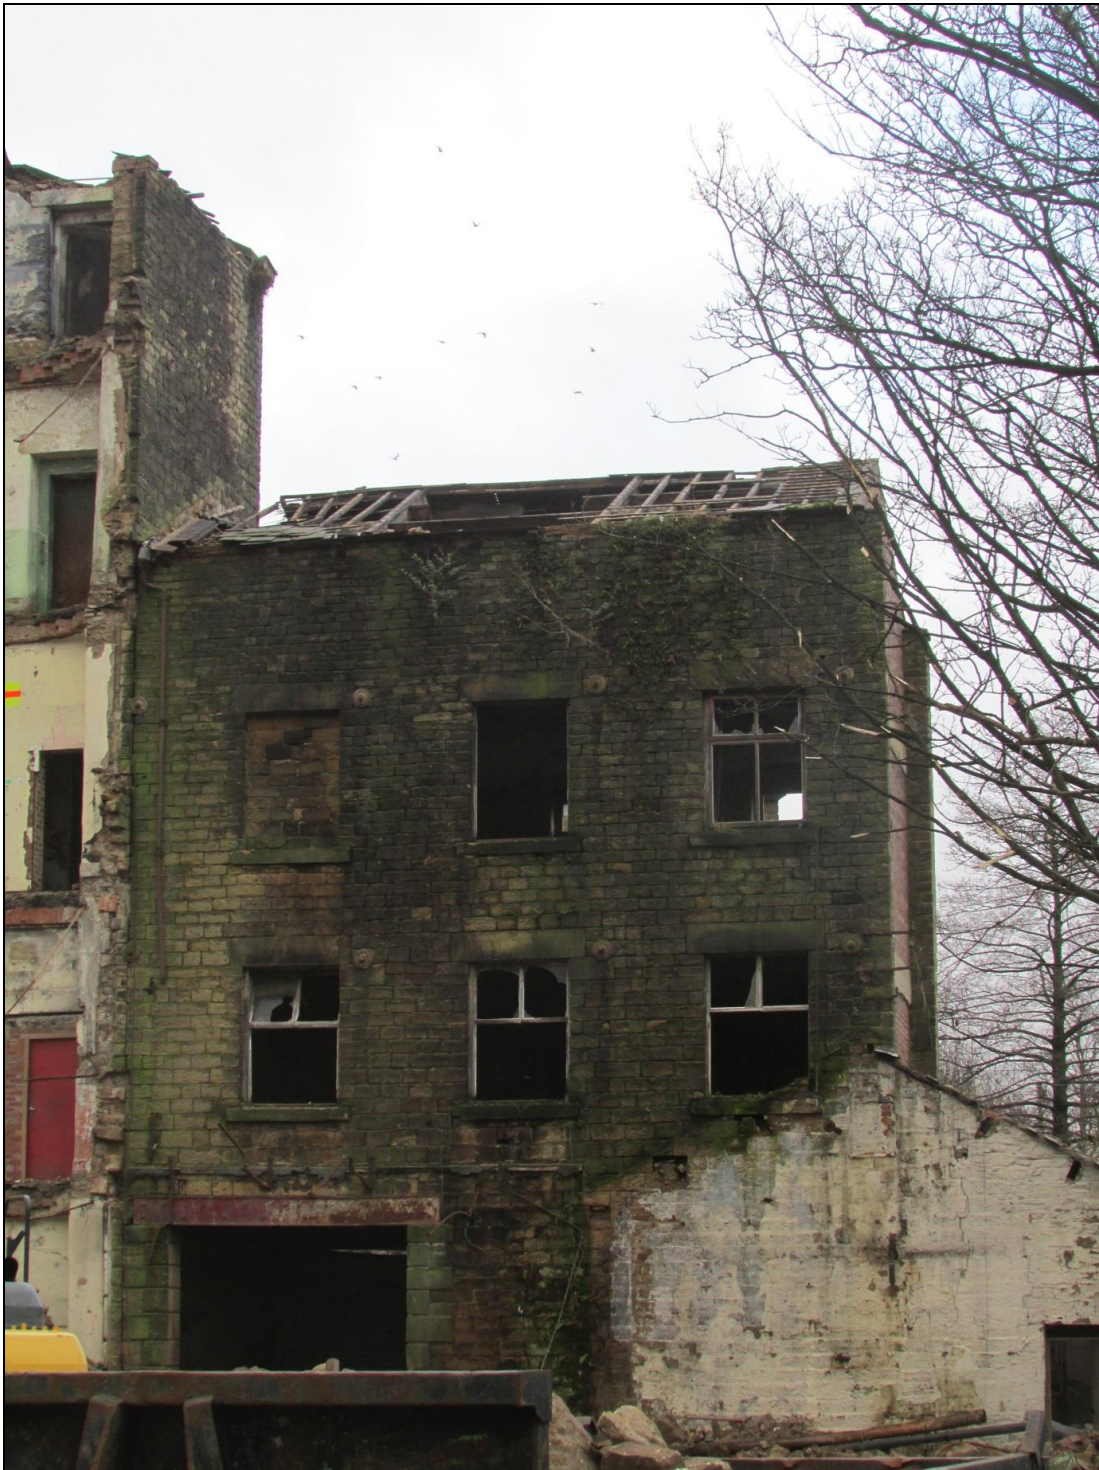
**Plate 67 Western elevation of the office block, after the demolition of the sheds**

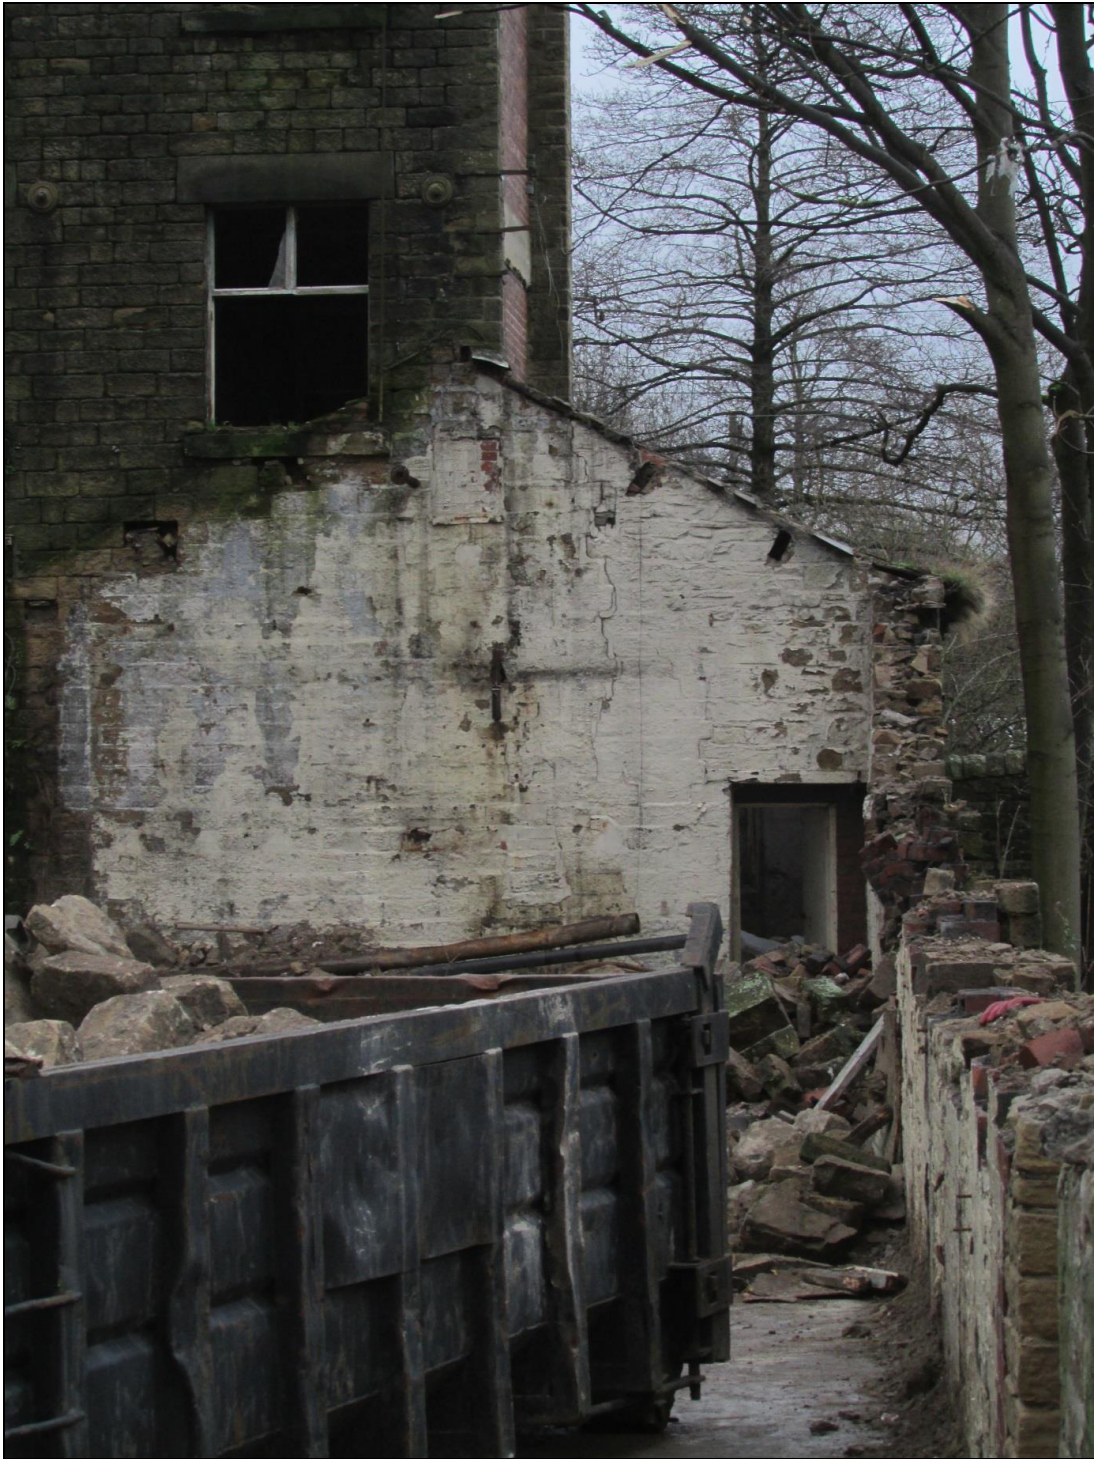
**Plate 68** Close up of the western elevation of the office block

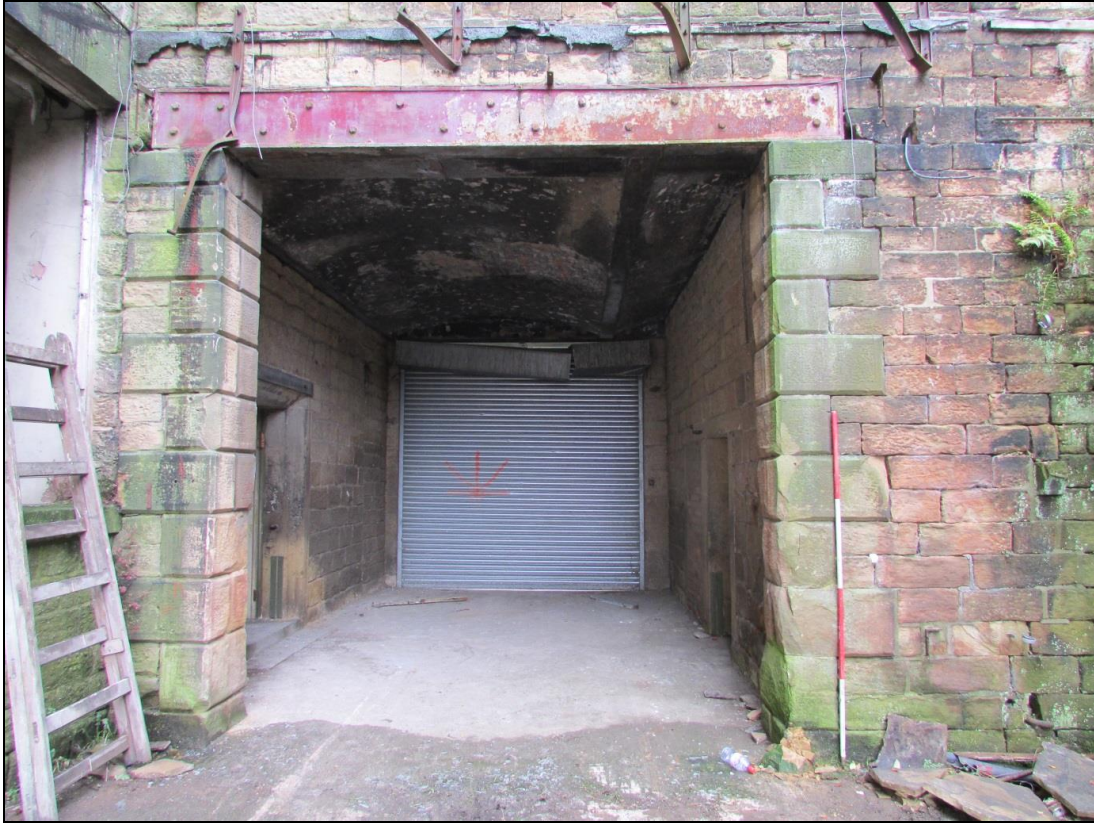
**Plate 69 Entrance to covered walkway between the spinning mill and the office block, also showing a later RSJ and fixtures for a possible canopy above**

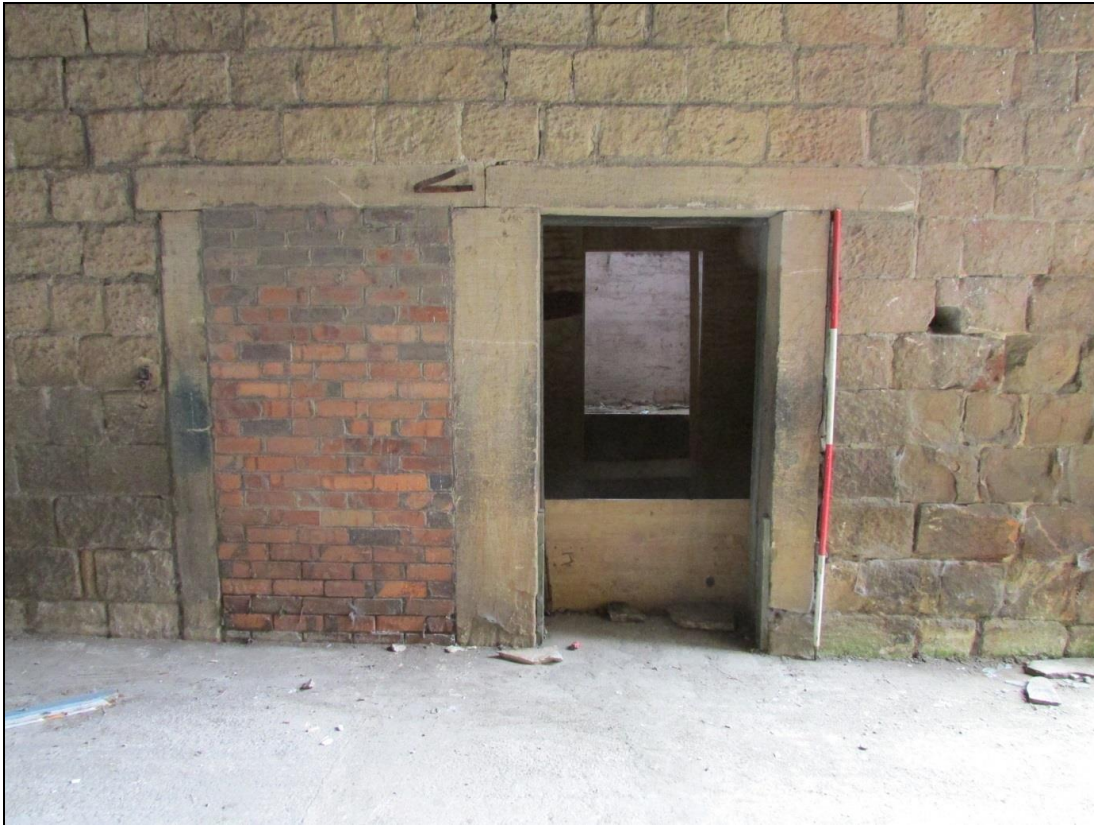
Due to health and safety concerns, the ground-floor of the office block was not accessed. However the entrance was through either one of two doors (one blocked subsequently) on the northern side (Plate 70) or a door from the east, which led into what was probably originally an open room. A later machine-made brick subdivision had been inserted running east/west.

**Plate 70 Entrances into the Office Block, from the covered walkway**

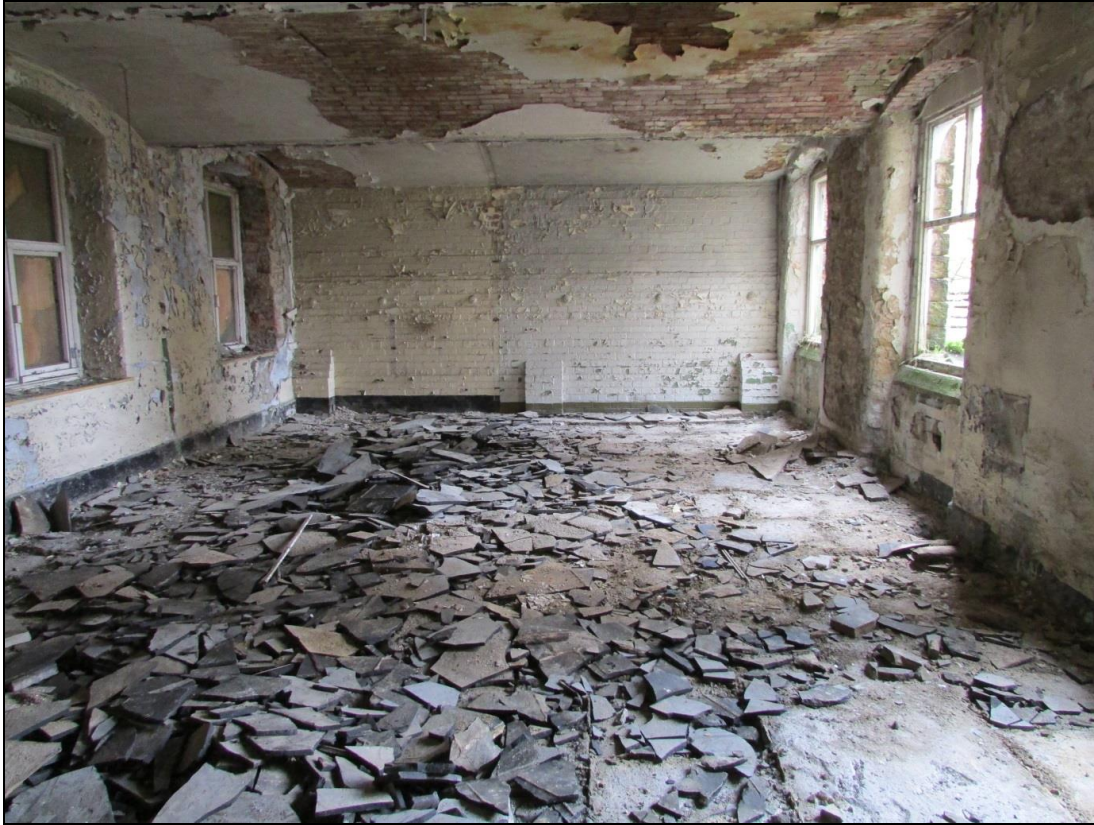
**Plate 71 General shot of the Office Block first-floor**

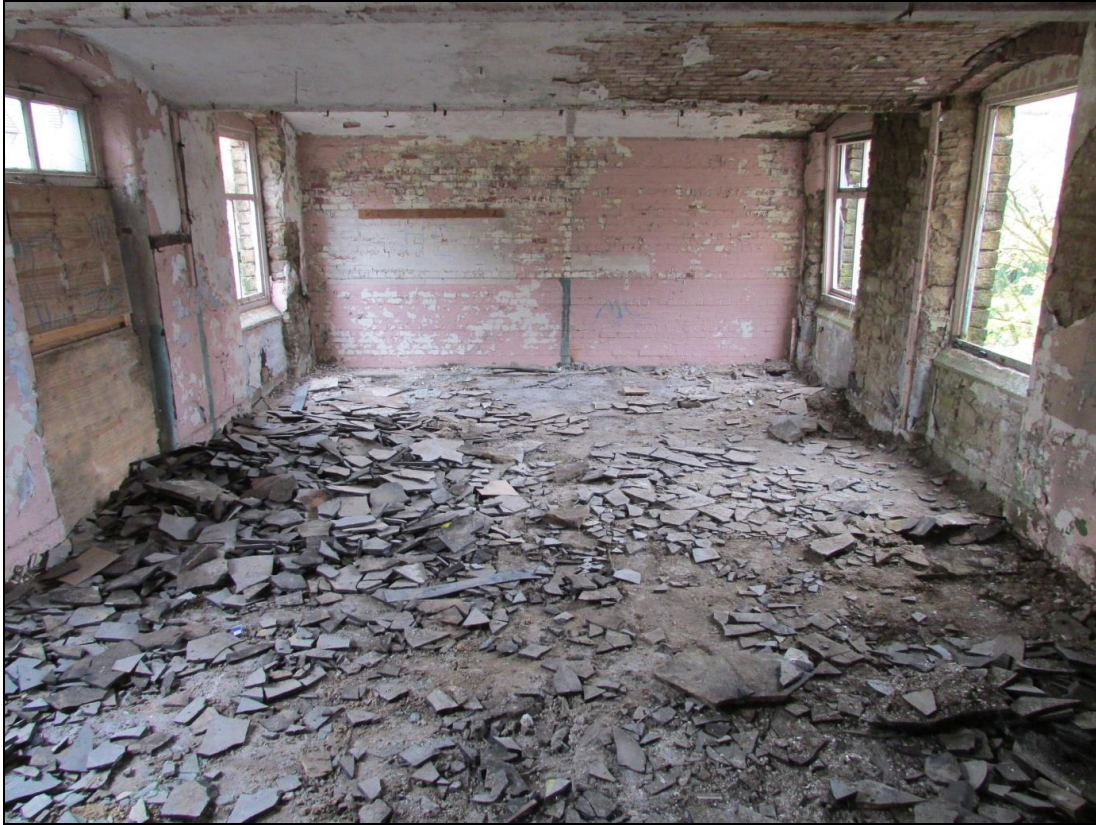
**Plate 72 General shot of the Office Block-second floor**

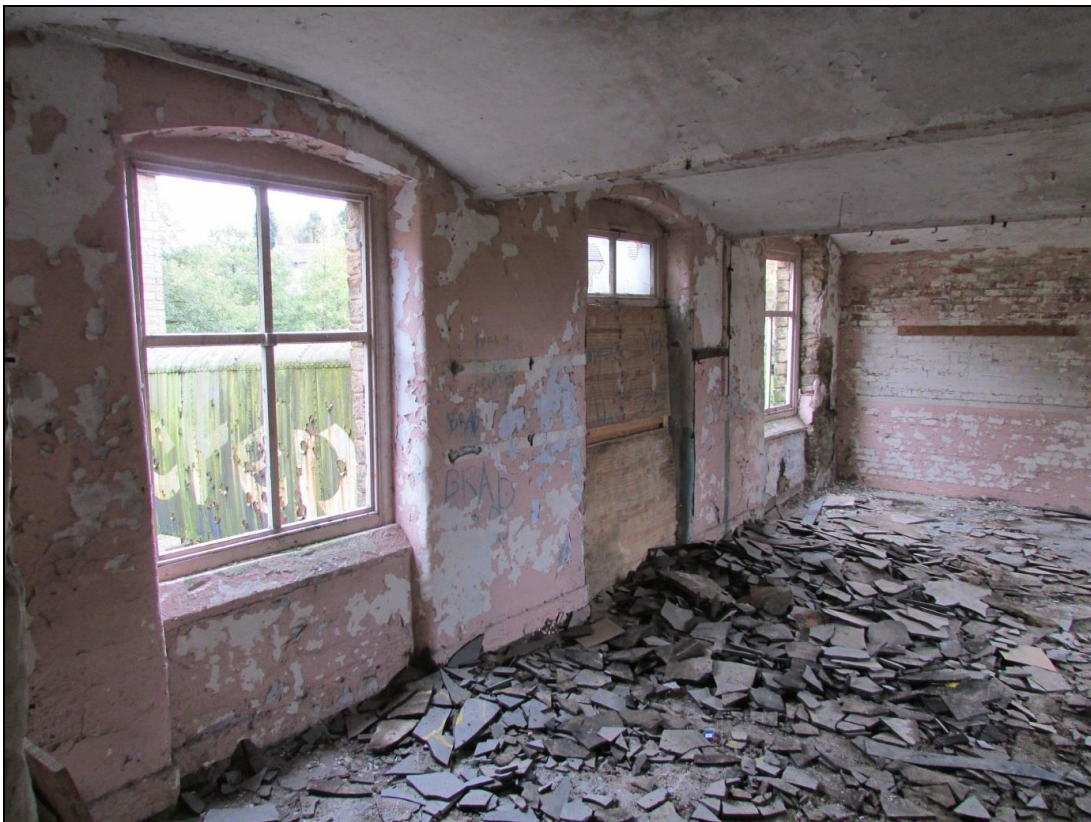
**Plate 73 The entrance to the walkway from the second-floor is visible, although boarded**

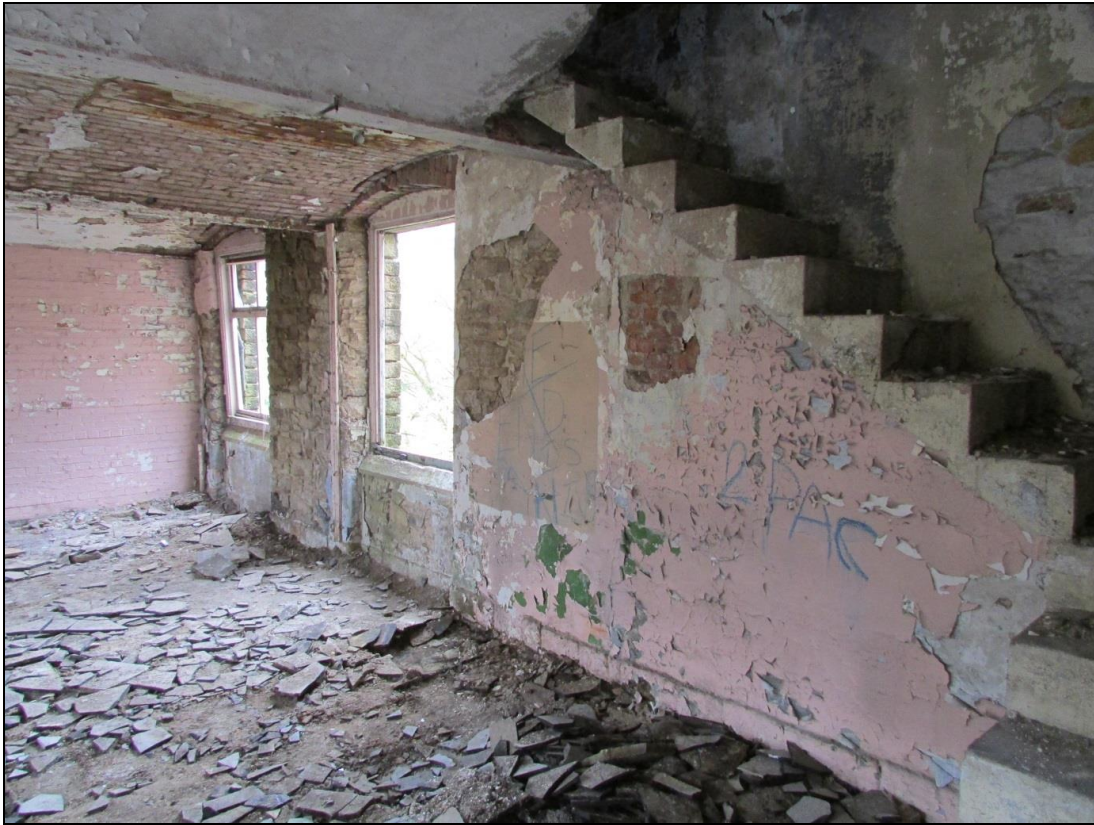
**Plate 74 Later steps leading to the third-floor within the office block. Also visible beneath the plaster is the brickwork blocking one of the windows**

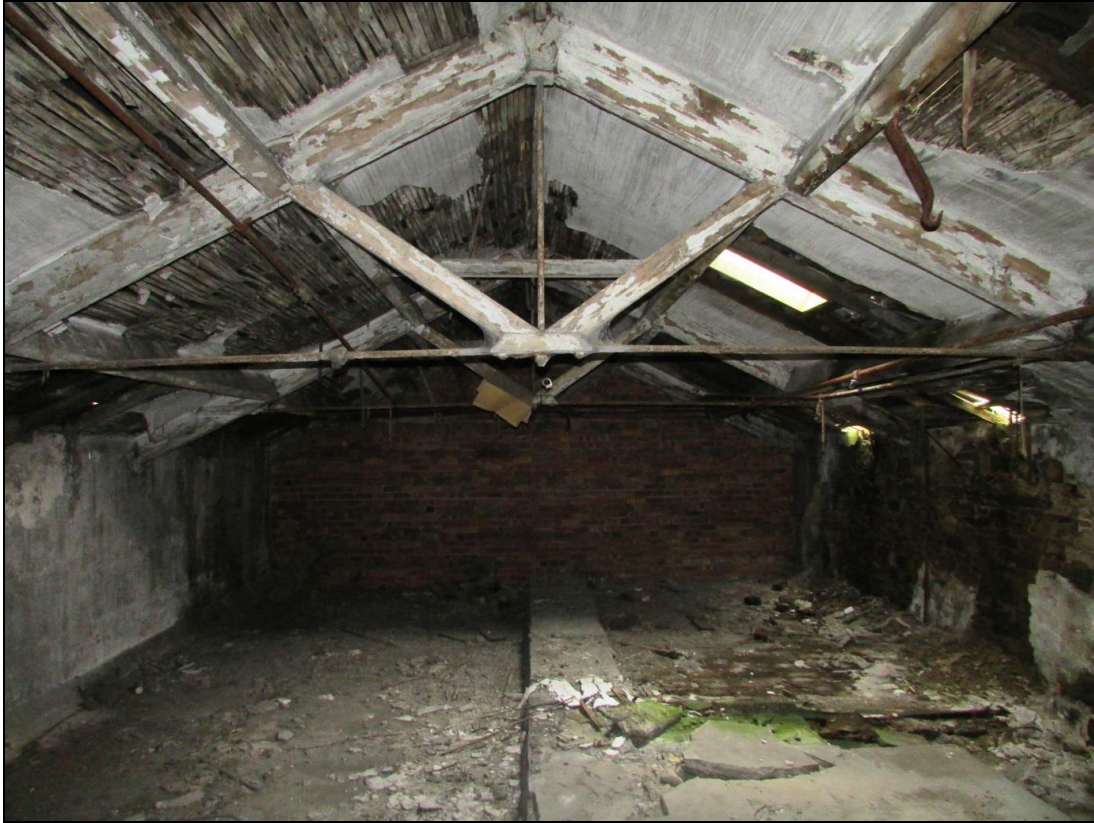
**Plate 75 Office Block third-floor. The later southern elevation is visible at the rear, as well as the single span roof incorporating both iron and timber**

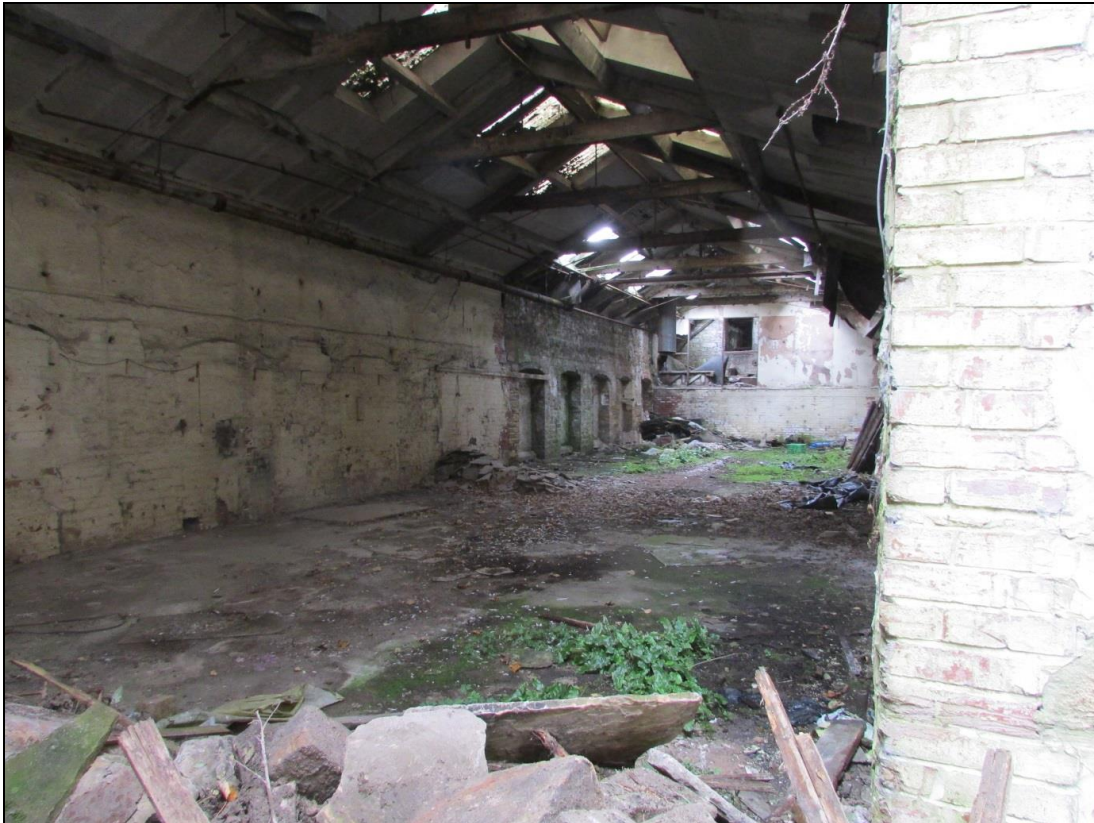
The interior could not be accessed due to the partial roof collapse over the only open entrance into the shed. However, the building was open plan from floor to ceiling, with a machine-made brick sub-division on the eastern side (Plate 80). The interior also incorporated the middle shed, although there was evidence externally to show where the two buildings abutted (Plate 81). The roof was single-span pitched with a timber frame, although the king post appeared to be metal. There were at least three skylights in both pitches of the roof.

**Plate 80 General view of the interior of the eastern and middle sheds. A machine made brick and timber division is visible in the background. Also visible are the former windows which were blocked subsequently**

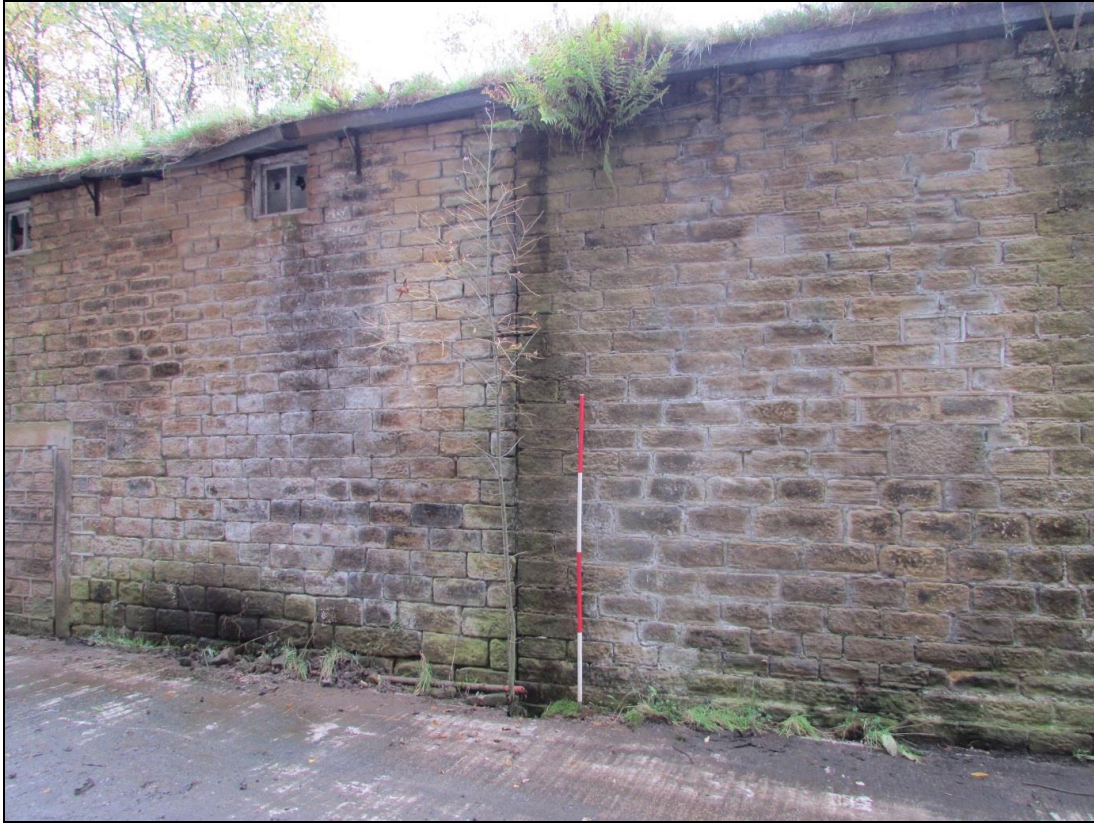
**Plate 81 Butt joint between the east (left) and middle (right) sheds**

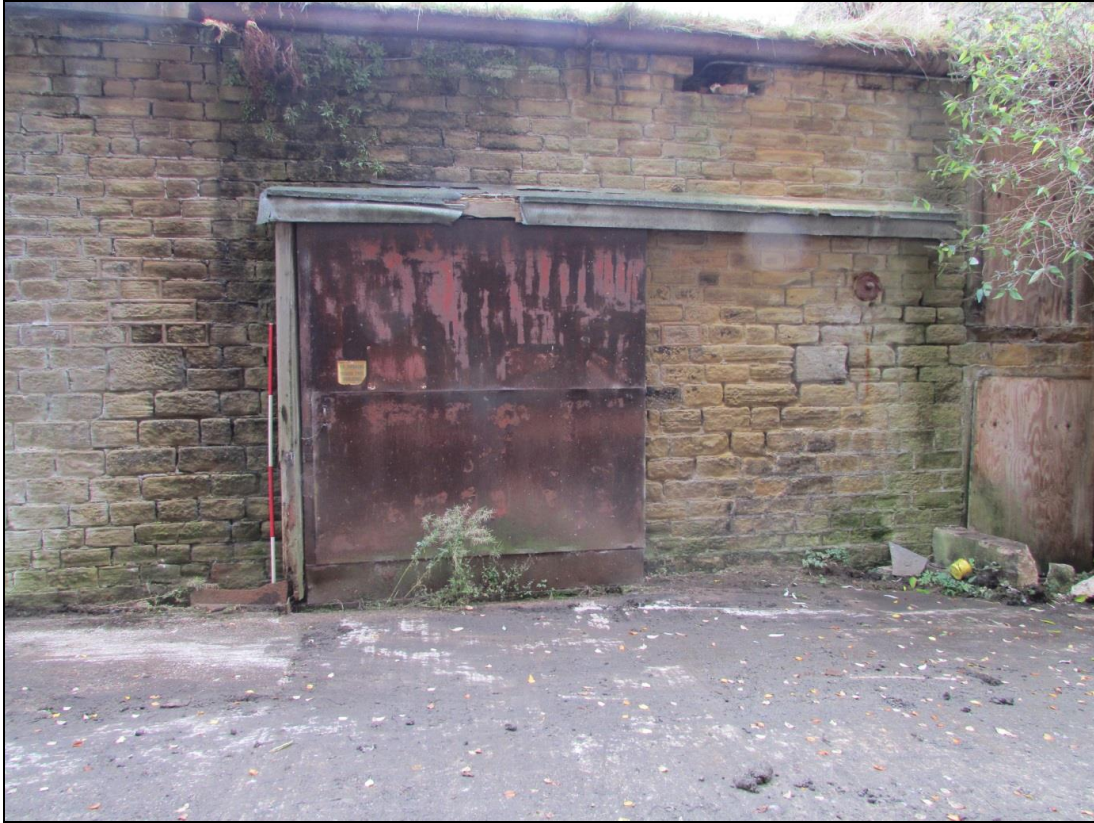
This elevation consisted of small random coursed stones with a gable roof consisting of slate. This abuts the eastern shed and there was a large sliding metal door towards the western end (Plate 83). This had a wooden frame with a small canopy. This appears to be a later addition as to the west at the end of the building, there was a window with dressed stone surround, subsequently boarded. Immediately below this was another opening with dressed stone surround (Plate 84). Although it was boarded, it was likely to have been an entrance with a low-level dressed stone exterior division. Immediately in front of this entrance, however, was a machine-made brick lining for a stone and slate lined drain.

**Plate 83 A later inserted door in the middle shed**

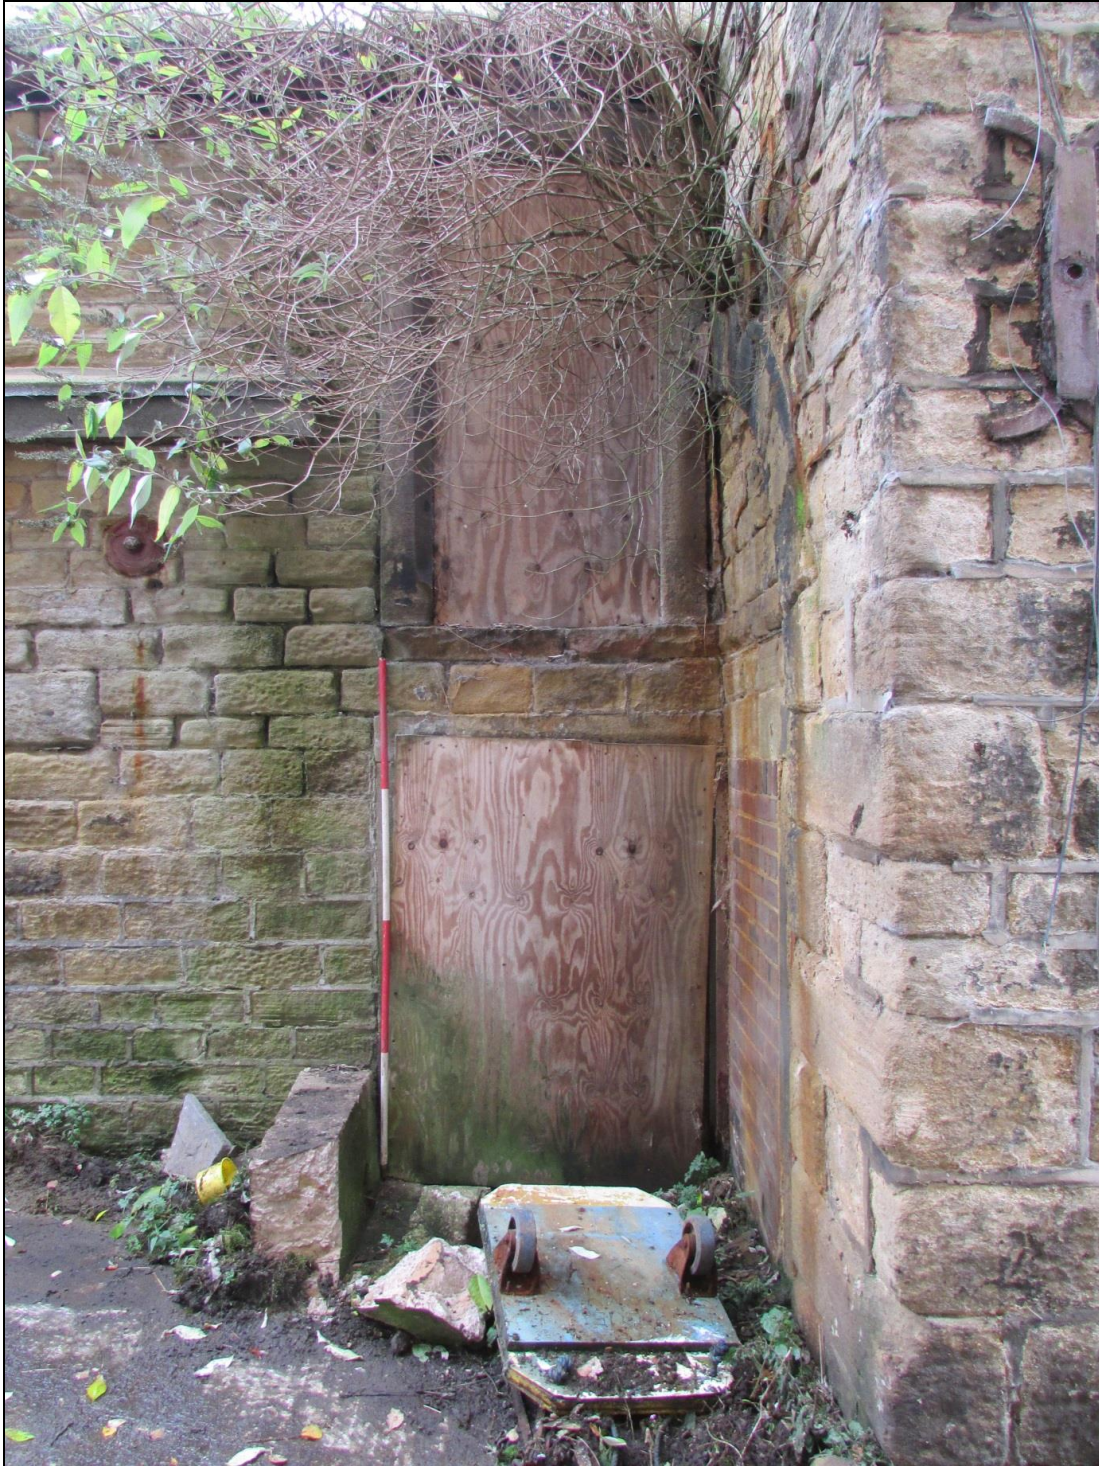
**Plate 84 Boarded entrances into the middle shed**

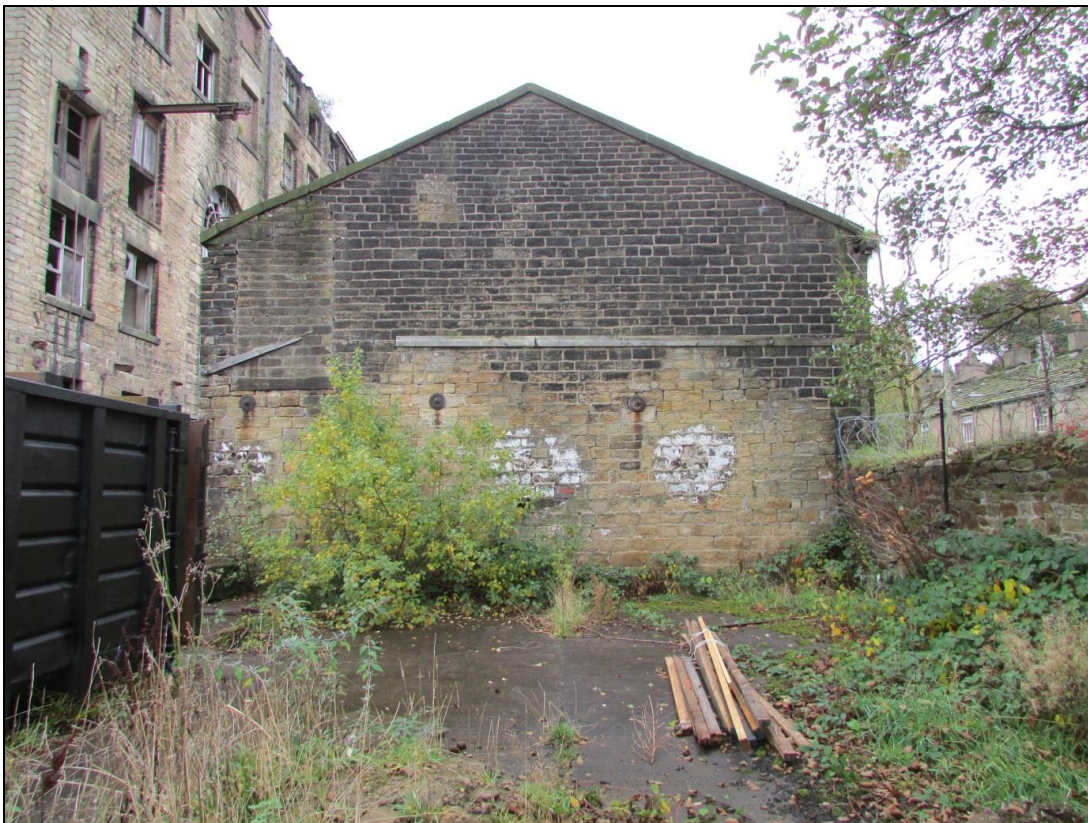
This elevation consisted of small coursed random stones, with a blocked entrance in the upper northern corner. There was a flat stone sill and it was blocked with coursed stone. There were also four tie rod plates, equally spaced horizontally below the door sill. The outline of a double-span asymmetrical roof was visible, indicating the position of a former building appended to the west side.

**Plate 85 Western elevation of the west shed. A blocked entrance/window can be seen in the top left corner as well as the outline of where another shed abutted**

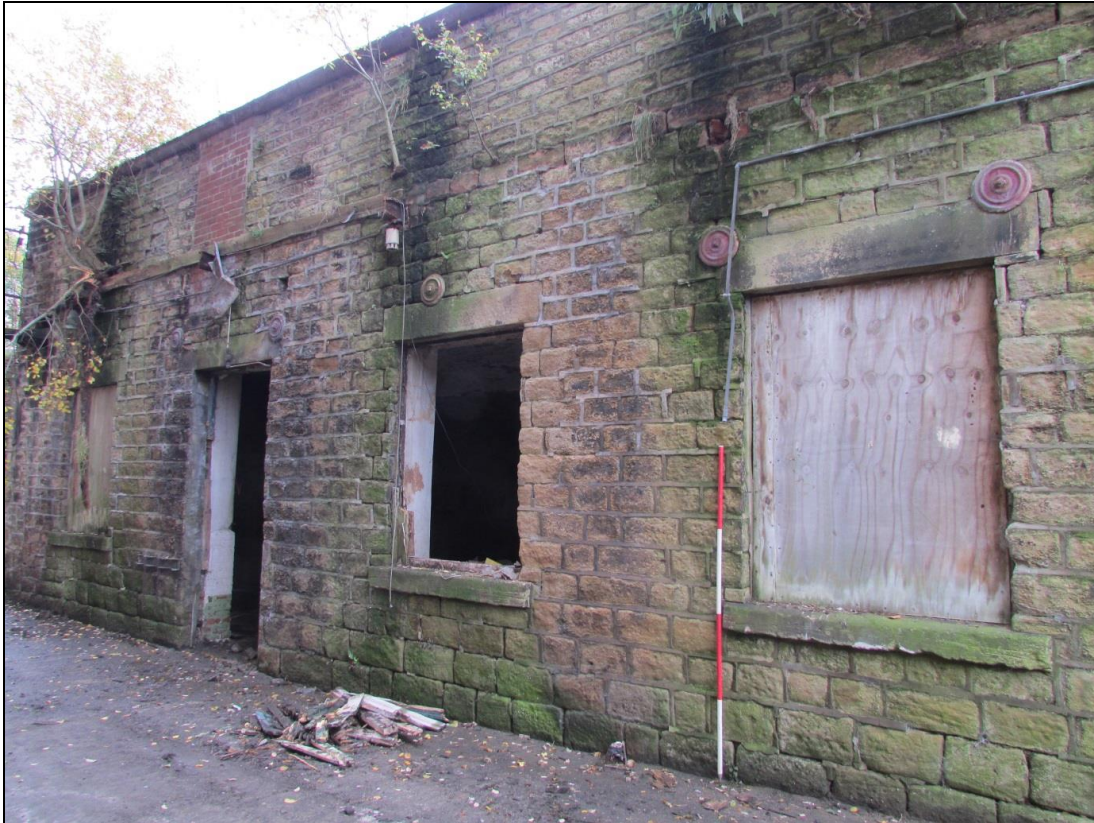
**Plate 86 General view of the west shed northern elevation**

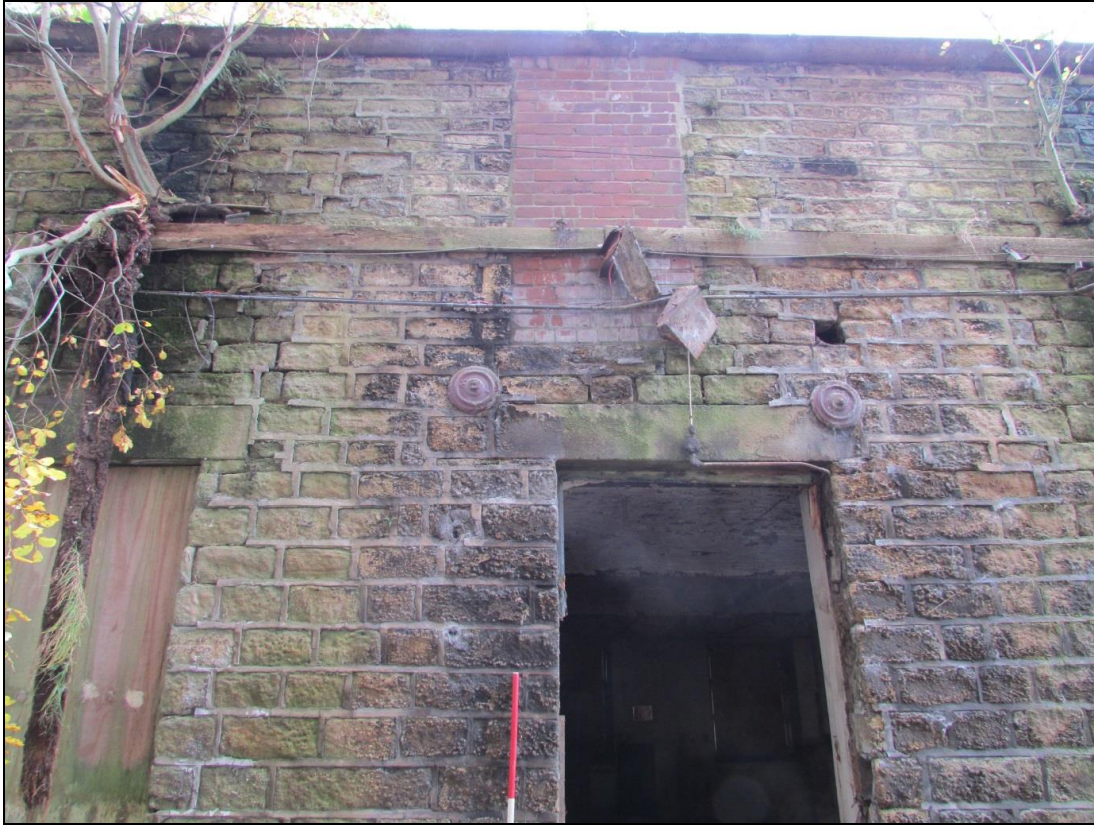
**Plate 87 A possible blocked window is visible above the entrance to the west shed**

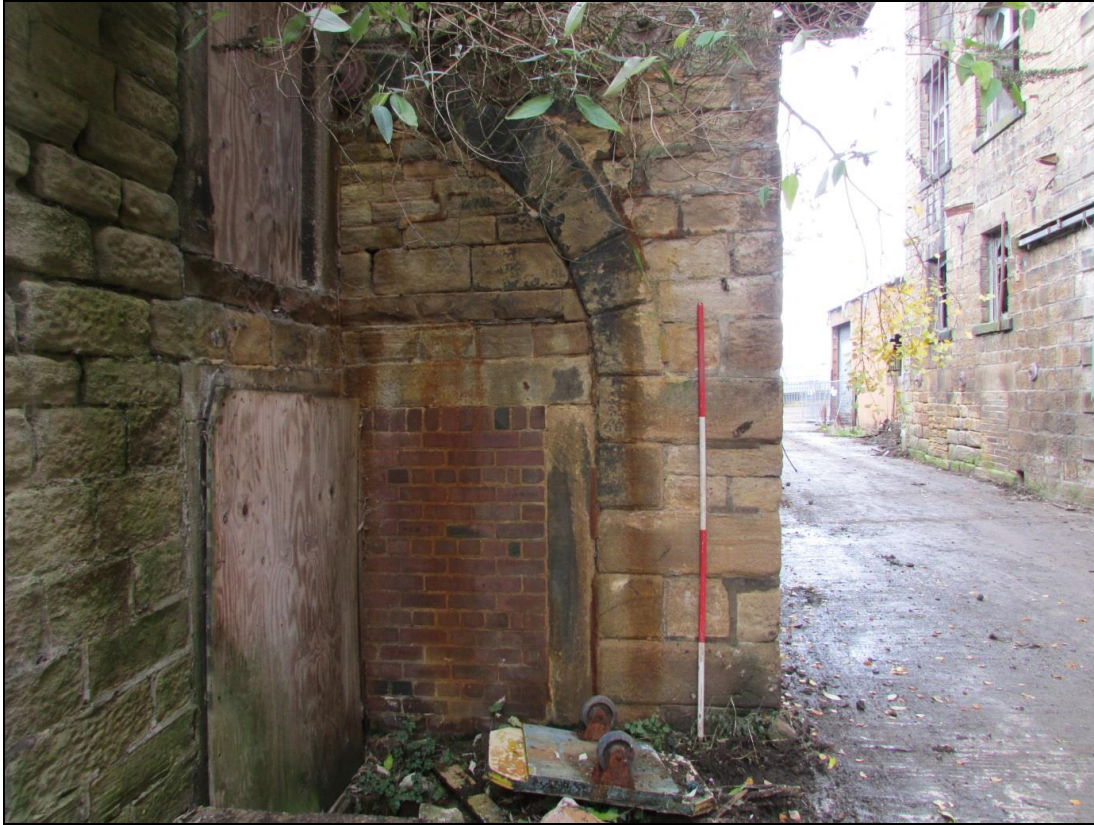
A small portion of this elevation was visible although most was obscured by the middle shed. Part of an arched entrance was visible with a single course of large dressed sandstone ashlar blocks. This appears to have been blocked with coursed stone with a smaller entrance inserted with a dressed sandstone surround. This was blocked subsequently with machine-made brick.

**Plate 88** The eastern elevation of the west shed, with a former arched entrance with two phases of blocking evident

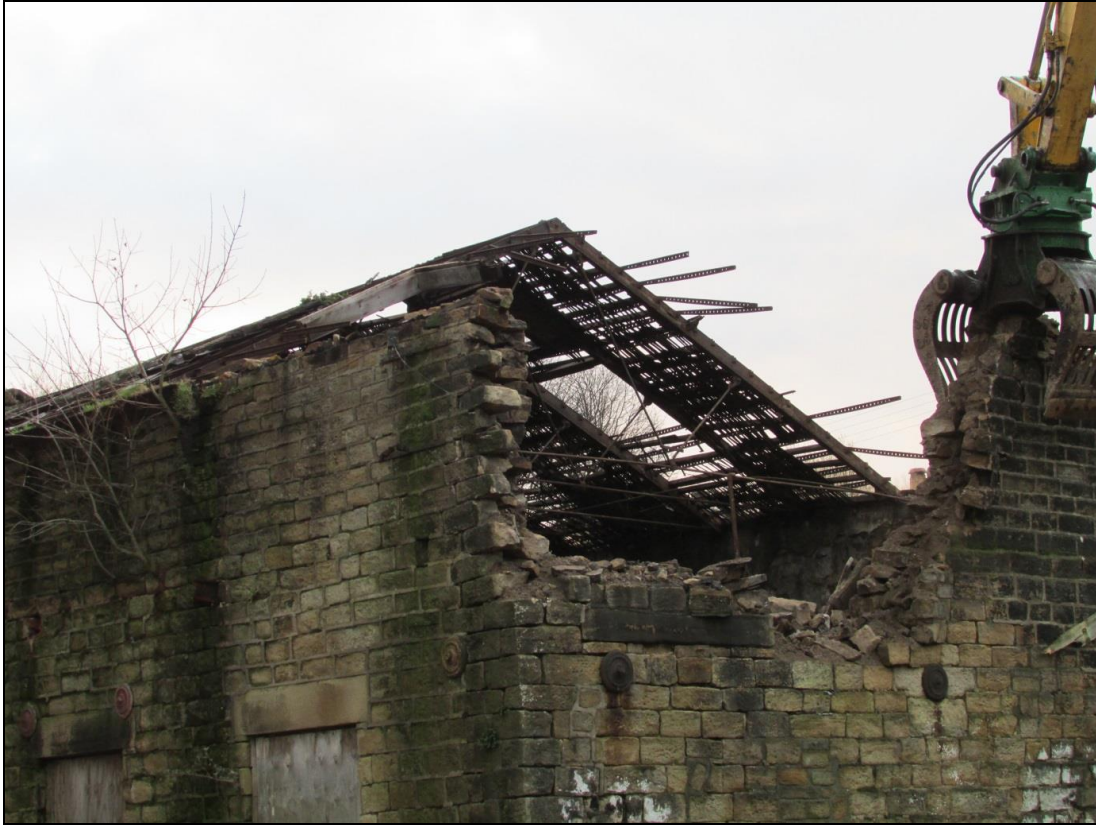
**Plate 89** The west shed during demolition. The roof was constructed entirely from iron

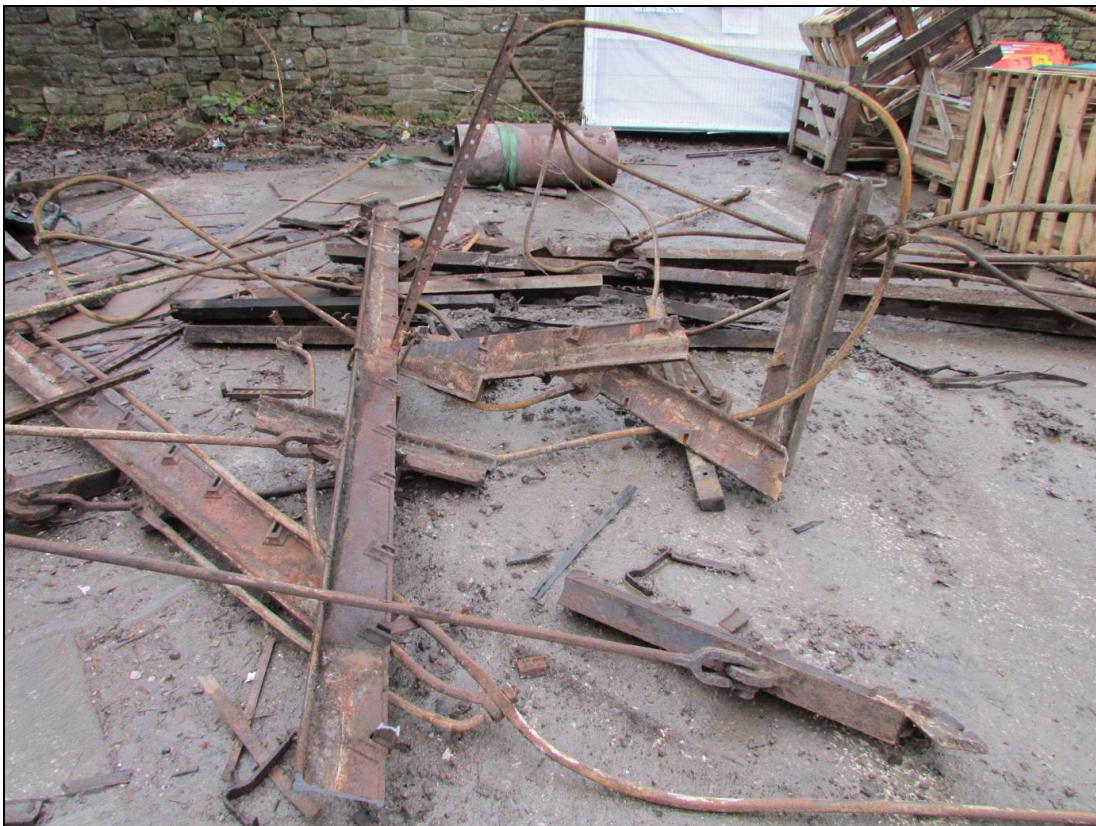
**Plate 90** Remnants of the iron roof of the west shed

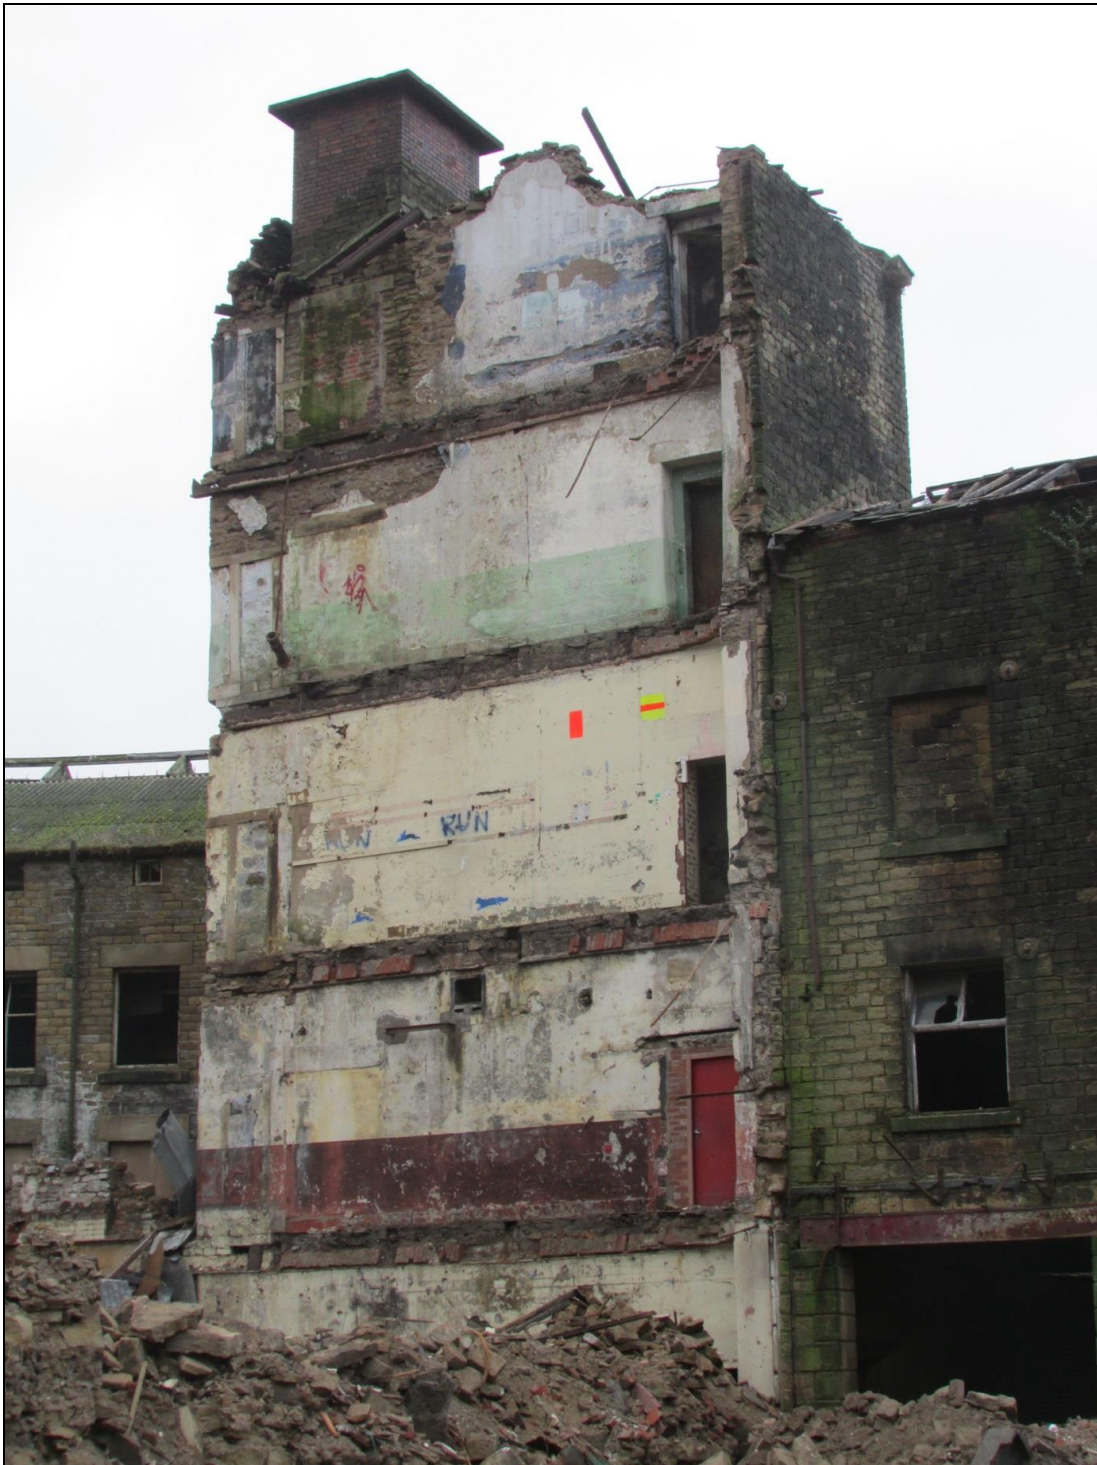
The change to electric appears to be reflected in the reconstruction of the hoist tower as the top of the headgear was partially demolished and reconstructed in brick, with apertures (Plate 91). This is assumed to be down to the change to an electric driven

**Plate 91** The demolition of the central part of the mill revealed the phasing of the lift shaft

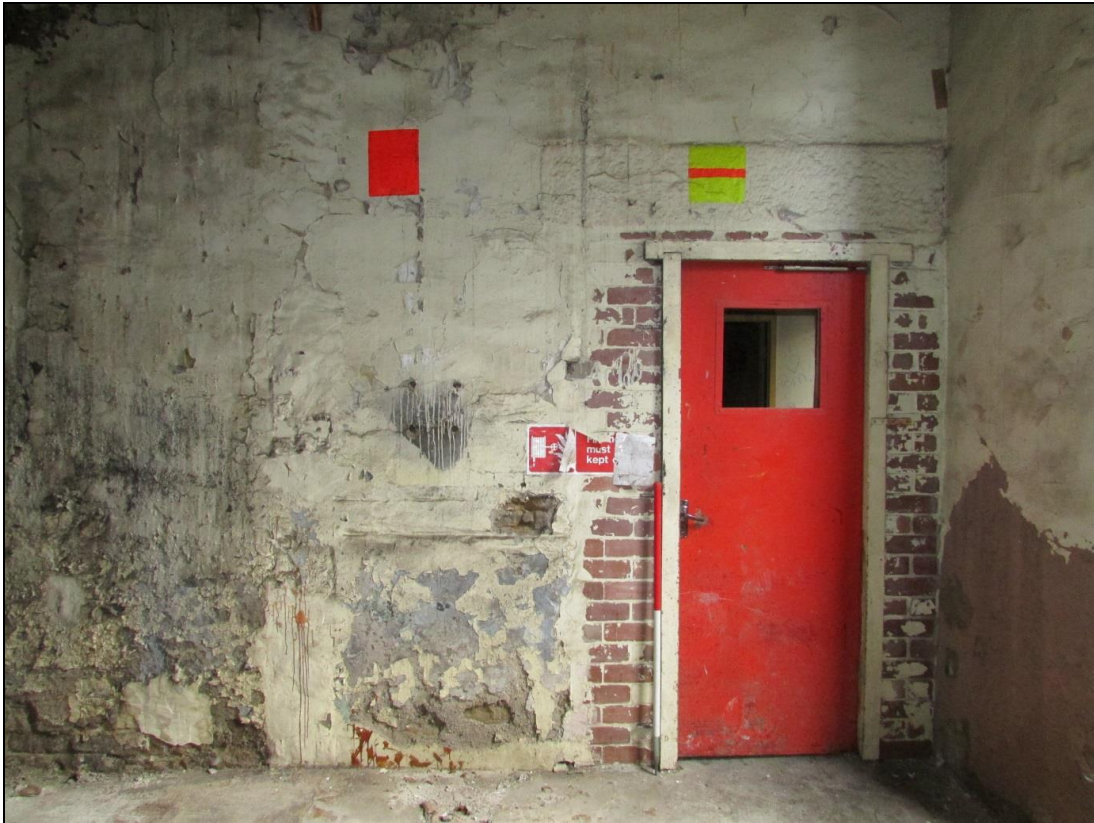
The entrance into the former hoist tower on the ground-floor was modified and made smaller, possibly to utilise the area for storage. Similar materials were used to modify the entrances from the stair tower into the mill. The entrances on all floors (except the fourth-floor) were made smaller by using machine-made brick and inserting fire doors (Plate 92).

**Plate 92** The entrance into the spinning mill from the stair tower, modified and made smaller
