Stability analysis of geometrically non-homogeneous stratified slopes

*R. Sauffisseau¹, A. Ahangar Asr¹

¹School of Computing, Science and Engineering (CSE), University of Salford, Salford, M5 4WT

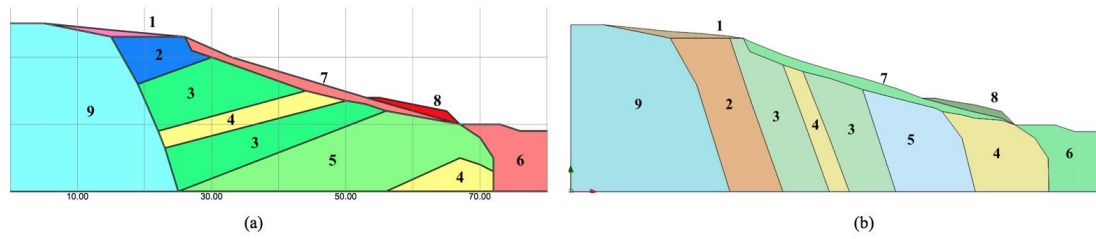
Figure 1: Presentation of the models: Case 1 (original) (a) and Case 2 (b)*

* C: crest location of the slope; Numbering corresponds to a material type as presented in Table 1.

Guo and He [2] used a stratified slope model in their research which is used again here with Limit Equilibrium and Finite Element methods as it is a good representation of a natural slope. To observe the impact the stratification of the ground has on the stability of the slope, the original model was modified by changing the inclination of the main layers within the slope keeping approximate equivalent layer thicknesses (Figure 1 (a) and (b)). With the main focuses being the slope geometry

and stratification effects, the water table was placed very deep and its effects are not considered. Initially, the slope face rests at an angle of 18 degrees, then 56 degrees after the cut (Figure 1 (a) and (b)) to observe any change in behaviour of the slope when increasing the steepness.

Initially, the case study used in this research had a layer of cobblestones (Layer 7 in Figure 1) which was replaced in the analysis by a different material because (i) while running the limit equilibrium analysis a factor of safety of 0.064 was found (very low factor of safety) for the “after cut” case (Figure 2 (b) and (d)) and (ii) it was also observed that this failure was local in the cobblestones at the very top of the slope rather than a general failure. The OASYS Slope software conveniently allows the user to select which failure surface to be shown. Using PLAXIS 2D, the local failure of the cobble-stones was a much greater problem as the software calculates the overall lowest factor of

The slope was modelled to observe its stability and failure mechanisms prior and following a cut. In its natural environment, the slope (case 1; Figure 1) had a factor of safety of 2.201 (stable; Figure 2 (a)), which was observed to drop significantly after the removal of the soil down to 0.839 (unstable; Figure 2 (b)). Regarding the slip surface before the cut (Figure 2 (a)), the high point 'm' was located at 7m away from the crest to the left and the lower point of the failure surface 'n' at $\frac{3}{4}$ down the slope with a maximum normal depth to the slope surface of 10m. After the cut (Figure 2 (b)), the slip surface was 6m to the left of point C (point 'm', closer than previously) and reaches the very bottom of the slope where slope and horizontal ground meet (point 'n') showing a full slope failure. The failure plane was shallower at a depth of 7m.

Then, case 2 (Figure 1 (b)) was modelled and analysed. Prior any excavation, the stratified slope had a factor of safety of 2.131 (stable; Figure 2 (c)), then 0.618 after the removal of the soil (unstable; Figure 2 (d)). Regarding the slip surface before the cut (Figure 2 (c)), the high point 'm' was located at 2m away from the crest 'C' to the left to half way down the slope with a maximum normal depth to the slope surface of 5m. Following the cut (Figure 2 (d)), the slip surface at 'm' followed the interface of the dirty sandstone and mudstone layers (approximately the same as before the cut) and like in case 1, it reached the bottom of the slope 'n'. The failure plane was shallower at a depth of 5m.

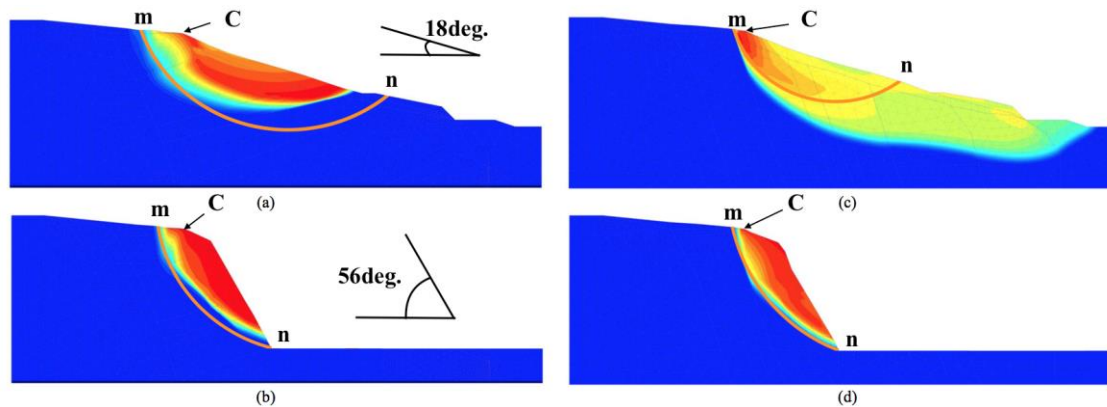
Figure 2: Slip surface results with Limit Equilibrium (orange curved line) and Finite Element (colour shading): Case 1 (a) before and (b) after cut and case 2 (c) before and (d) after cut

The FE method resulted in differences in the factor of safety, the location and shape of the failure line. In case 1, the factor of safety was 1.877 (stable; Figure 2 (a)) before the cut then 0.533 (unstable; Figure 2 (b)): lower than LE (Table 2). Before the excavation (Figure 2 (a)), the slip surface was located at a lower depth than using LE (6.5m-7m) and a non-circular abnormality was observed at the location of the dirty sandstone where the slip surface depth was even lower which can be explained by the shear strength parameters of the soil type ($c=100$ kPa; $\phi=30^\circ$) which were higher than the average layer. After the cut (Figure 2 (b)), (compared to LE), it was observed that the bottom end of the slip surface was not located at the toe of the slope but at approximately 2.5m above this location.

In case 2, a factor of safety of 2.003 (stable; lower than LE, Table 2) was obtained before the slope cut (Figure 2 (c)). Compared to case 1, the top of the slip surface was located 2m to the left of point C (same as LE in case 2) but the bottom end of the slip was located at the very bottom of the slope with a slip located at 10m depth. After the removal of the soil, the factor of safety was 0.545 (unstable; Figure 2 (d); lower than LE, Table 2). As observed in case 2 with LE, an even more significant meeting line between the slip surface and the interface of the dirty sandstone and mudstone layers was observed demonstrating the impact the verticality of the layers has on the location of the slip surface.
