Title: Living with helicopter noise - evaluating sound insulation techniques for domestic dwellings using real helicopters

Abstract

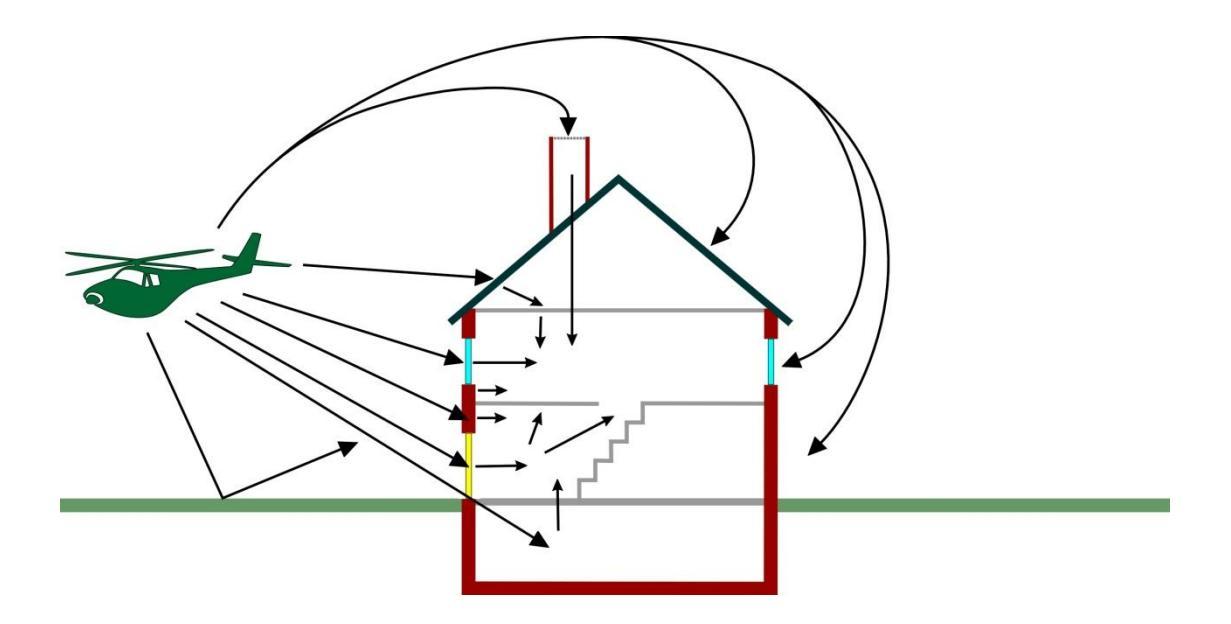
Figure 1: Illustration of sound transmission paths from a helicopter into a residence

Figure 1 illustrates a number of routes by which sound can enter a dwelling. In a conventional UK style brick built house, the walls and substantial roofs usually provide effective sound insulation but single glazed windows, lightweight or badly fitting doors, roof spaces without internal sound absorption (or constructed from lightweight timber/felted sections) and ventilation bricks and conventional chimneys can significantly reduce its effectiveness resulting in intrusive levels of noise in habitable rooms.

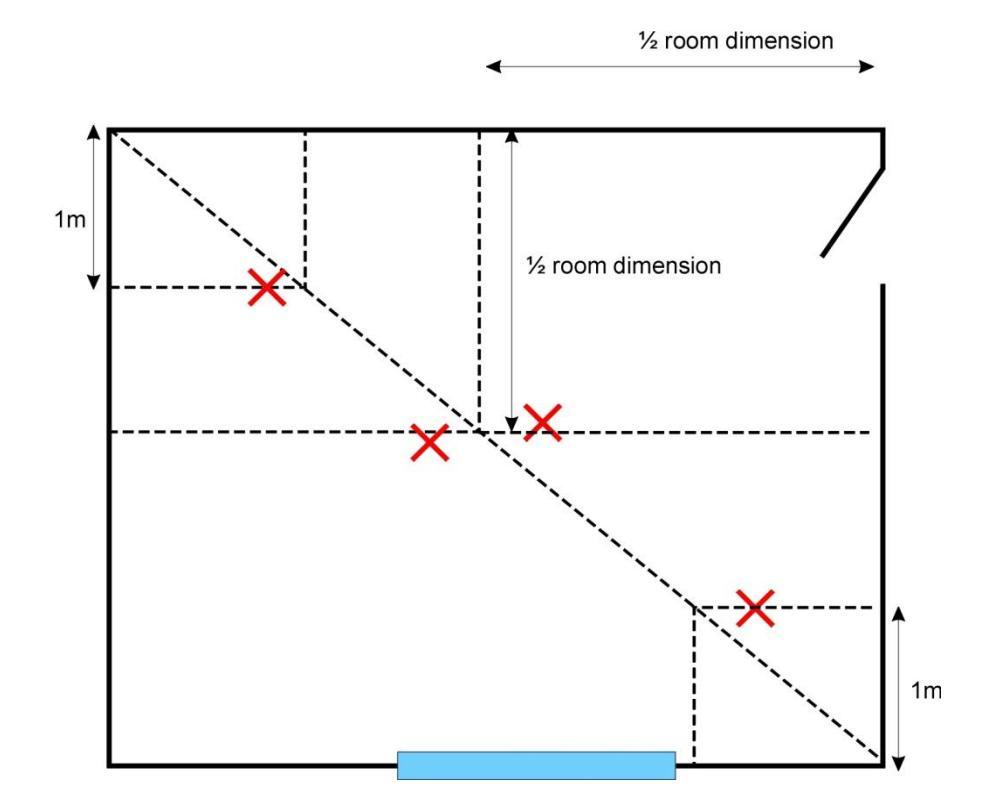
Figure 2 Typical microphone positions

Microphones were placed simultaneously inside and outside selected rooms. Inside, microphone positions were selected to ensure a reasonable spatial average of the flyby level would be obtained and to minimise undue room mode effects. Four positions were defined in each room as shown in Figure 2, chosen initially by drawing an imaginary diagonal across the room and placing the microphone tripods approximately:

- 1. One metre along the outside wall away from the front window wall and just off the diagonal
- 2. Half way down the outside wall, just off the diagonal
- 3. Half way along the window wall and just off the diagonal

4. One metre from the rear wall and from the internal wall

The microphone was fixed vertically on the tripod at either 1.2 or 1.5m above the floor. Usually two positions were selected at each height and the microphone offset ensured that the microphone positions were not symmetrical.

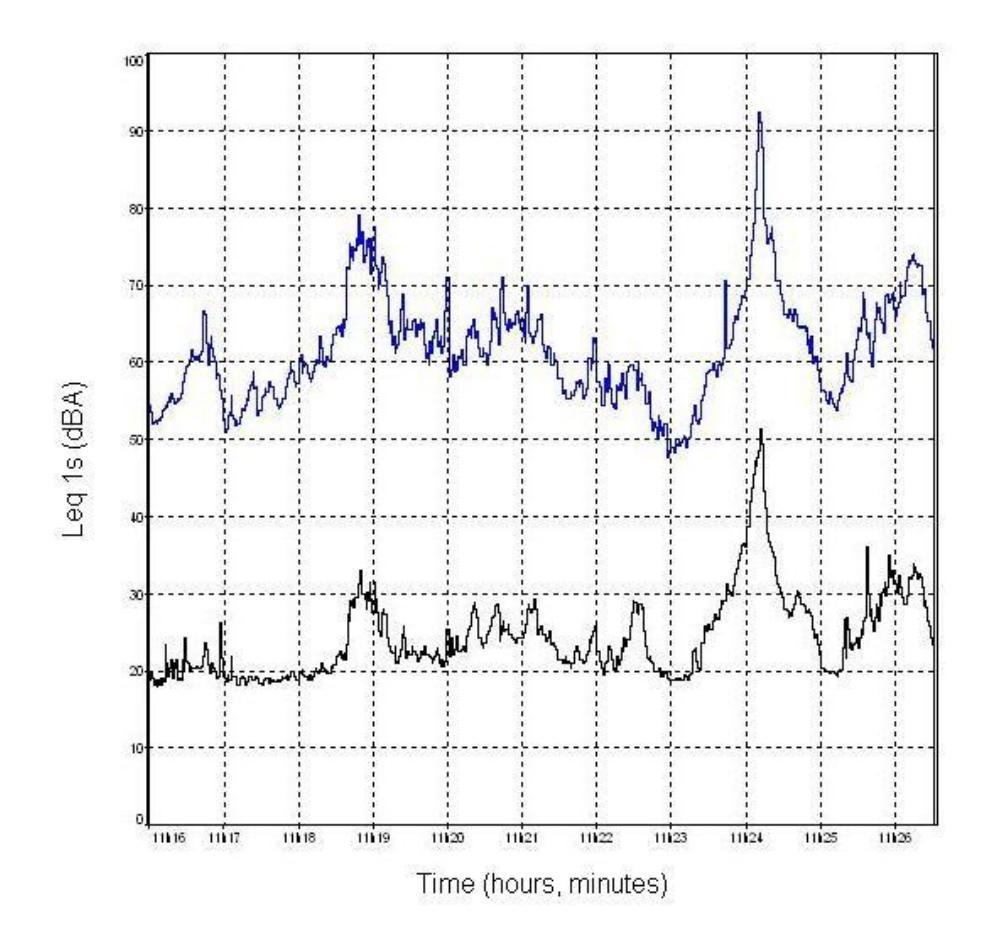
Figure 3: Leq dBA level time histories measured inside and outside the front left bedroom. High level trial flyby used for insulation calculations: 11h24m08 to 11h24m14. Routine operational flyby: 11h16m36 to 11h16m52

For each recorded flyby, the time the helicopter was in close proximity to the dwelling was taken from the time history, and defined as the time the noise level was within 10dB of the maximum level as measured on the external microphone. The time averaged one-third octave spectra were calculated for each microphone, internally and externally. The differences between the measured external and internal 1/3 octave spectrum measured at each microphone for each flyby was calculated, and the sound insulation was then calculated as the average of these differences.^a An example of a measured time history is shown in Figure 3.

Examples of the time histories of these operational flybys can be seen in Figure 3 alongside examples of the trial flybys. Generally the flyby levels generated outside a dwelling in the vicinity of an airfield or helicopter landing ground will be dependent on the type of aircraft, the type of manoeuvre and the track and distance to the dwelling and the relative amount of shielding that parts of the dwelling itself might provide. The data presented in this section should only be considered as an example of the noise levels that can be expected at this particularly property when a particular runway is in use. The results are presented in Table 3 in terms of the A and C weighted equivalent continuous noise level (Leq) over the relevant noisiest part of the flyby and as spectra in Figure 6.

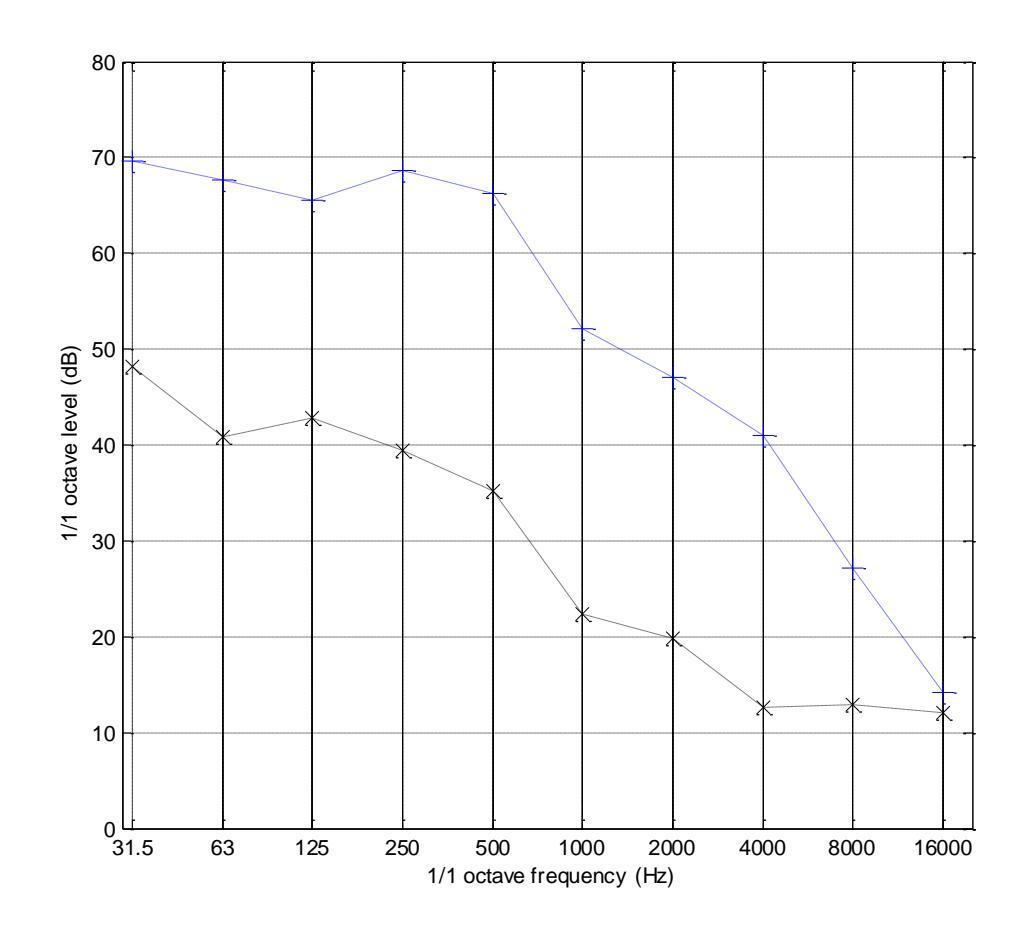
Figure 4: Internal (black) and external (blue) spectra for a typical flyby.

Examples of internal and external noise levels and spectra are given in Figure 3 and Figure 4. The analysis was carried out in 1/3 octave bands but to simplify the discussion the data have been reduced to octave bands and the resultant measured sound insulations plotted in Figure 5. A simple single value measure of the sound insulation is provided by the weighted standardised level difference $D_{H,1m,nTw}$ in Table 2. This has been compiled using the basic 1/3 octave data. The single number quantity term $D_{H,1m,nTw}$ is essentially the same as the term $D_{E,1m,nTw}$ which is derived from the octave $D_{E,1m,nT}$ values. The subscript _H has been substituted for _E to clarify that the source is a helicopter.

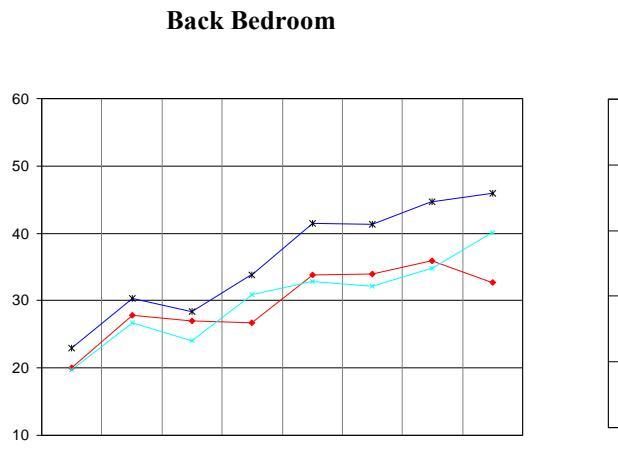
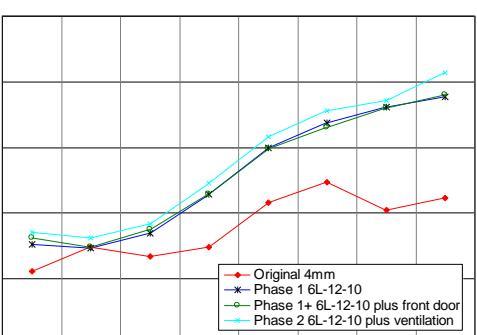
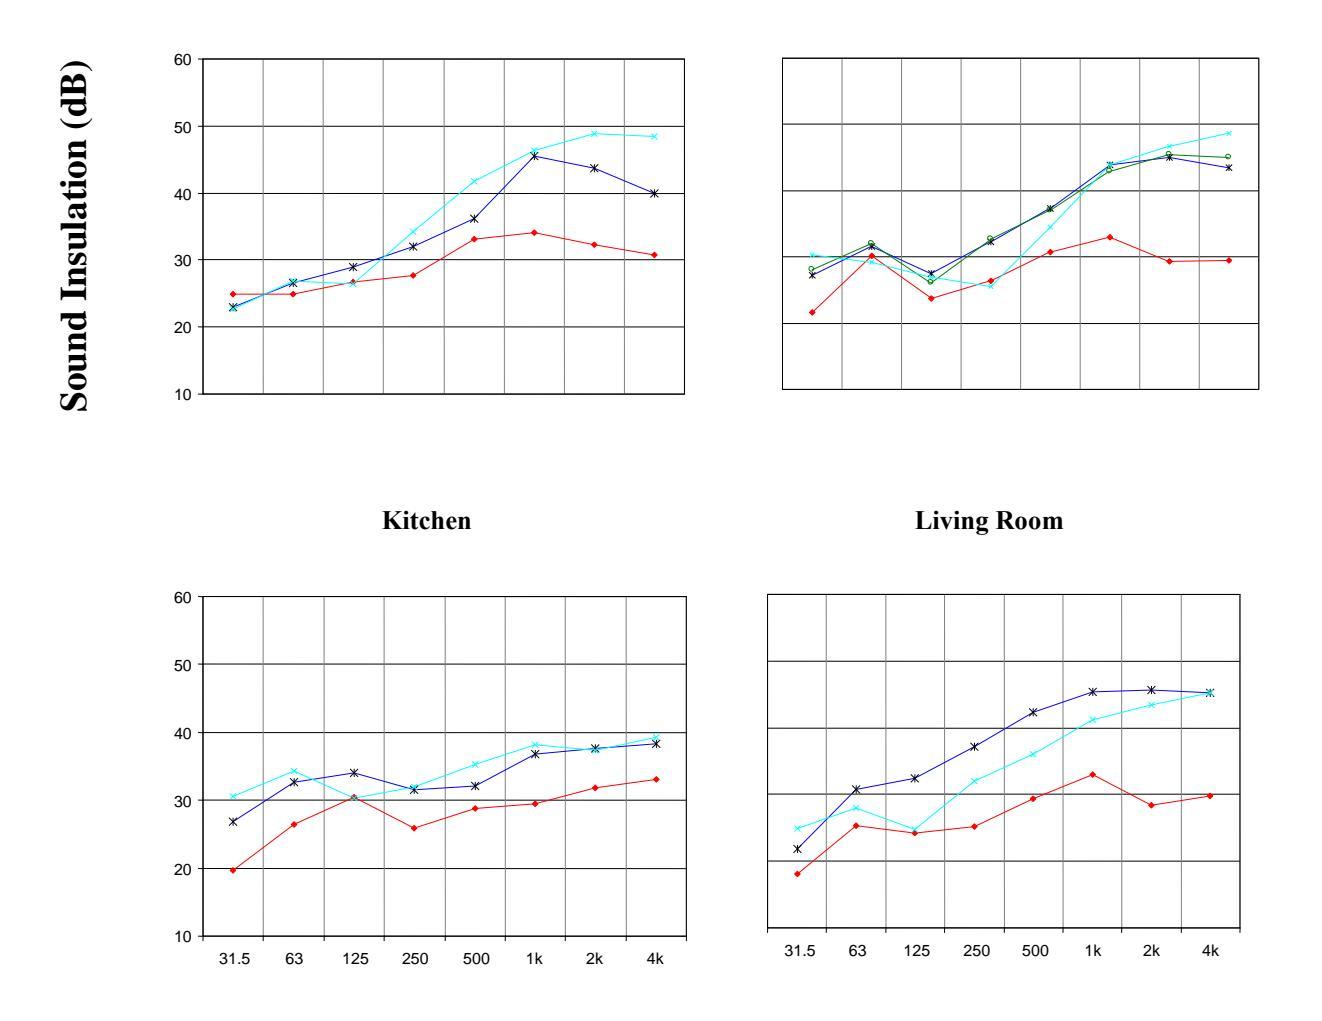
Figure 5: Sound insulation measured in each room

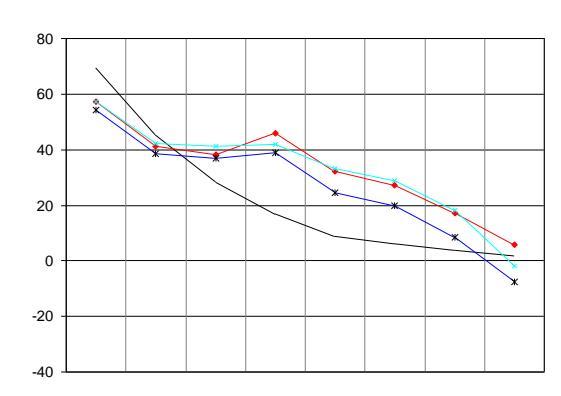
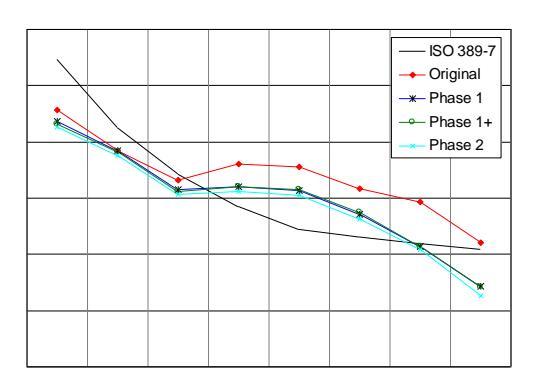
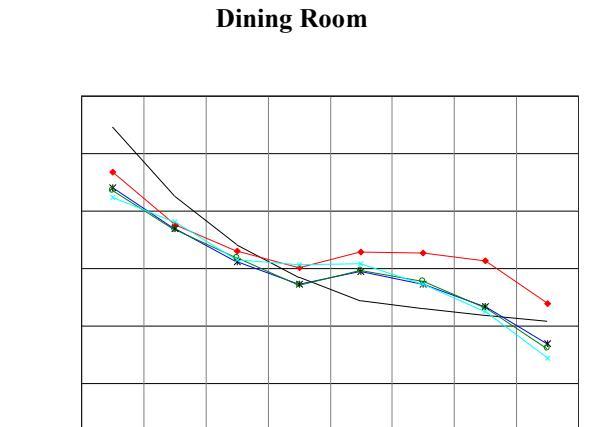
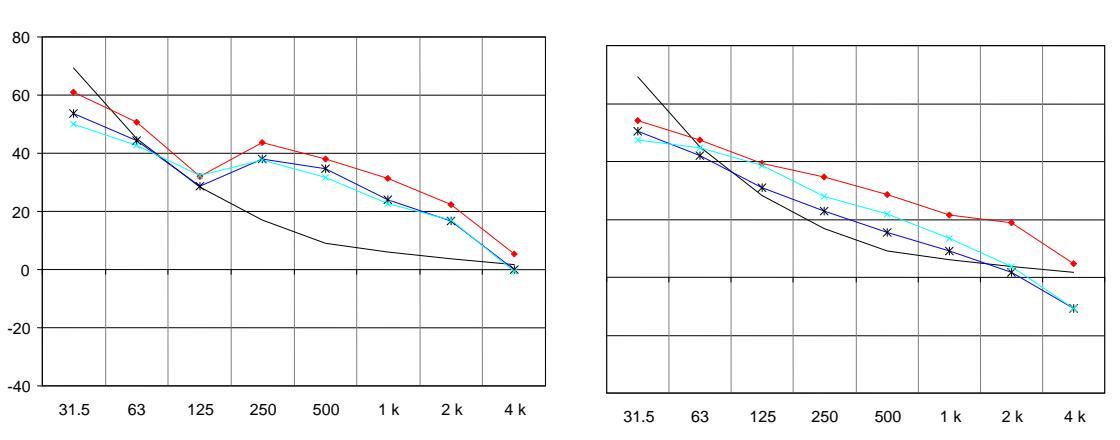
Figure 6: Internal noise level measured in each room
