Measurement and Characterisation of Faults in the Intake System of a Turbocharged Engine Using a Directional Acoustic Probe

R. Mishra¹, B. Fazenda¹, F. Gu¹, C. Stubbs¹, A. D. Ball¹

University of Huddersfield, U.K.

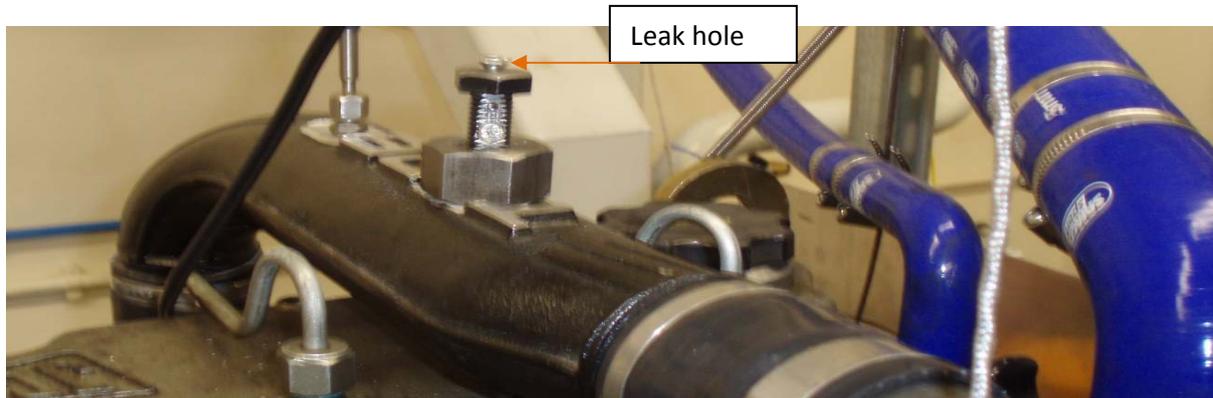
Figure 3 - Leak hole location on the outlet of turbocharger compressor

In the present investigation experiments were conducted for four different leakage conditions. These include no leak condition as well as leak through 3mm and 5 mm diameter holes. The leaks were created by drilling the holes on a bolt. As shown Figure 2 and Figure 3, the bolt is mounted on the immediate downstream of the turbocharger.
