Understanding Our Heritage: Monitoring of energy and environmental performance of traditional terraced houses of Northern England.

Keywords – Traditional Housing; Monitoring; Energy Performance; Northern England; Terraced Houses

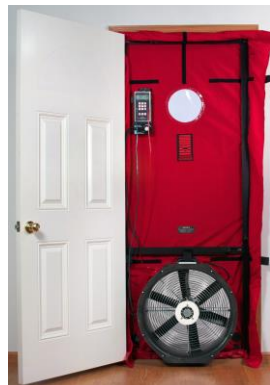
Figure 4: Air tightness test

Air tightness testing: Air tightness tests using the ‘blower door’ method (figure 4, above) were carried out to determine the rate of air infiltration. The test gives a result as a q₅₀ value, being the volume of air (m³) infiltrating the building envelope (m²) per hour (hr) at a pressure difference of 50 pascals (50pa). The tests conformed to BS EN 13829:2001 methodology [17].

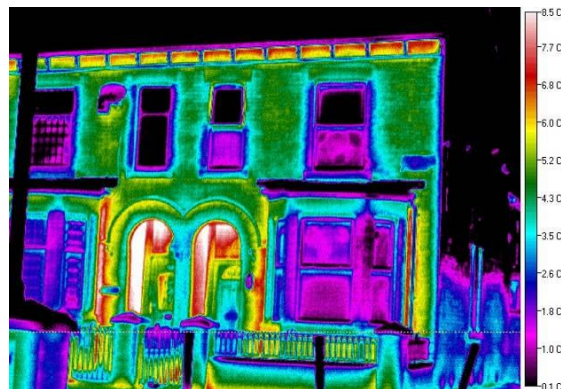
Figure 5: Thermographic image

Thermography: For maximum accuracy, and in conformity with the BS EN 13187:1999 methodology [18] (Figure 5), the surveys were carried out in the evening at least 2 hours after sunset when the internal temperatures of the building were a minimum of 10°C higher than external air temperature.

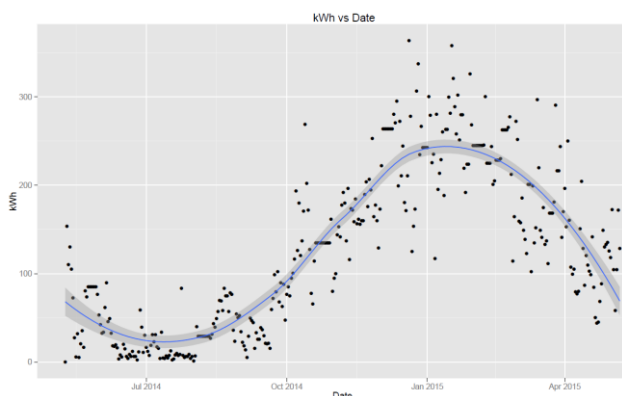
Figure 6: kWh gas use by date (example)

Bottom-Up: Energy consumption is a key indicator to evaluate the improvement of a retrofit strategy. Gas and electricity consumption has been measured in all the selected houses. A first problem encountered was that primary energy use data cannot be compared between houses directly as the monitoring interval was not identical. As an assumption, degree day regression was used to normalize the energy use against external temperature. Graphics comparing the consumption and the degree day regression assumption has been developed for all the houses what allows direct comparison of energy data from multiple houses over different time periods (see Figure 6 and 7). The distribution of the values in figure 7 display a strong positive correlation, with an r^2 value of 0.77. This is at the high end of the range of r^2 values indicating that the energy use in this house is particularly responsive to changes in temperature, suggesting an effective use of heating controls.
